THOMAS PENDLETON HOUSE

PRESERVATION PLAN

August 2, 2022

RQAW Corporation
8770 North Street, Suite 110
Fishers, IN 46038
Phone: (317) 588-1762
www.rqaw.com

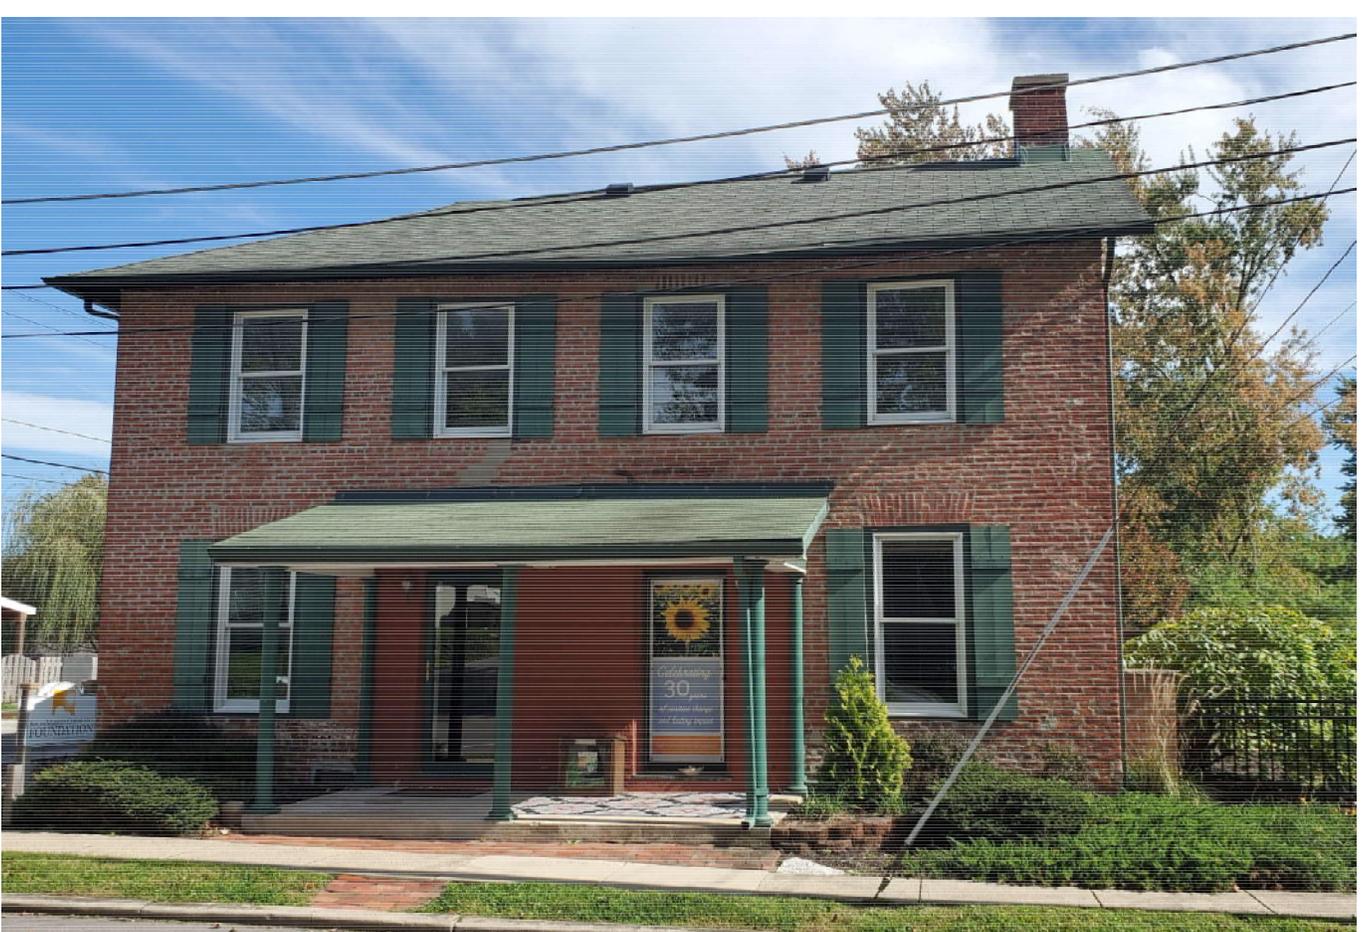
1. Integrity with original fenestration and gable/hip roof. Shed roof porch addition and faux shutters reduce integrity. Recommend removing the porch and faux shutters to restore the façade.

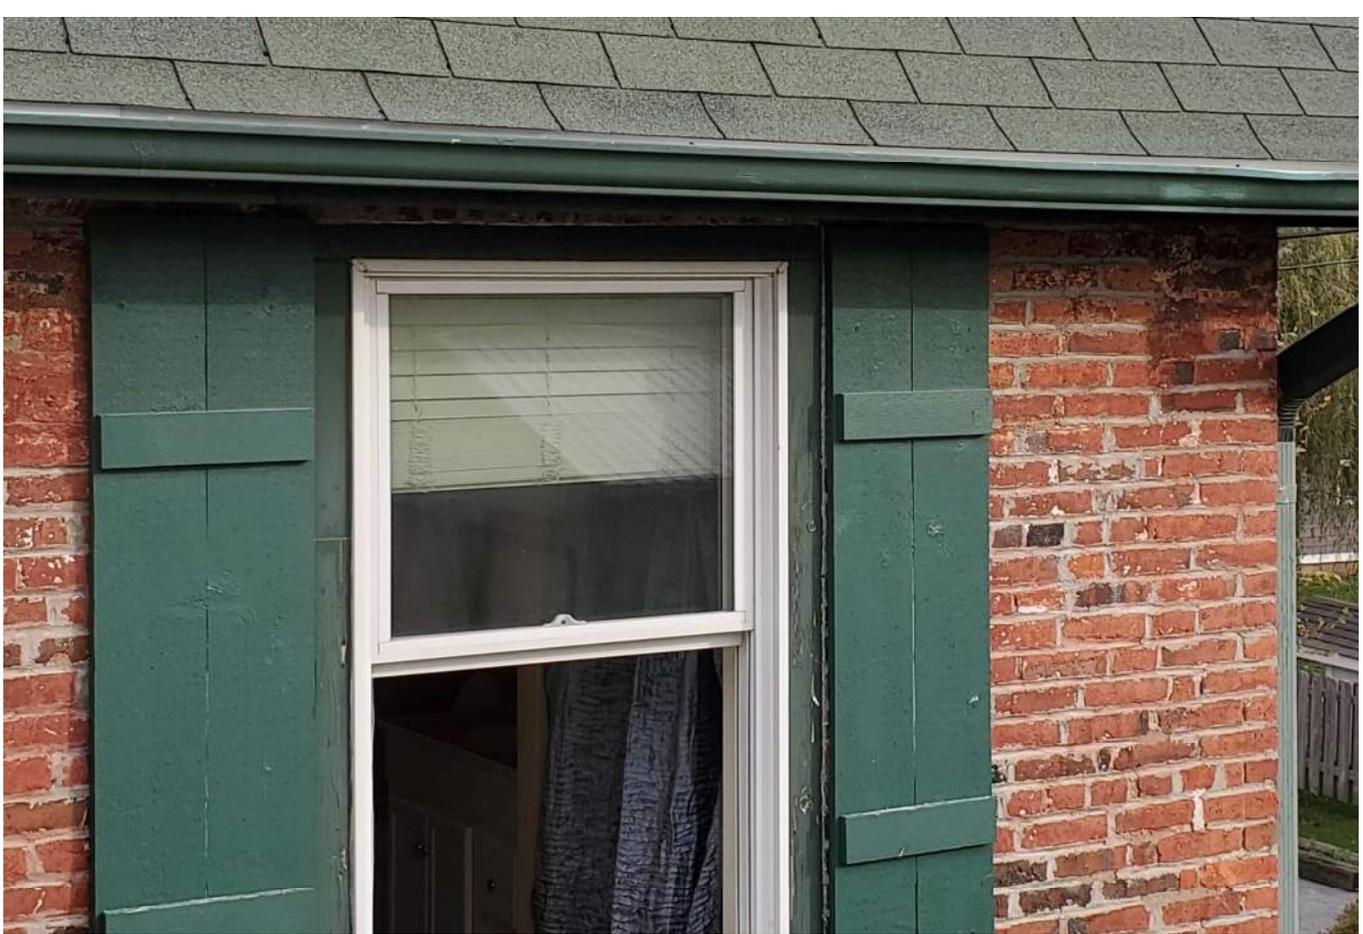
3. Vinyl replacement windows and frame alterations lower historic integrity, but overall fenestration is largely intact. Recommend wood-sash replacement windows to fit original openings when needed.

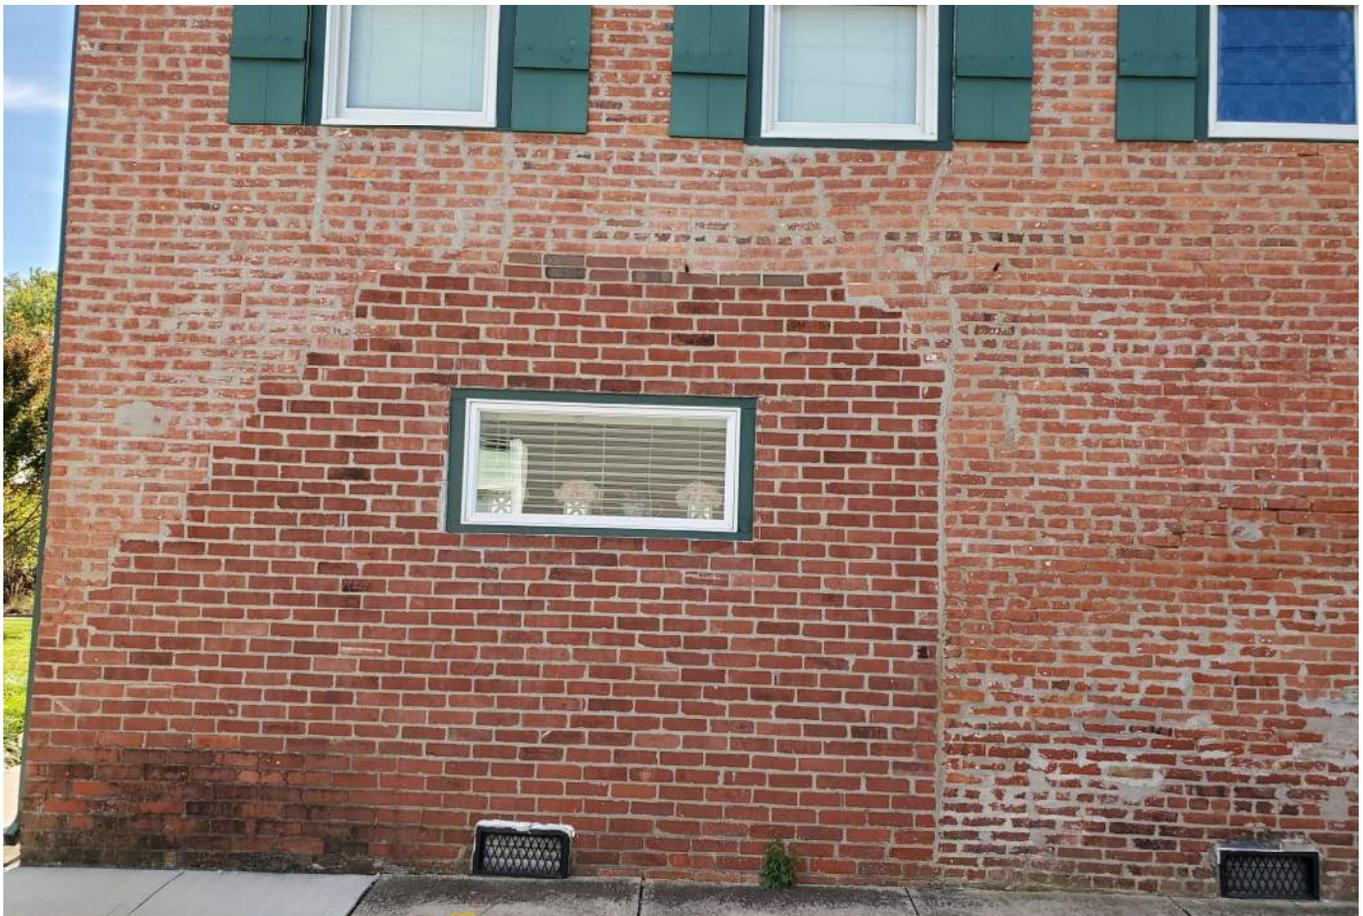
4. Reduced integrity due to wall and window opening alterations. The horizontal window is not appropriate for the fenestration. Recommend removing and filling in with matching brick.

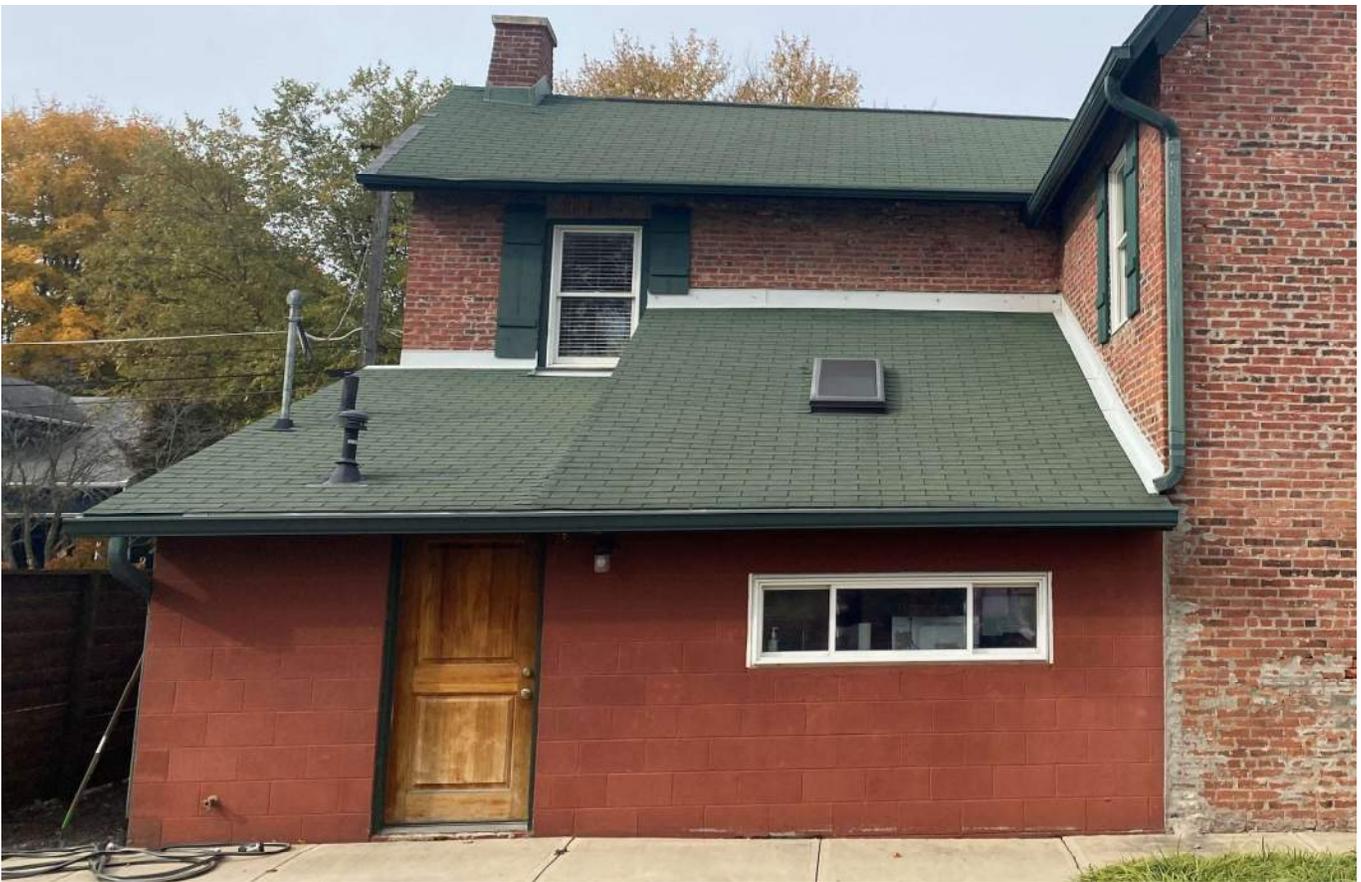
7. Reduced integrity due to c. 1965 single-story concrete block and shed roof alteration. Likely to have replaced a nineteenth century wood-frame rear porch. Consider replacing with a wood-frame structure. Original fenestration in second-story windows.

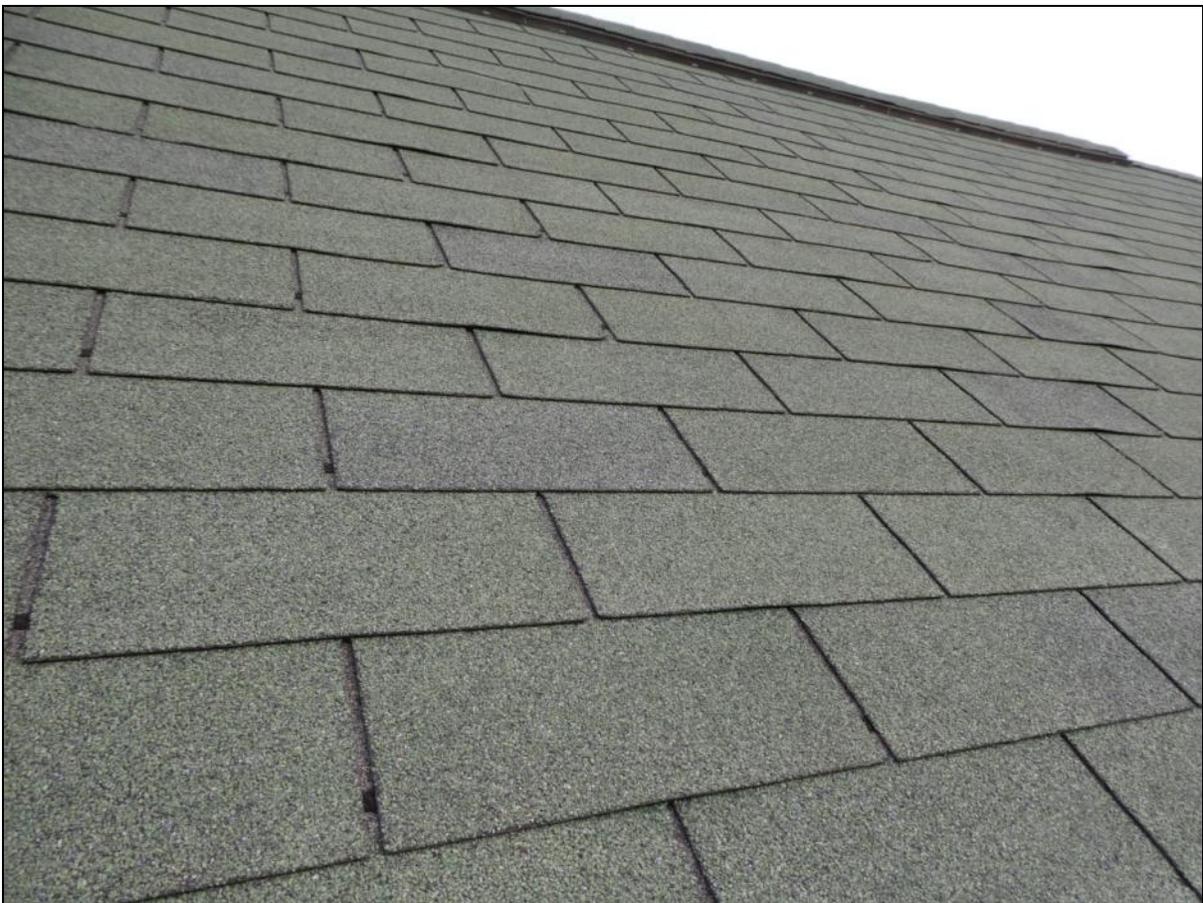
Photo 06 The shingles were found to be in fair condition.

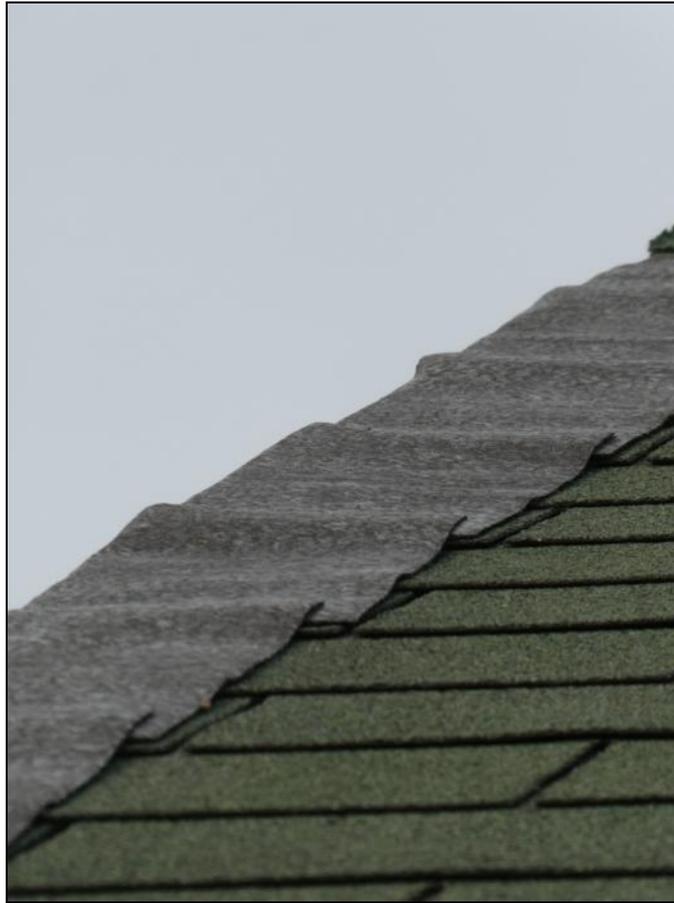
Photo 07 A patch in the roofing on the southern gable.

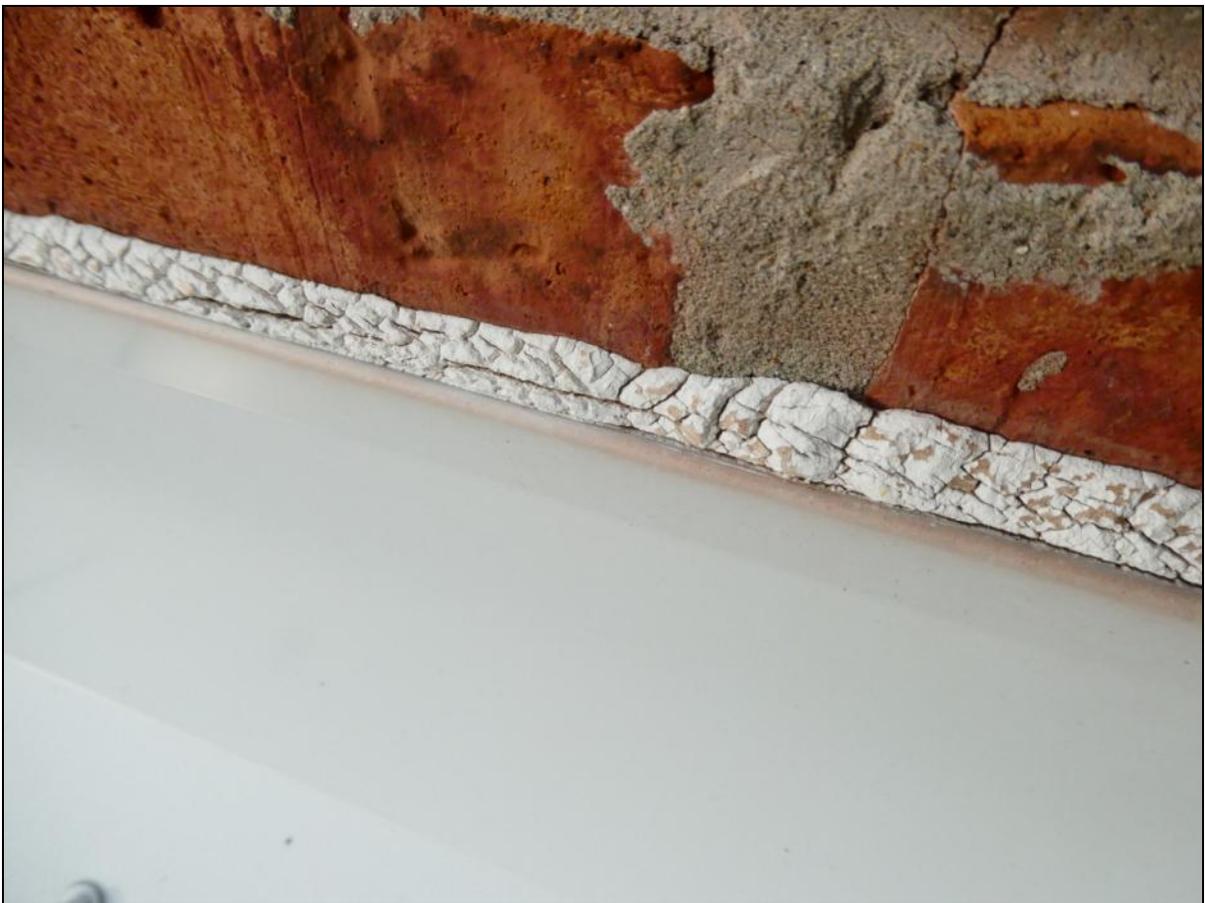
Photo 12 The sealant joints have typically failed.

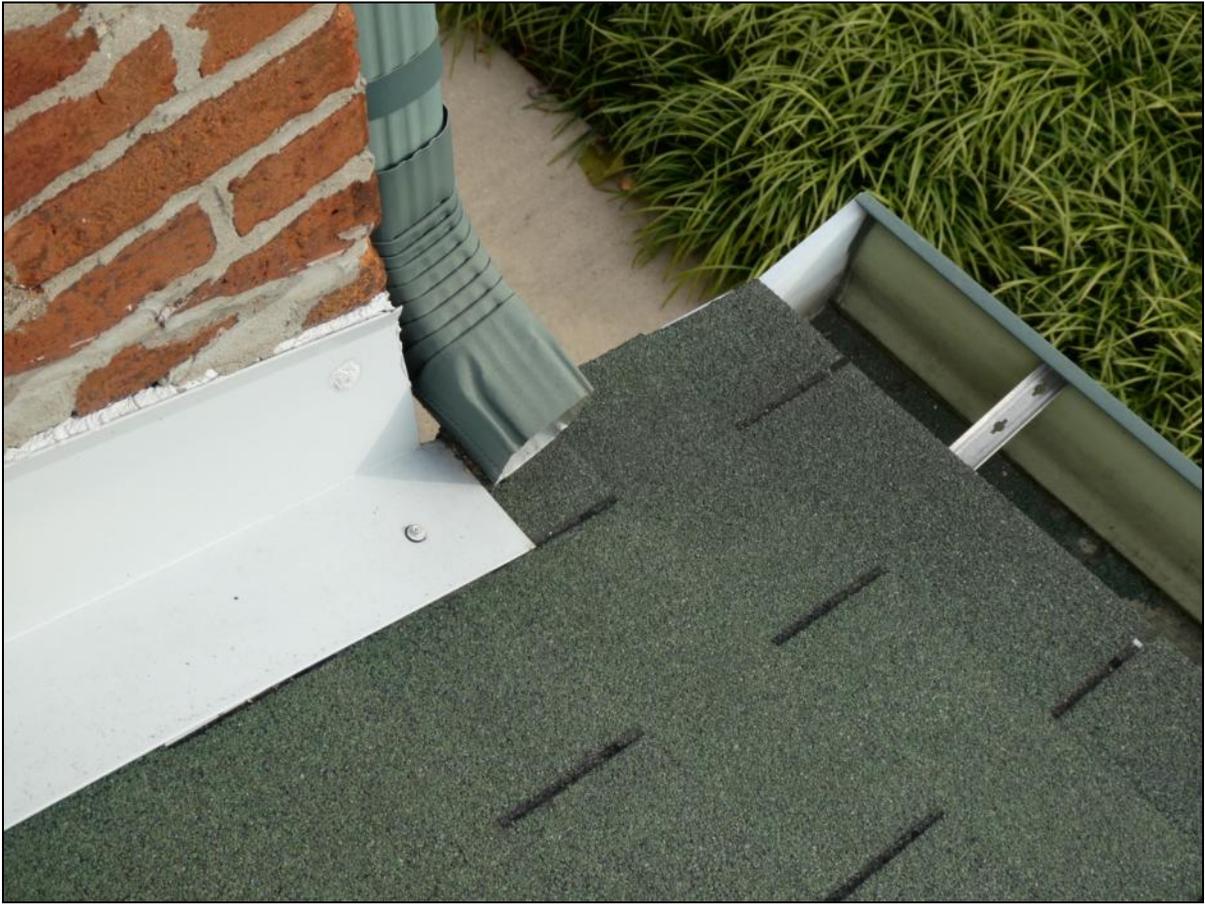
Photo 13 Downspouts from the upper roof empty onto the low roof.

| | Address bulk moisture by adding downspout extenders |

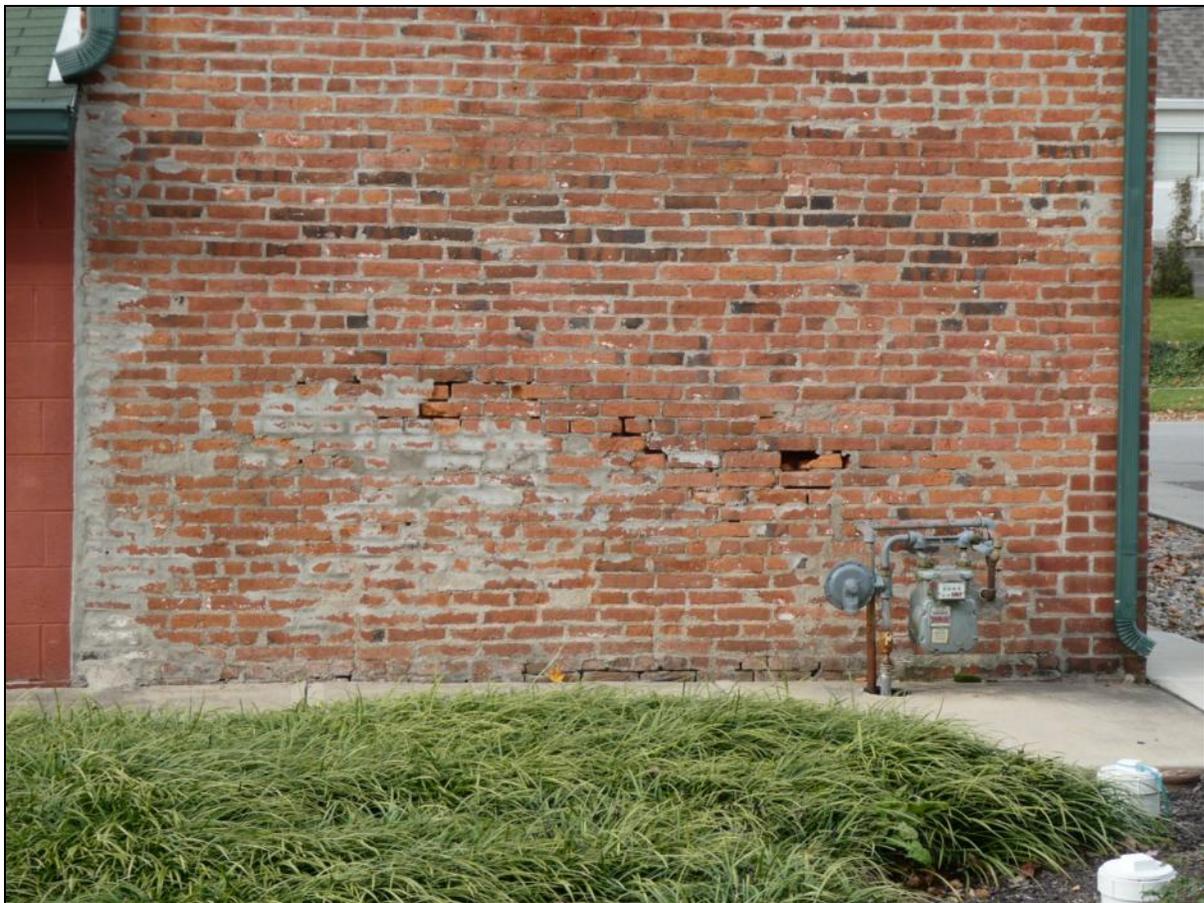
Photo 18 Eroded joints and missing brick masonry on the east elevation.

| High Priority | Repoint mortar joints and replace damaged or missing masonry |

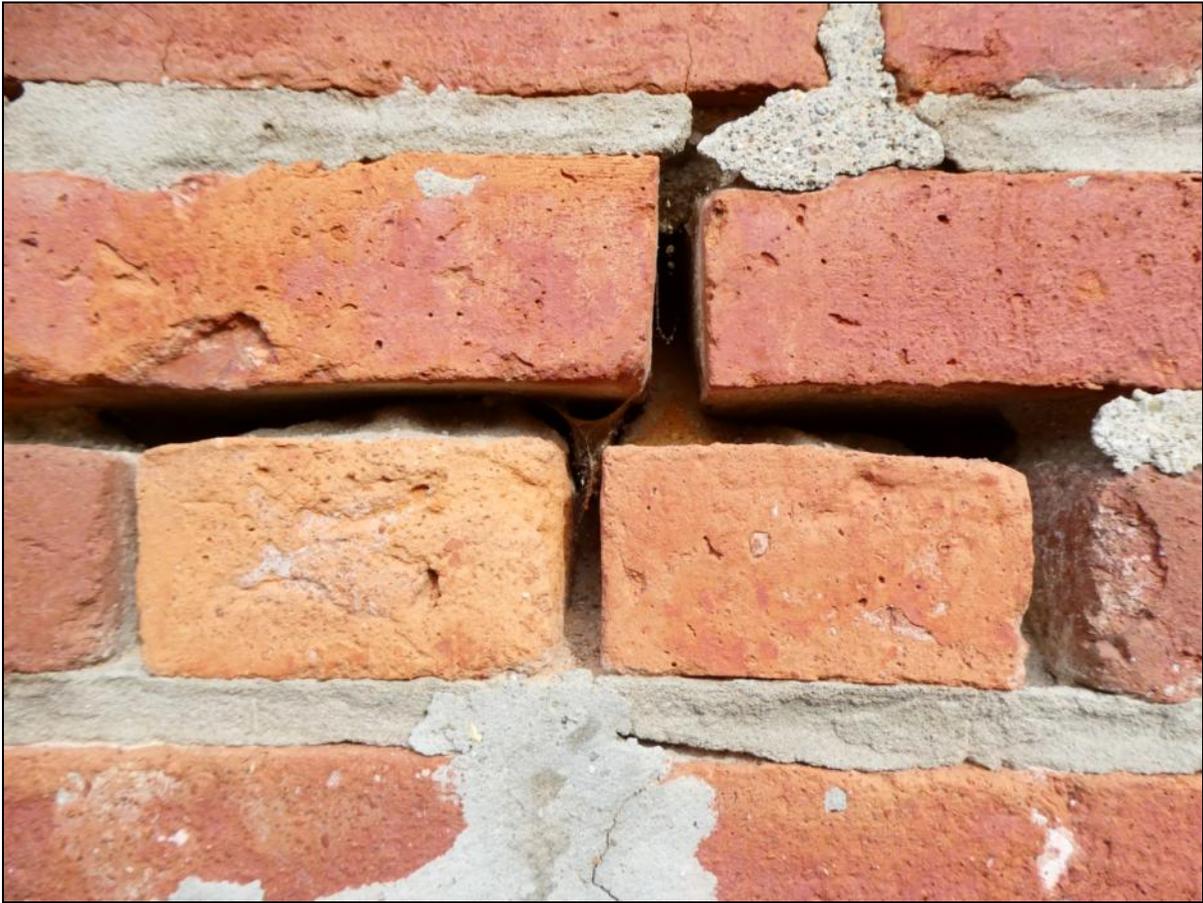
Photo 19 The joints in this location are completely empty.

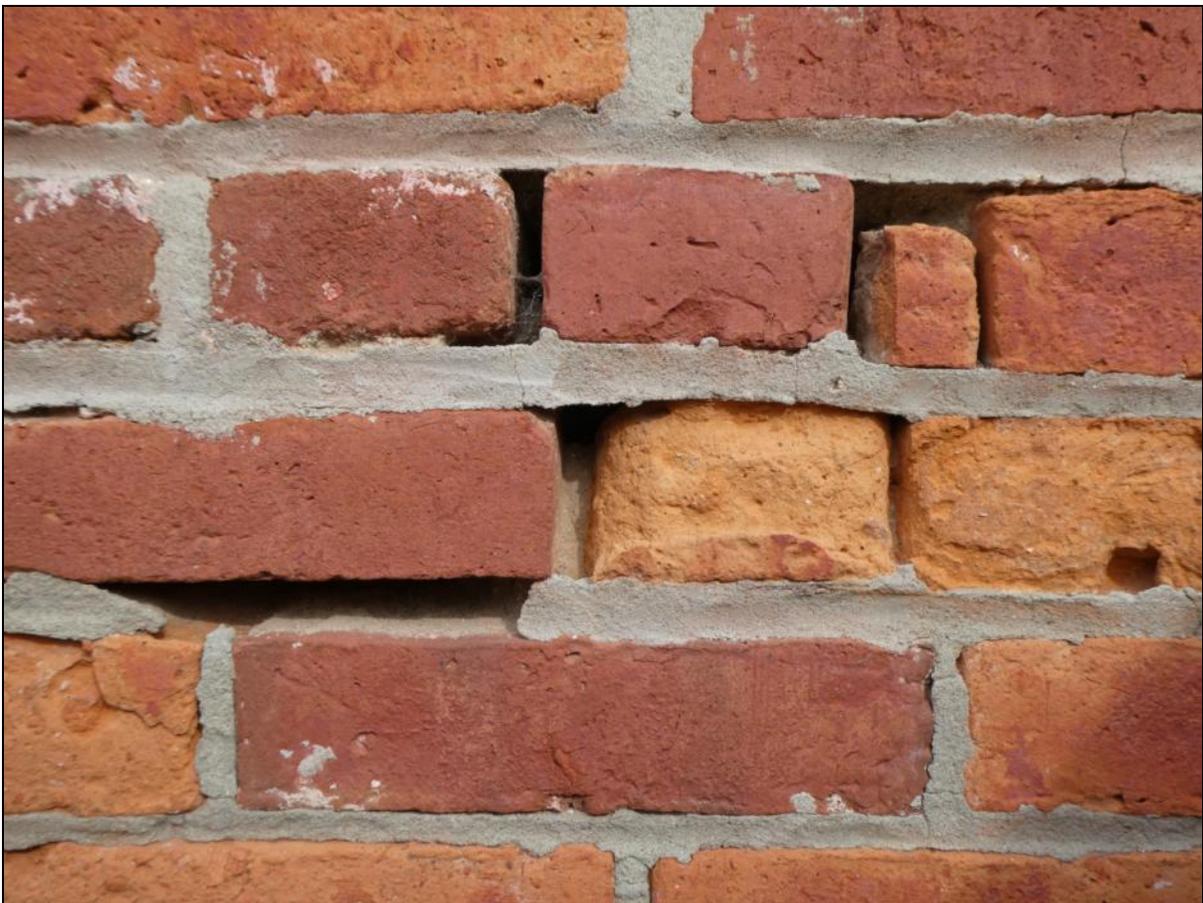
Photo 20 A inappropriate repair has hastened the erosion of the substrate mortar.

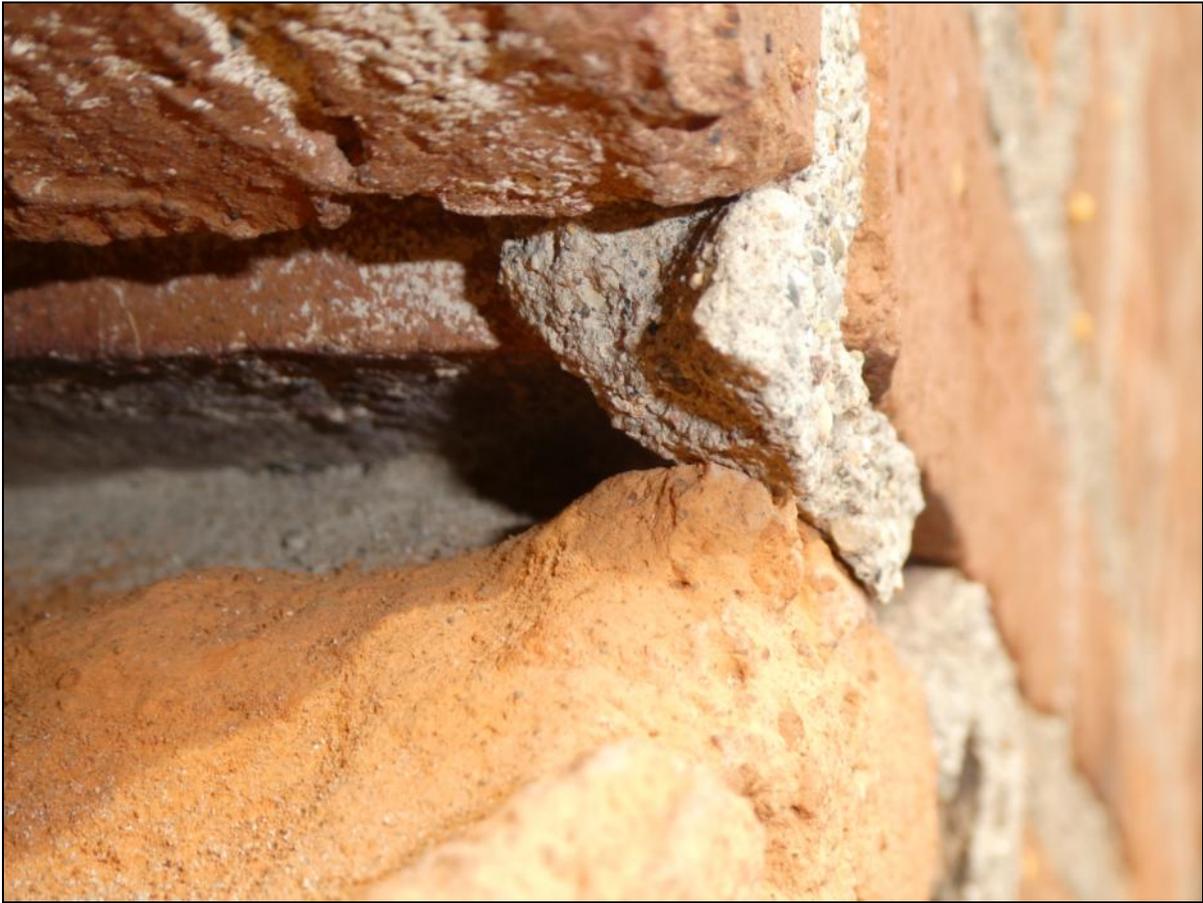
Photo 21 What appears to be sound mortar can hide significant erosion within the wall.

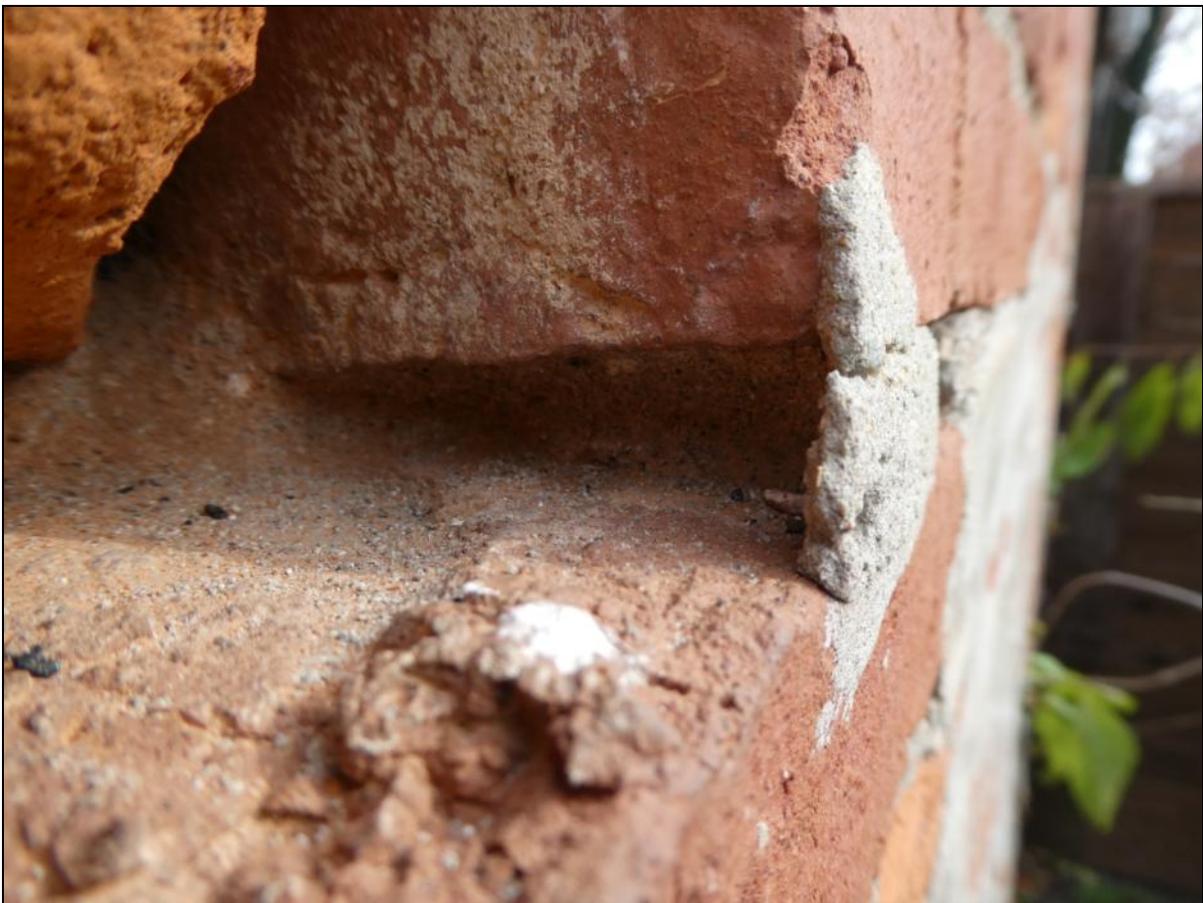
Photo 22 Other repairs were not of sufficient depth to be durable.

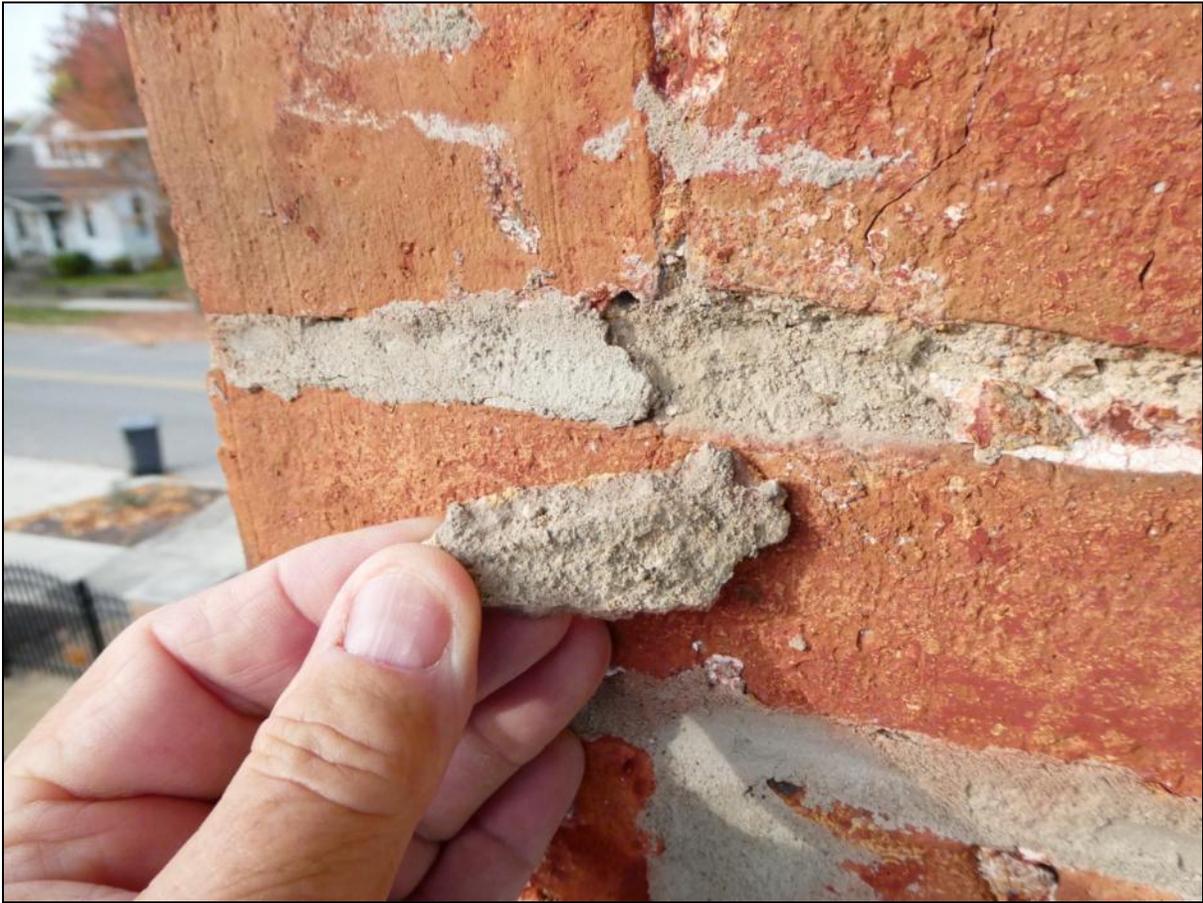
Photo 23 Another 'skim' repair on the east elevation.

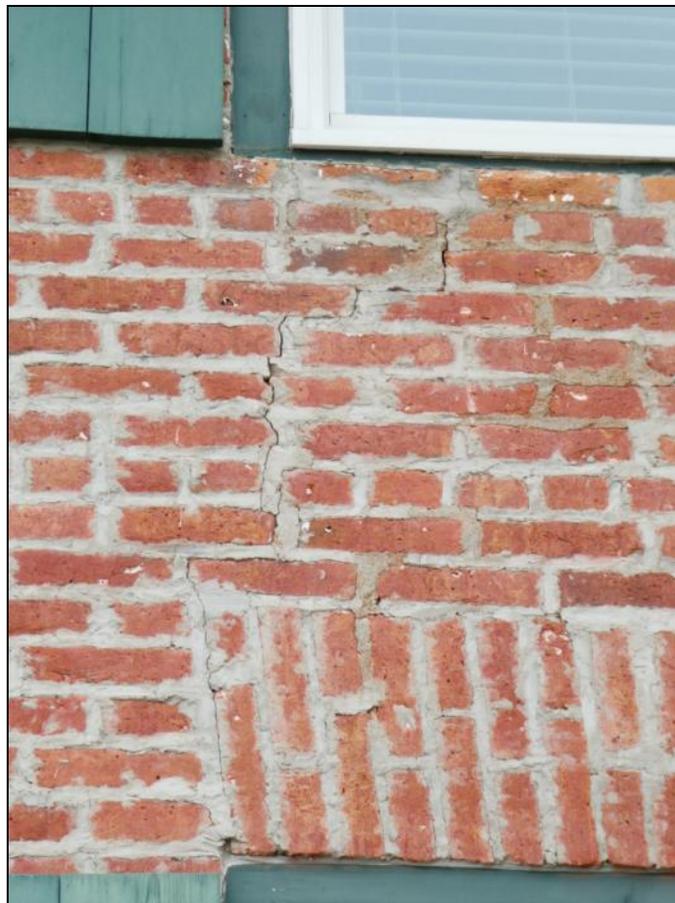
Photo 24 Cracked masonry between two windows on the west elevation.

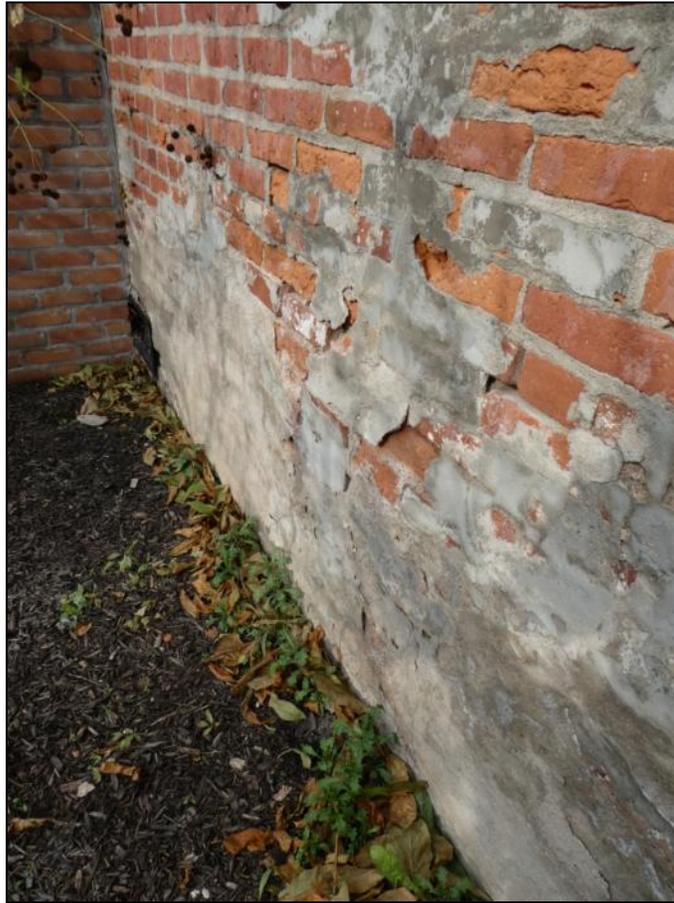
Photo 25 Remnants of a coating were present on the south elevation.

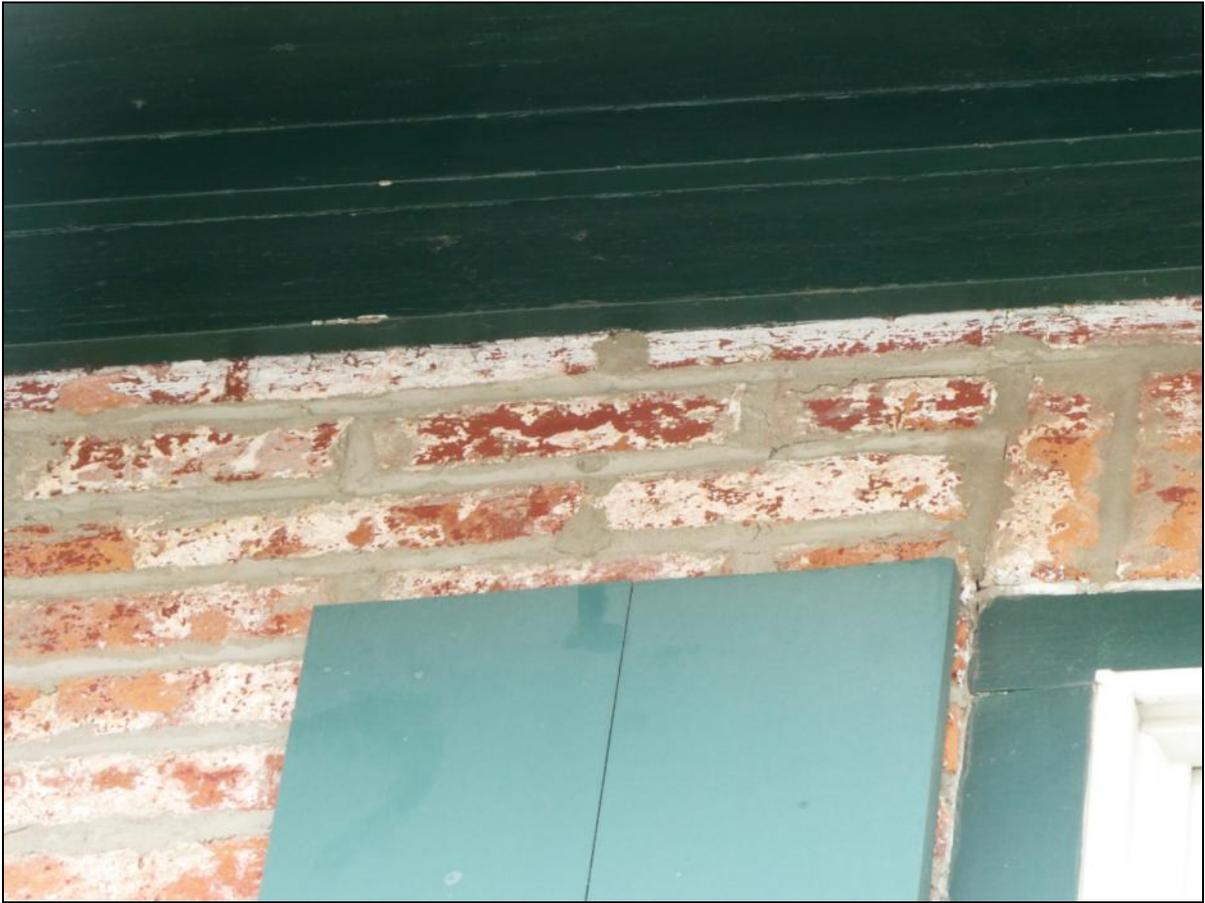
Photo 27 The masonry appears to have been coated at one time.

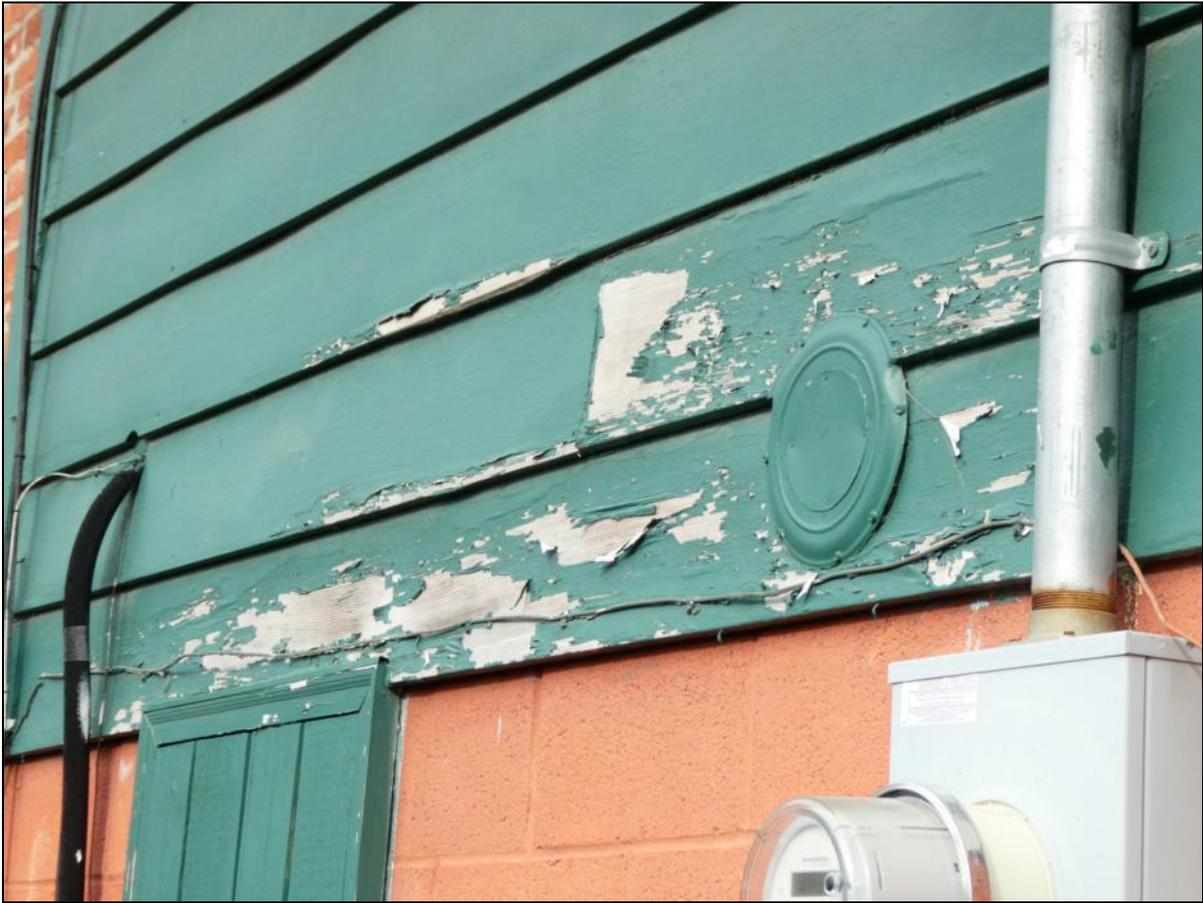
Photo 29 Failed paint on the south elevation of the addition.

| | Repair failed paint by preparing, priming, and painting all wood siding and trim |

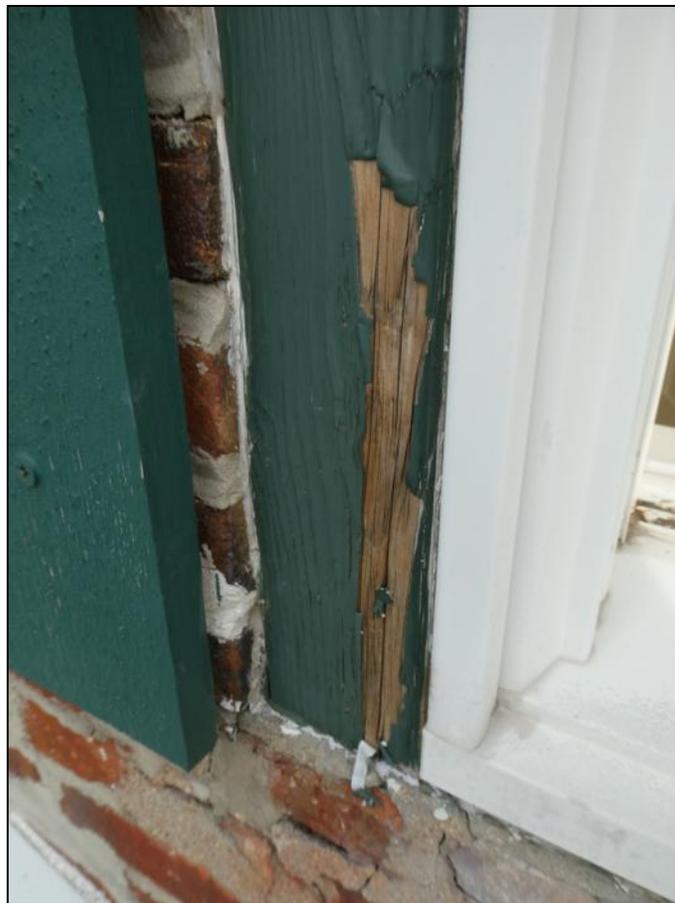
Photo 30 Failed paint on the window trim on the west elevation.

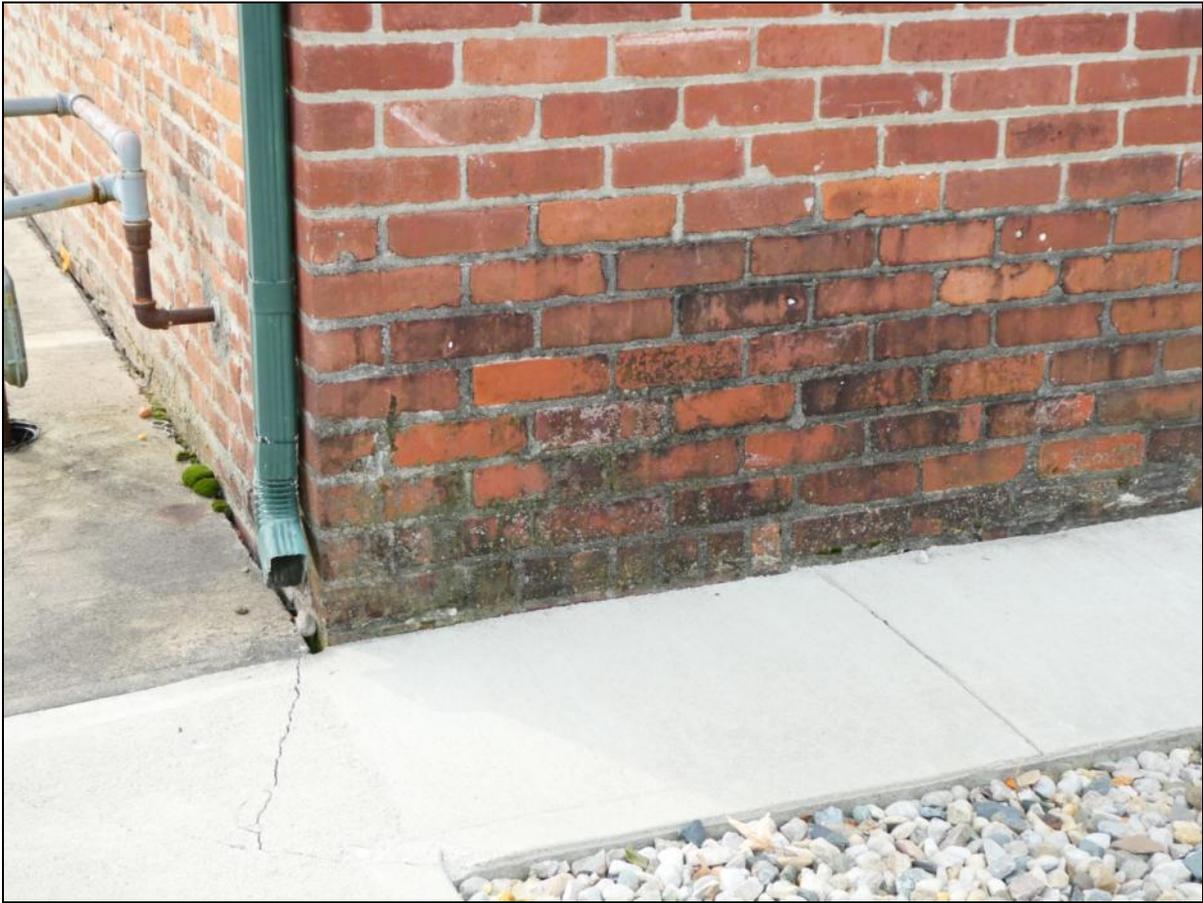
Photo 31 Soiled masonry near a downspout on the northeast corner.

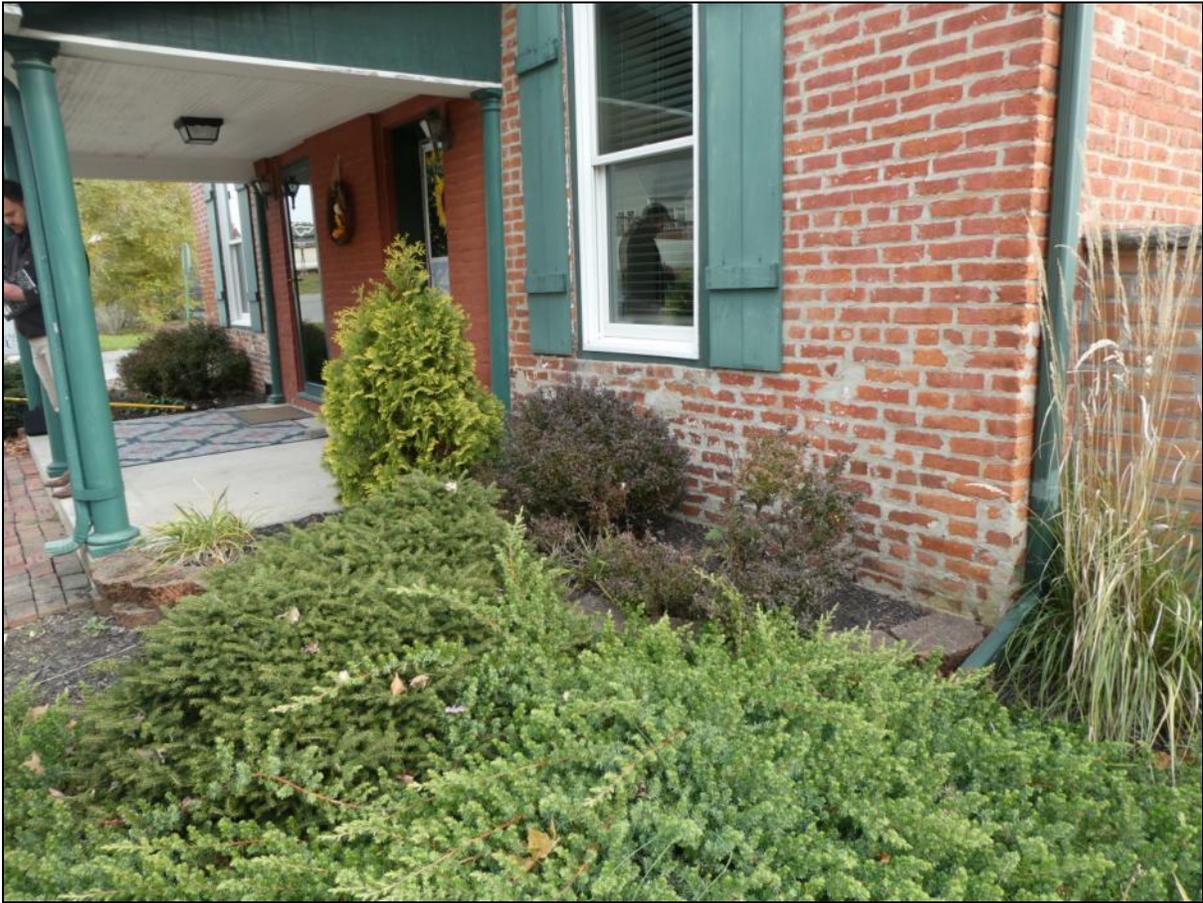
Photo 33 Similar condition on the south side of the entrance.

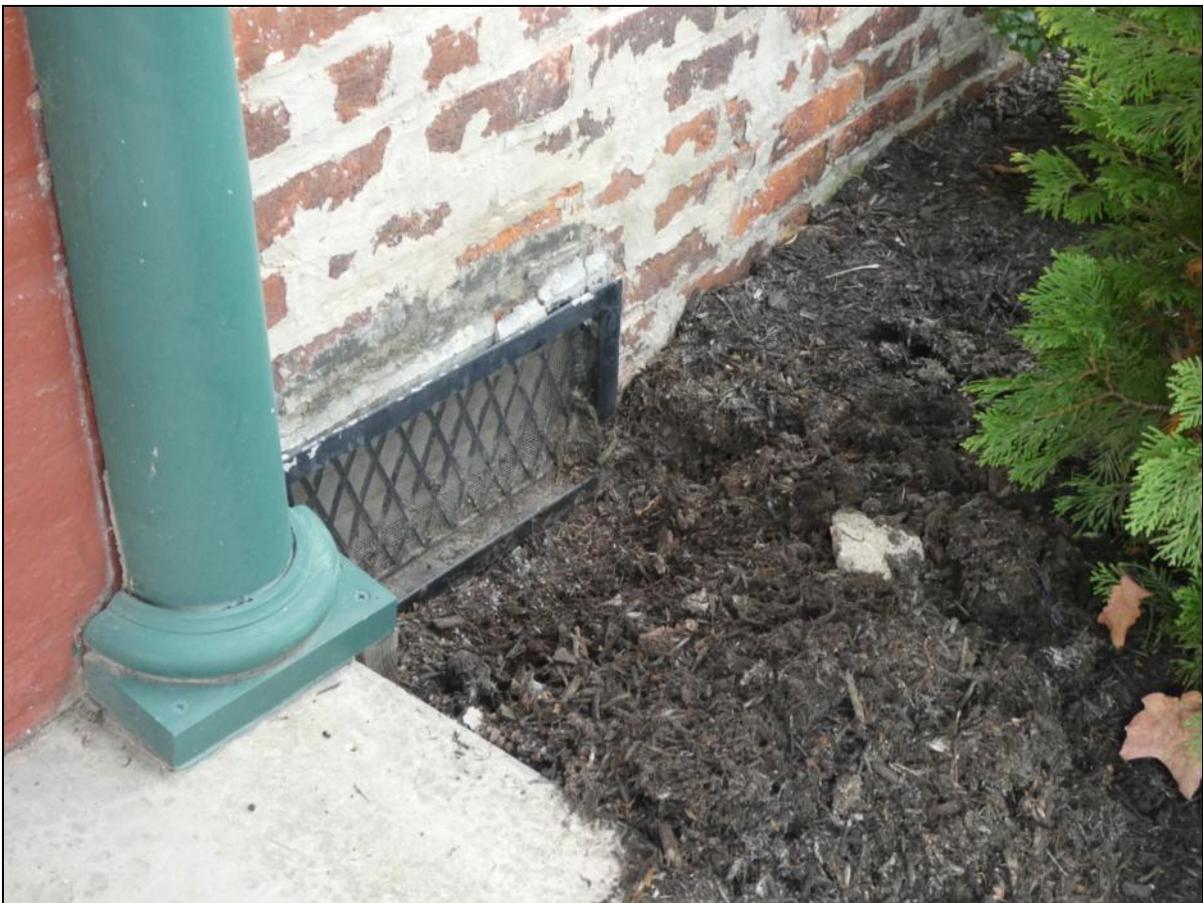
Photo 34 A thick layer of mulch can be a pathway for moisture and insects to enter the building.
