THOMAS PENDLETON HOUSE

PRESERVATION PLAN

August 2, 2022

RQAW Corporation
8770 North Street, Suite 110
Fishers, IN 46038
Phone: (317) 588-1762
www.rqaw.com

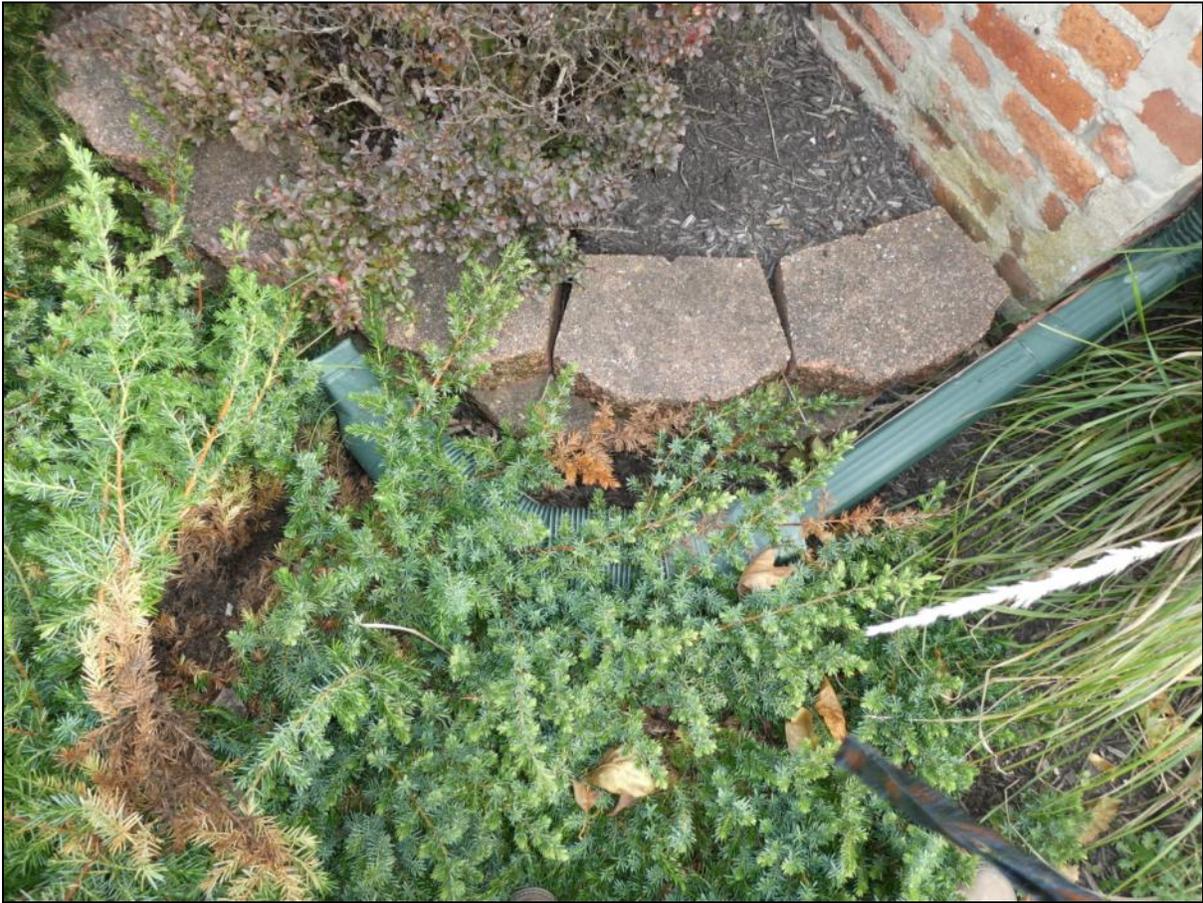
Photo 35 The downspout on this corner drains into the planting bed.

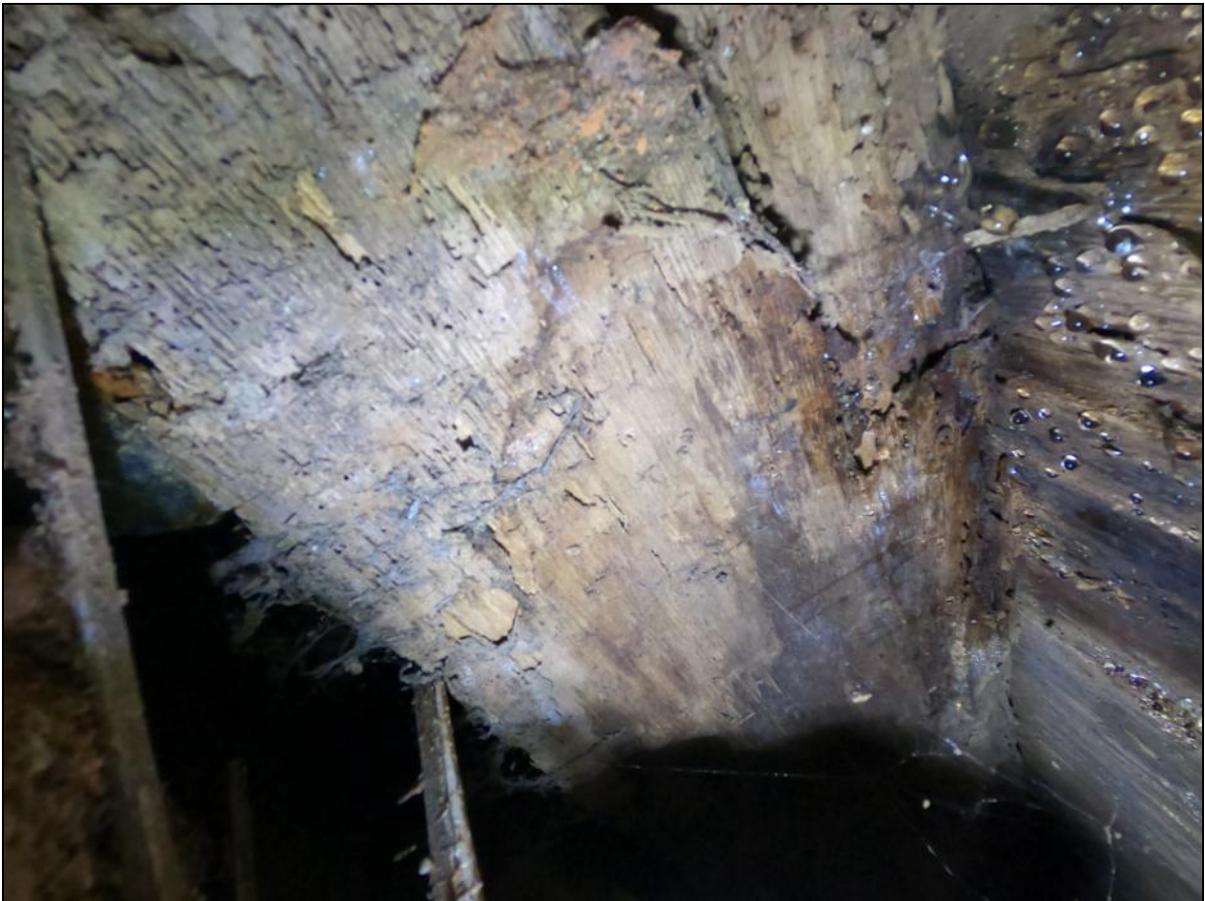
Photo 40 Insect damage visible on a framing member beneath the home. Droplets of condensation are also visible.

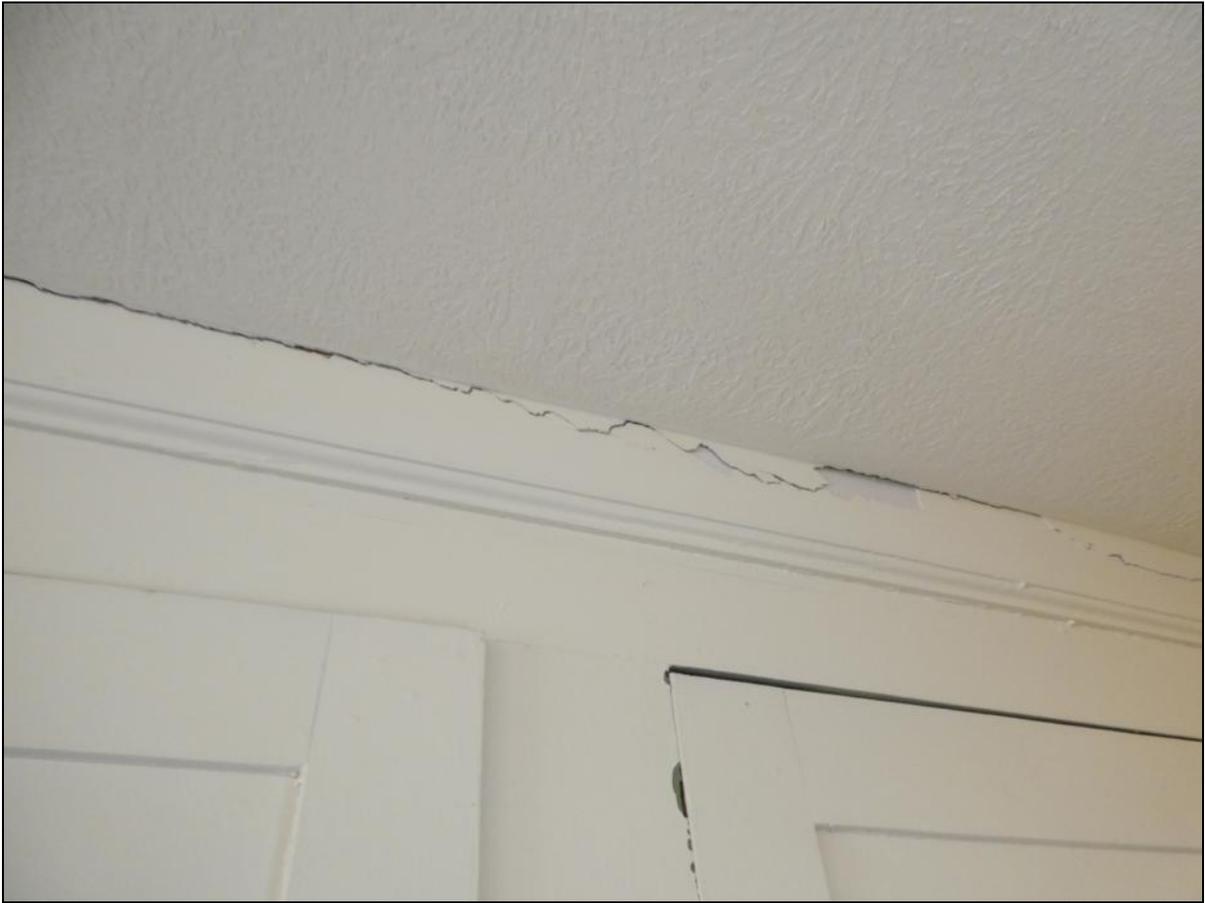
Photo 43 Failed paint where the cabinet trim meets the ceiling.

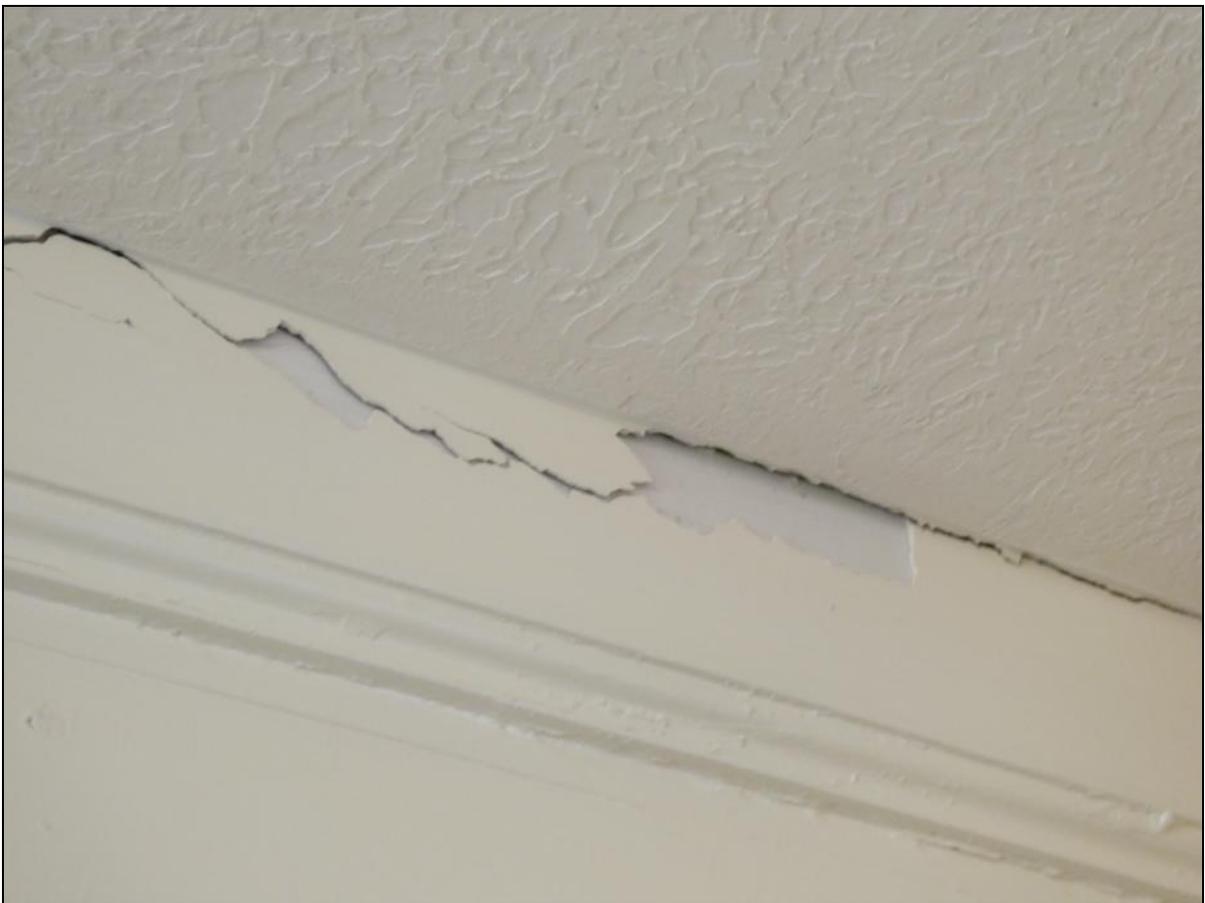
Photo 44 A closer look at the paint failure in this area.

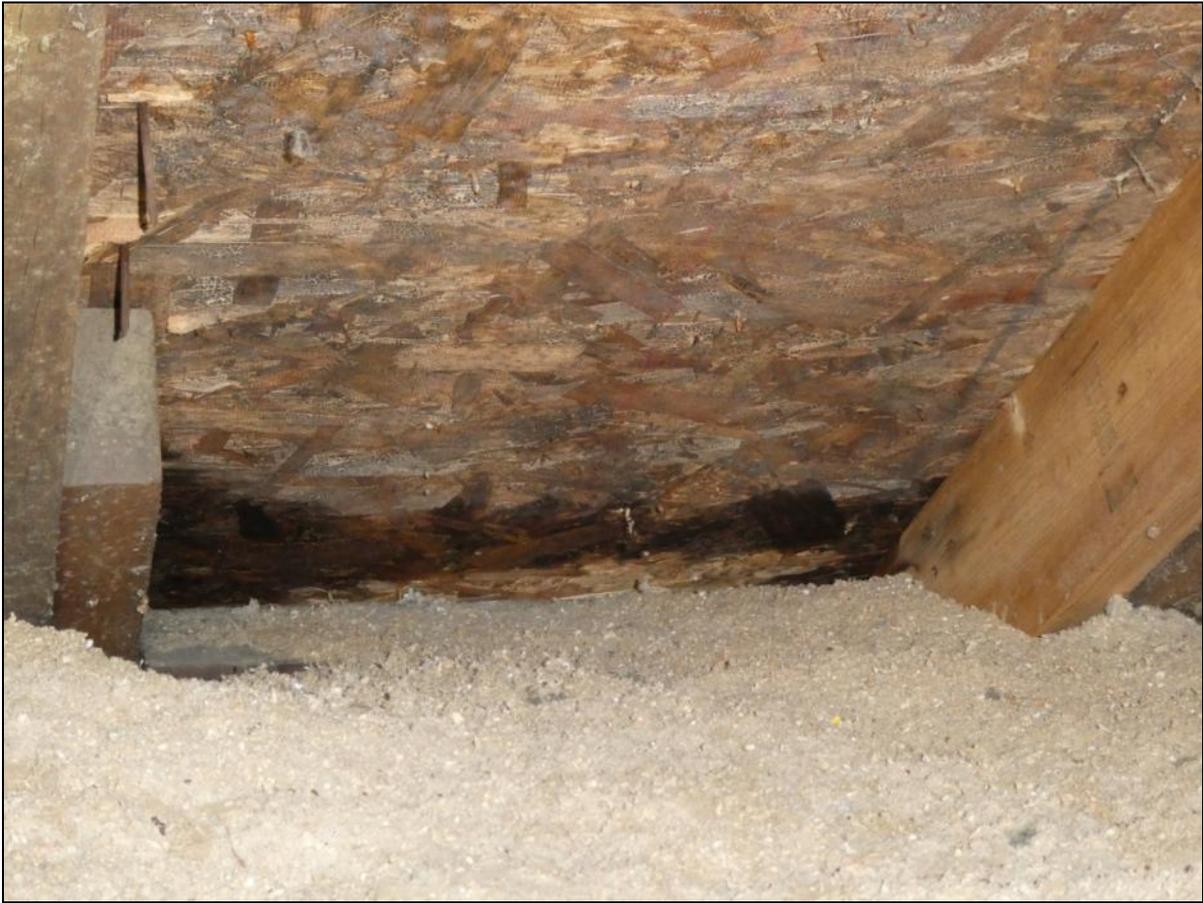
Photo 47 Wet and water stained areas were common near the roof edge.

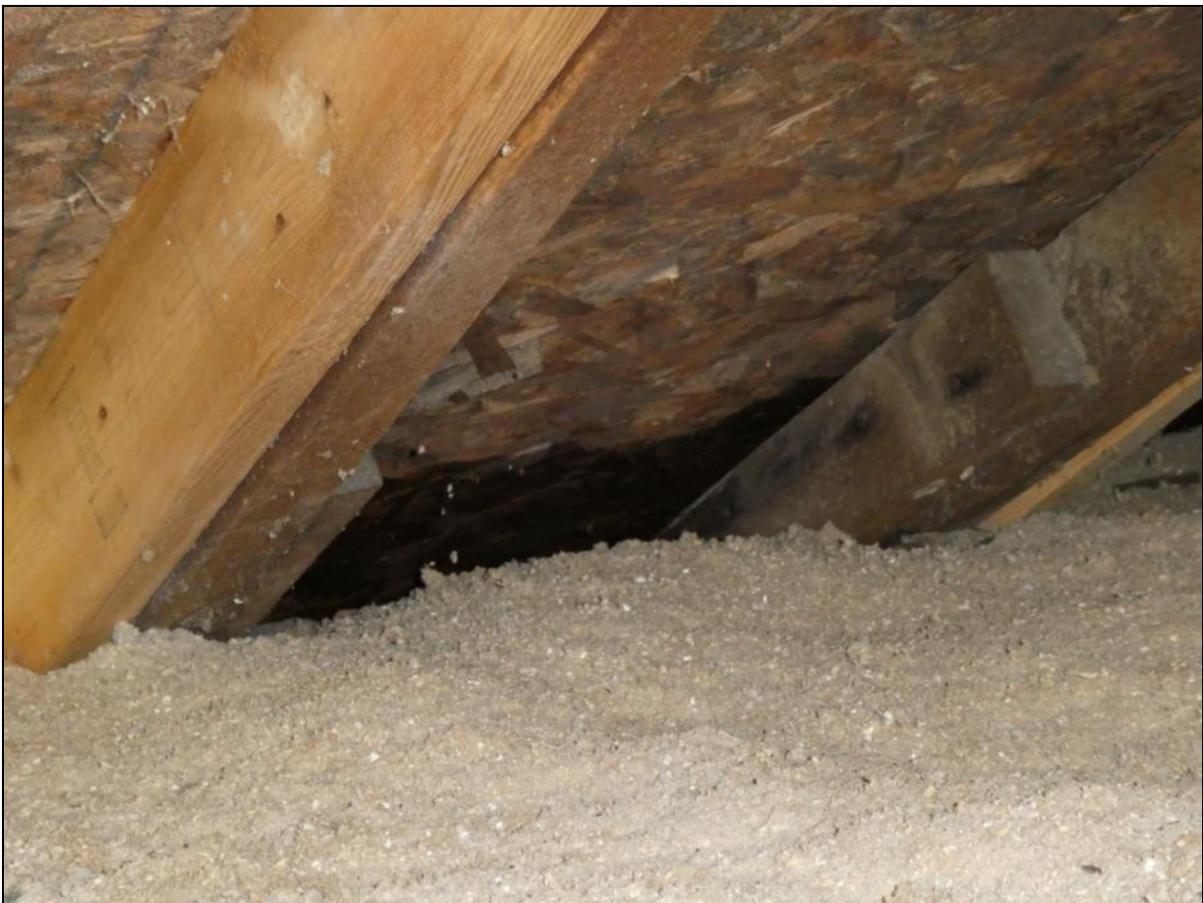
Photo 48 Another wet area near the eaves of the roof.

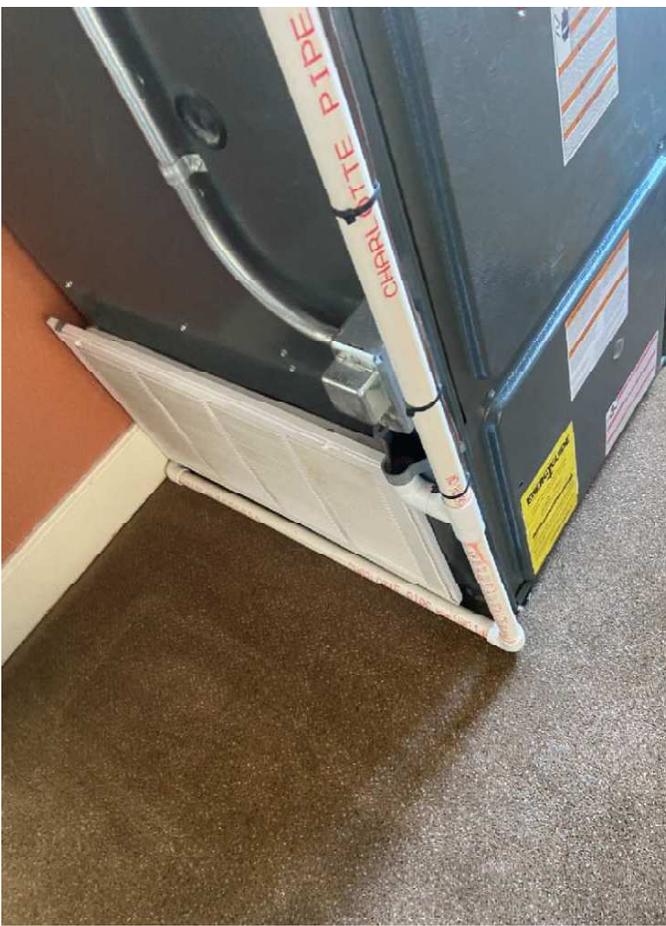
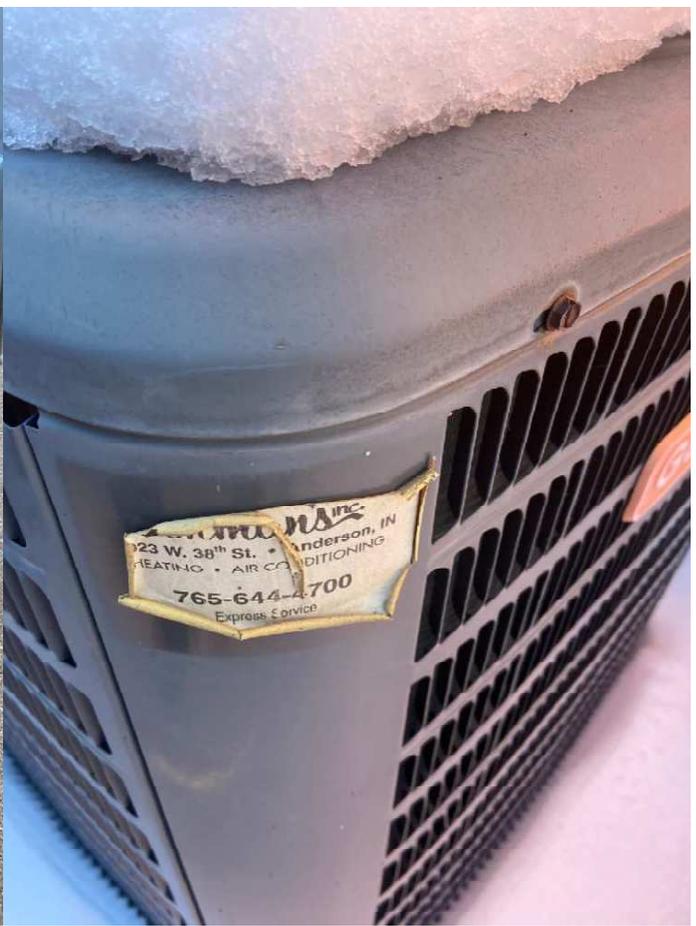
1. Goodman AHU with return grill low to the floor and no balance control. Goodman condensing unit.

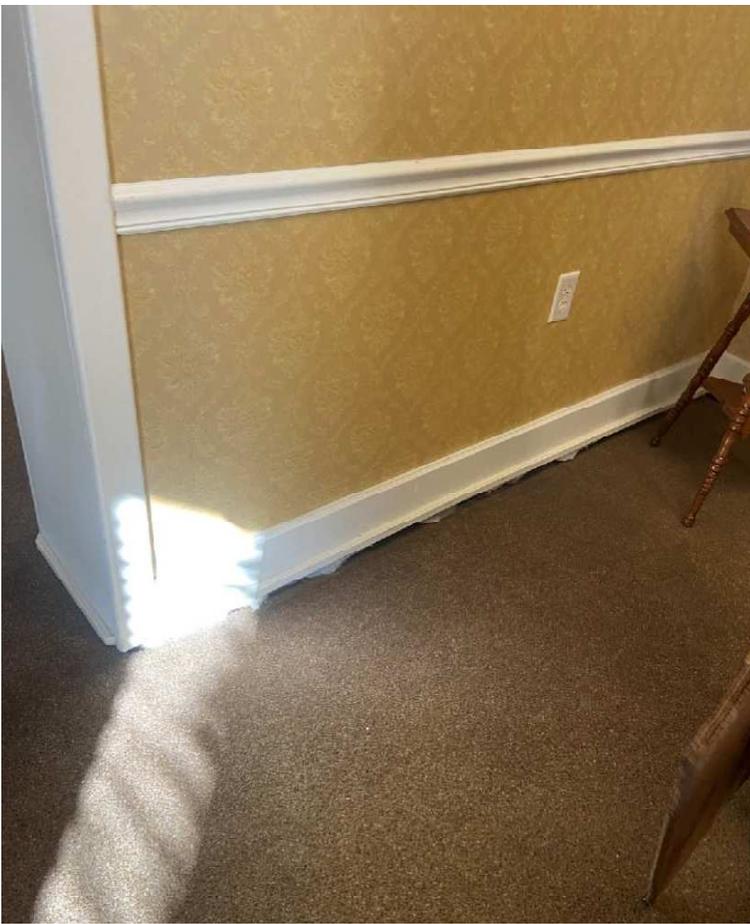
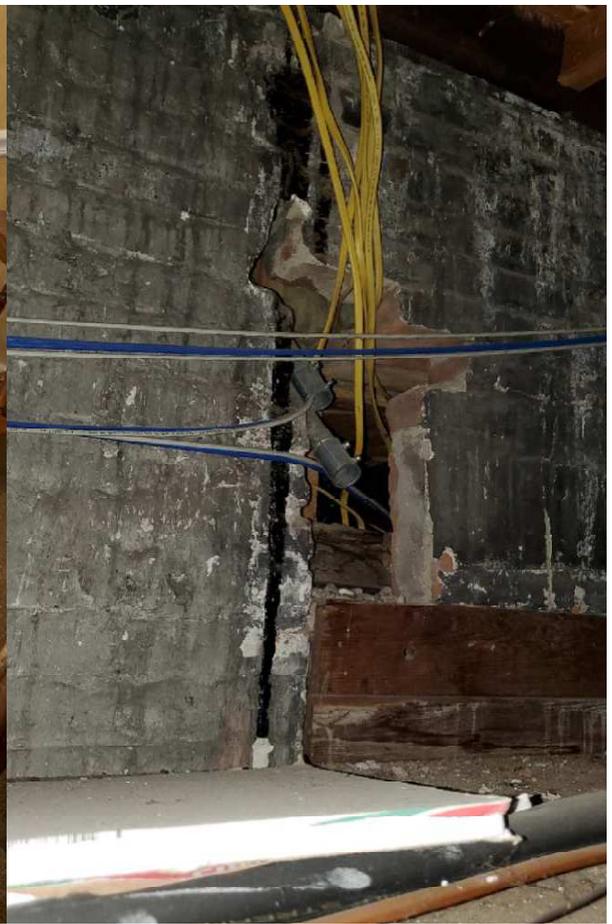
3. Exterior penetrations at the floor and wall allow for air infiltration.

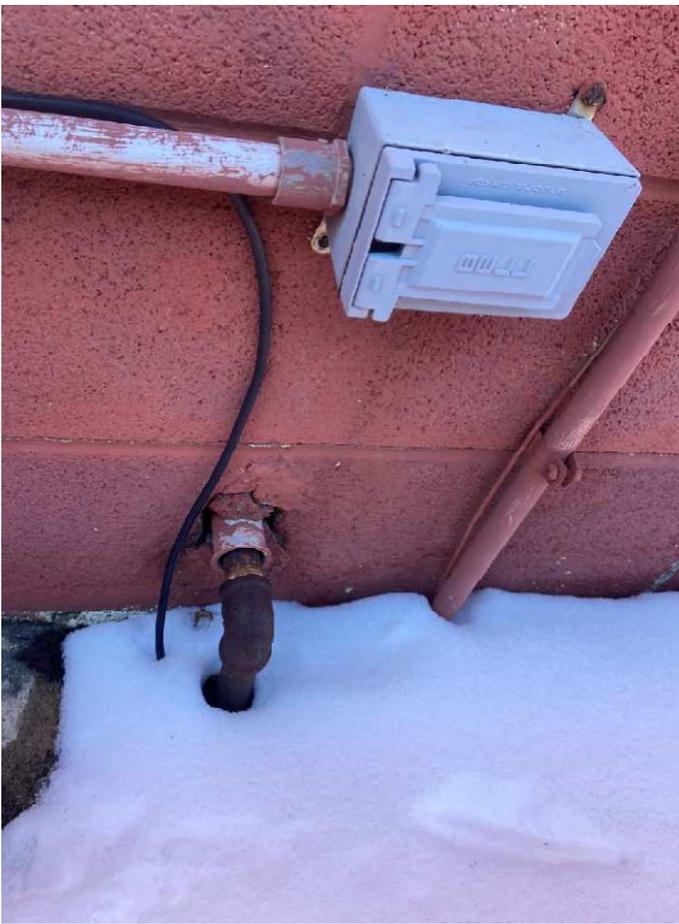
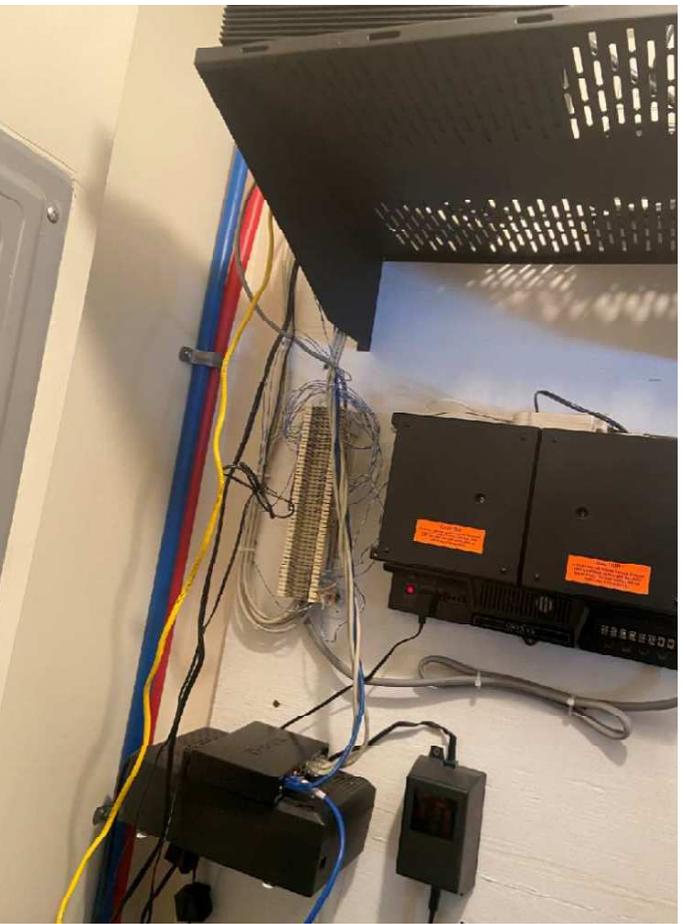
9. Gas line exterior wall penetration and recommend to construct soffit around water pipes around IT equipment.

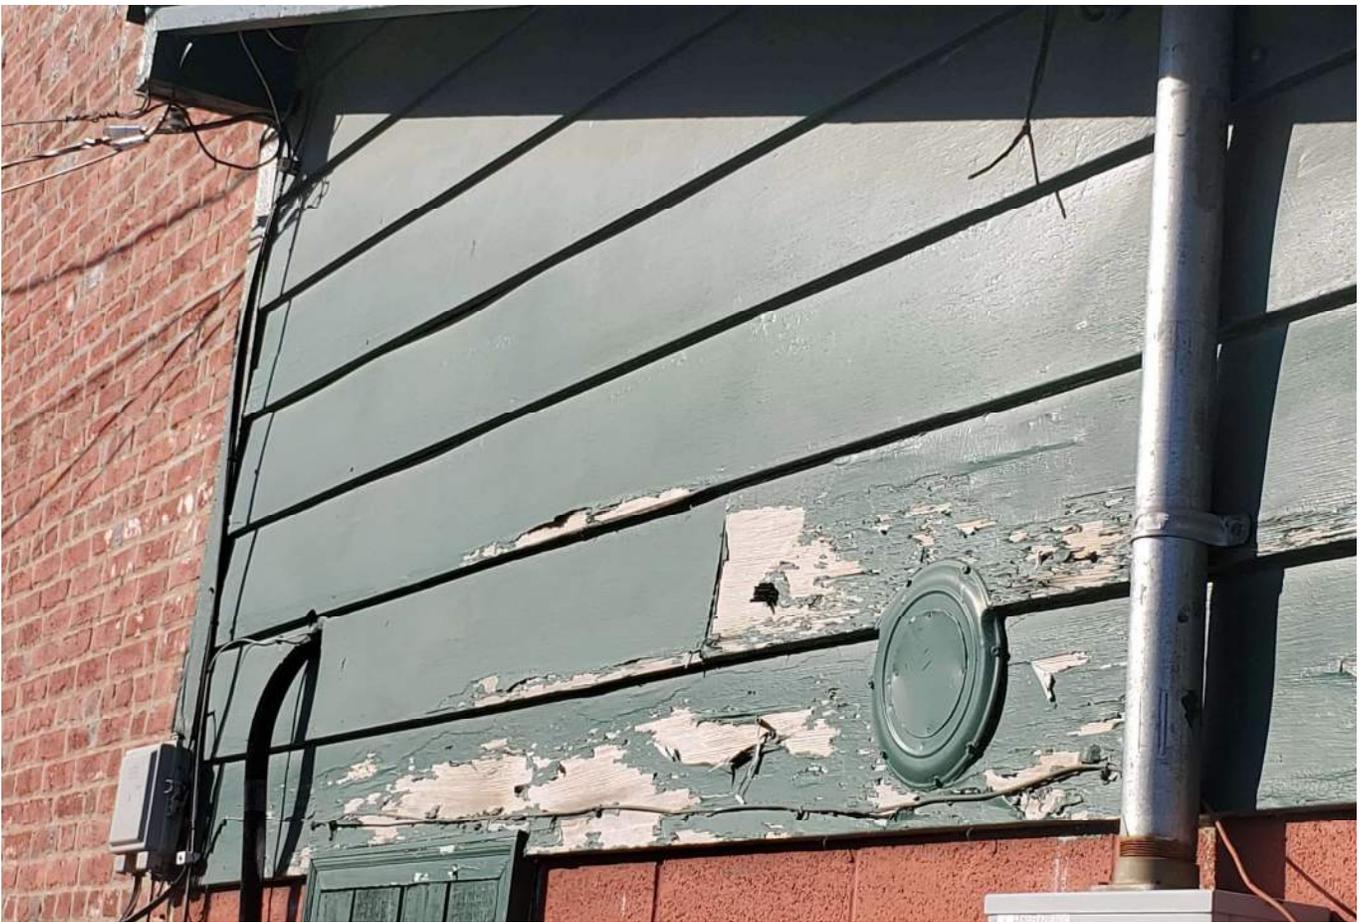
1. Failed paint on clapboards. Consider replacing clapboards with wall assembly that includes sheathing, a weather barrier and new siding. Additionally recommended to air seal penetrations.

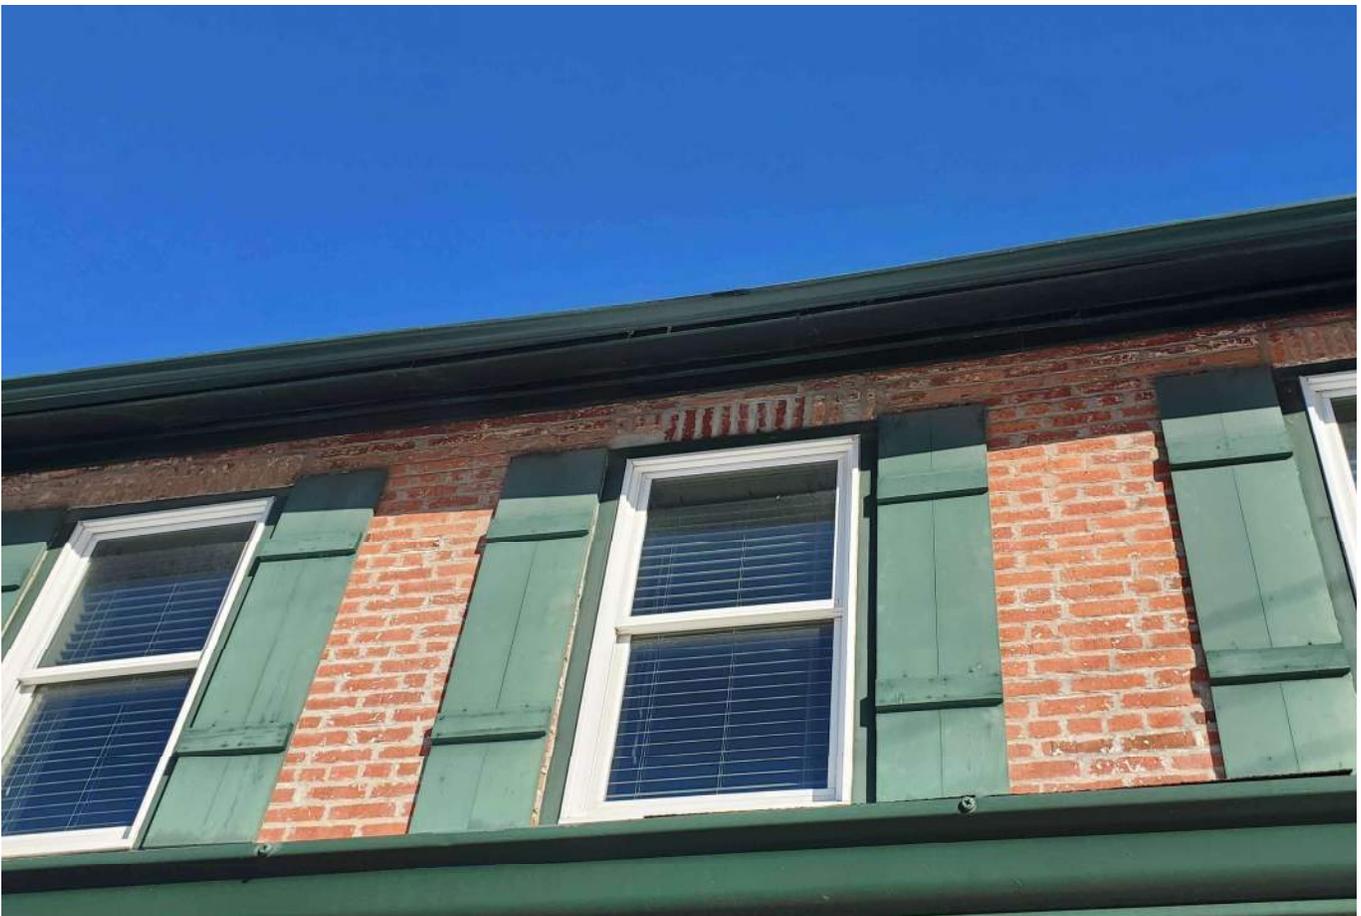
2. Front gutter overflowing. Recommend cleaning all gutters and adjusting to properly drain to downspouts.

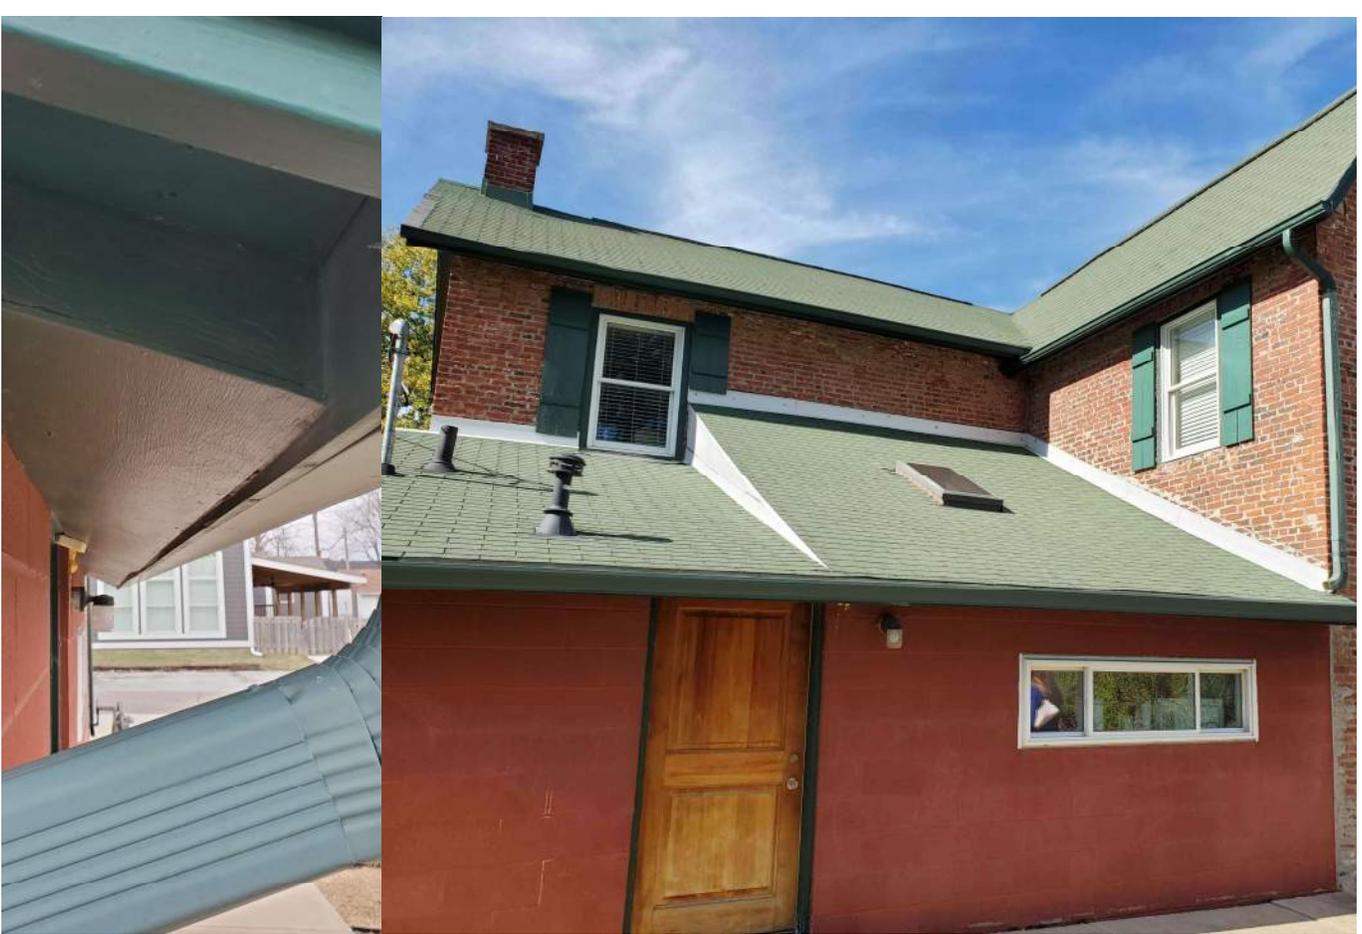
3. Shed roof is unvented. Recommend adding soffit intake vents and box vents near the top of the shed roof.

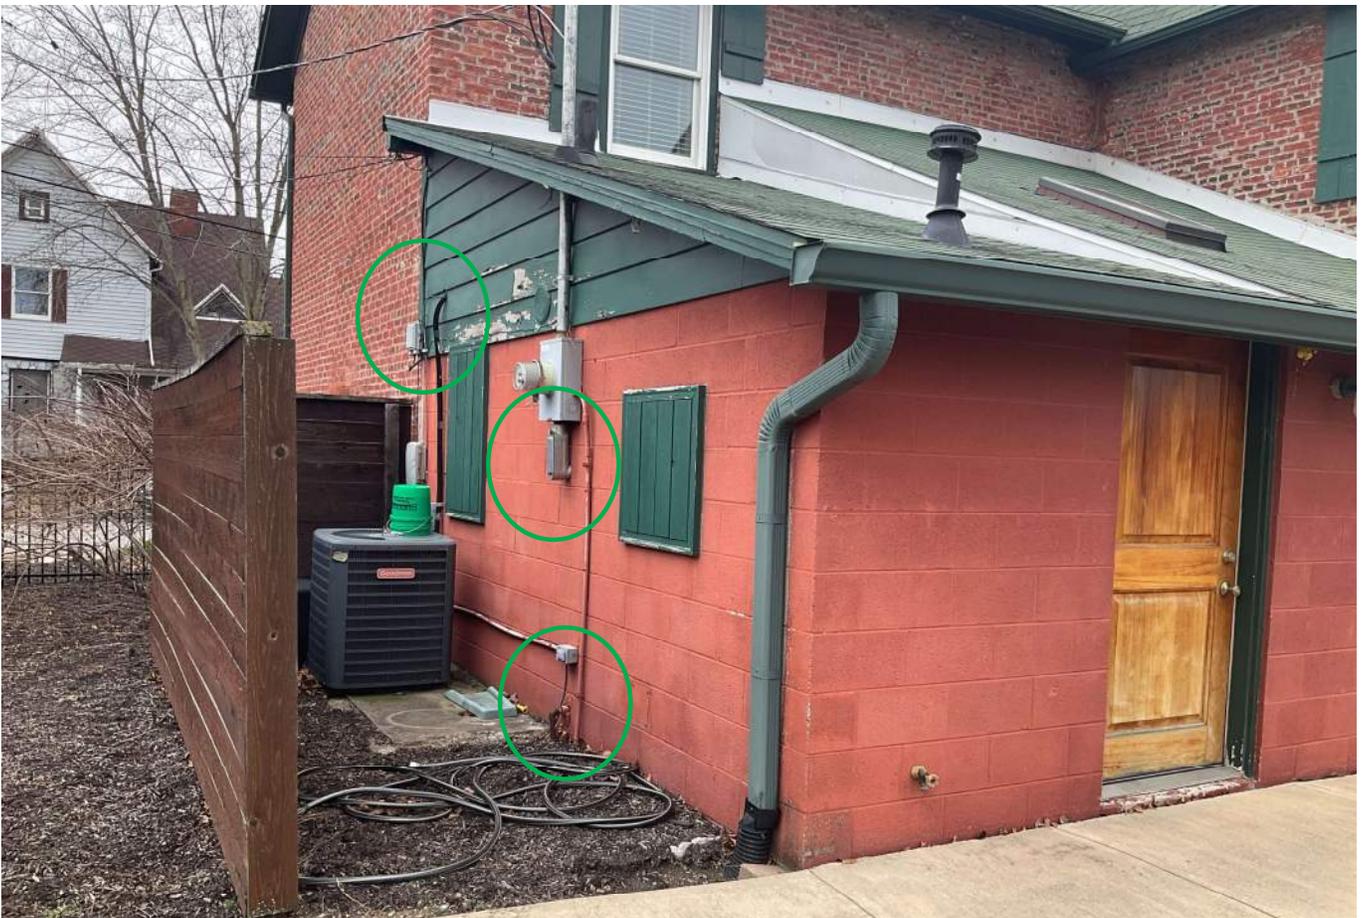
4. Air seal penetrations and rear door.

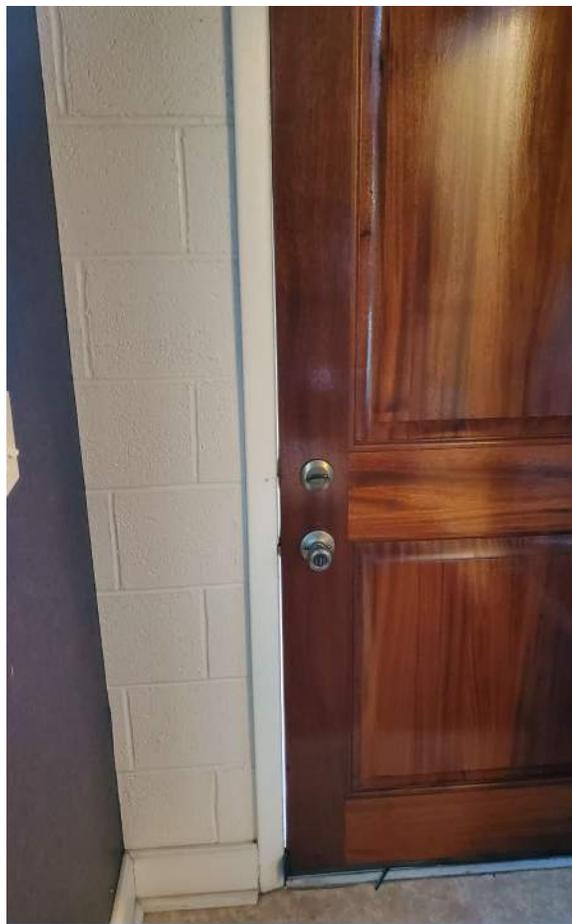
5. Visible light around rear door. Recommend to air seal.

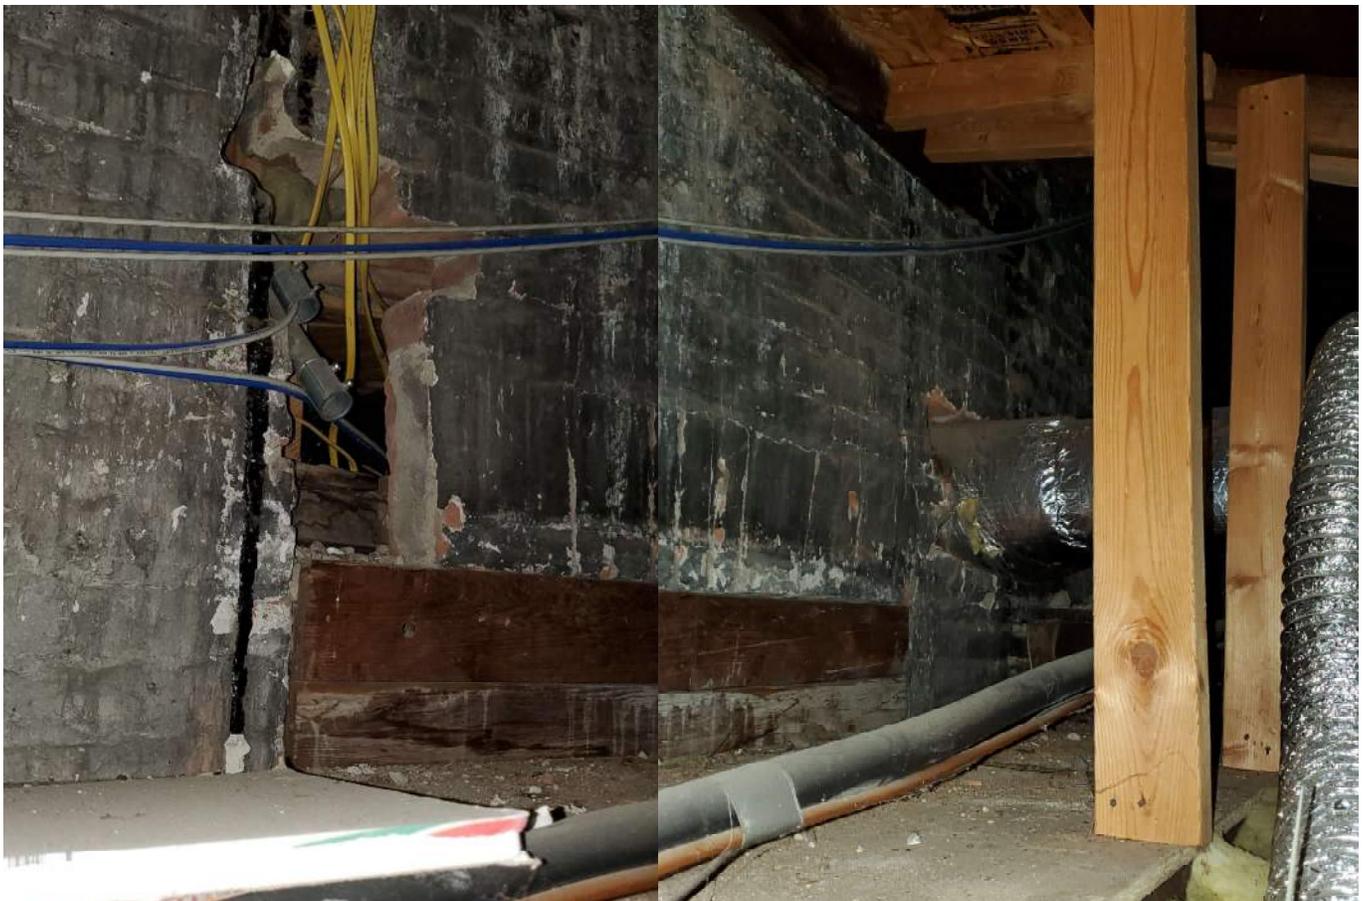
6. Penetrations through masonry wall (east facing wall under rear shed roof). Recommend air sealing all penetrations to reduce moisture infiltration. Recommend to refrain from adding masonry wall penetrations. Note the remnants of a window opening.

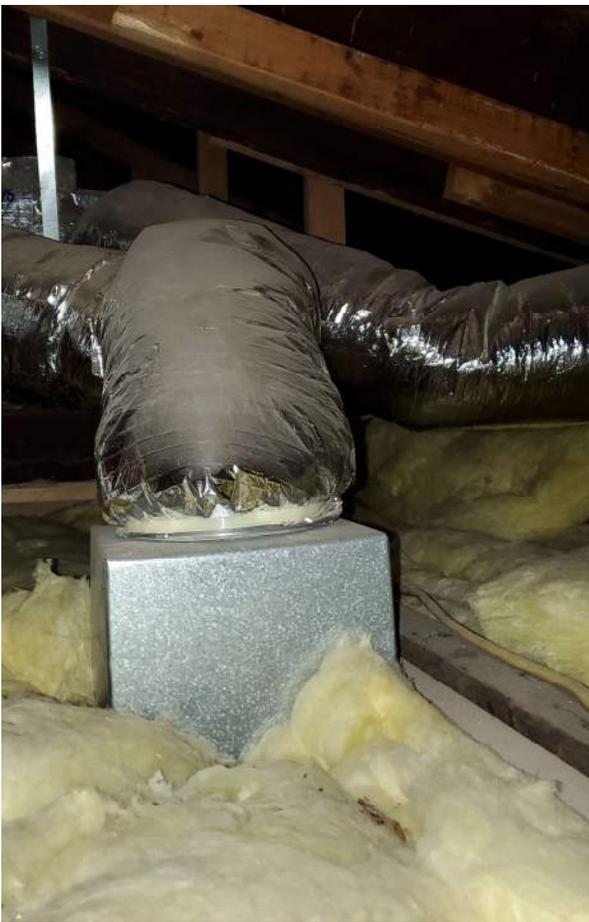
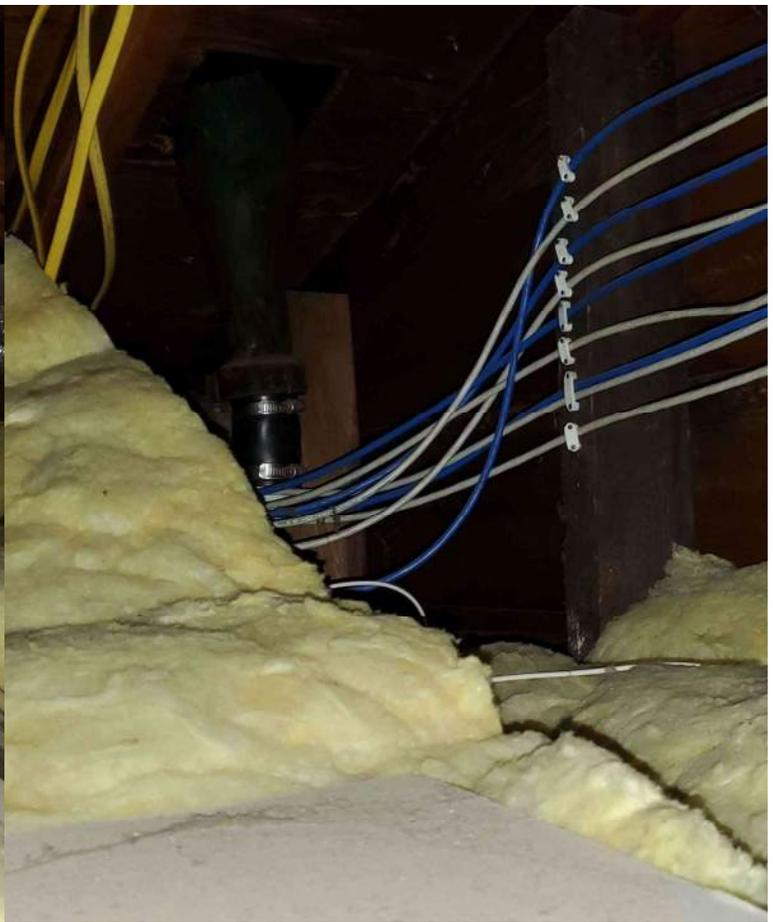
7. HVAC ducts, wiring, vent pipes, and insulation under rear shed roof. Recommend sealing ducts and air sealing ceiling penetrations.

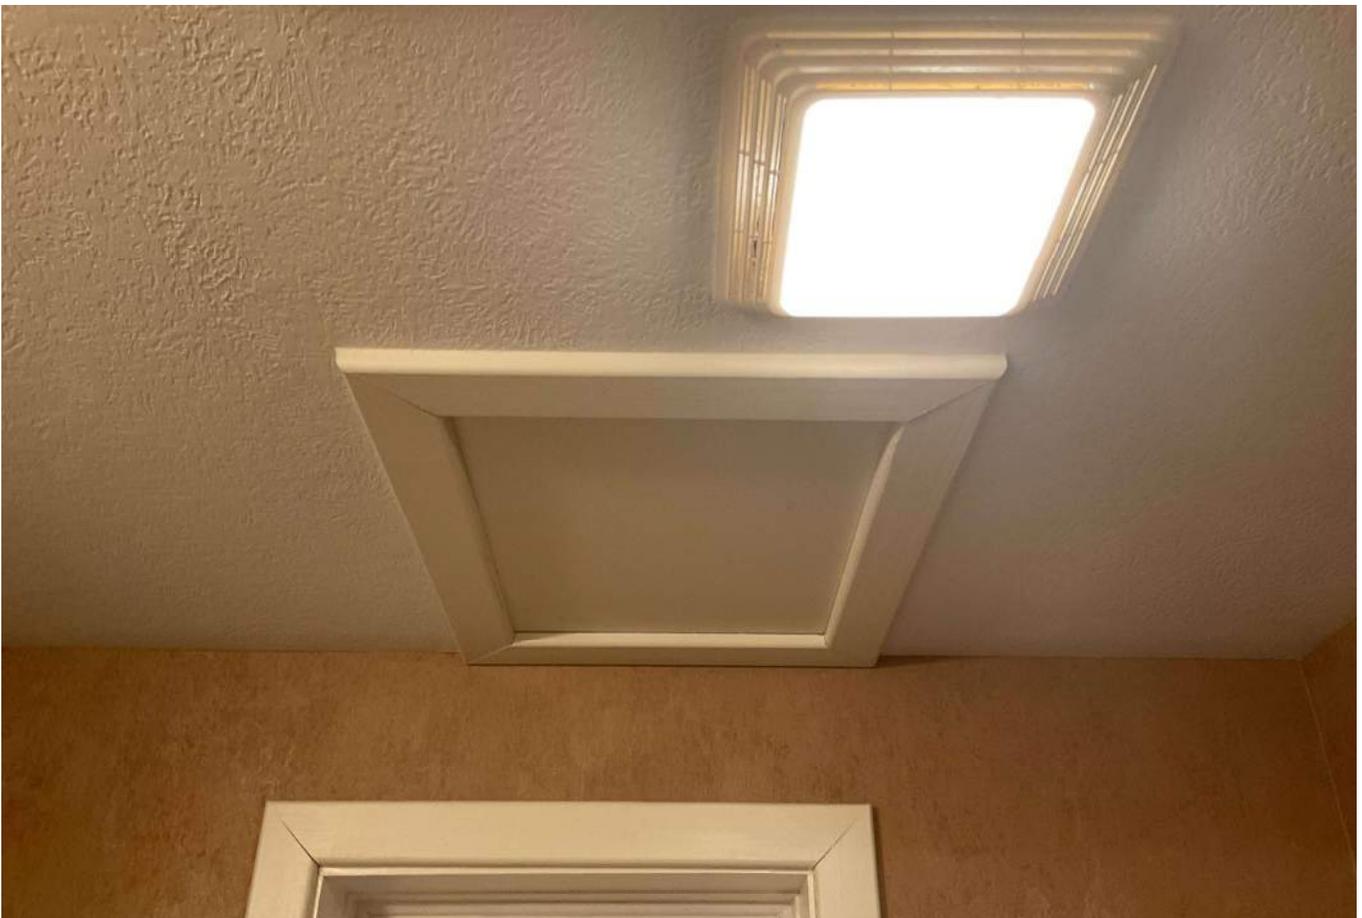
8. 1st floor access to shed roof attic. Recommend an air sealed access.

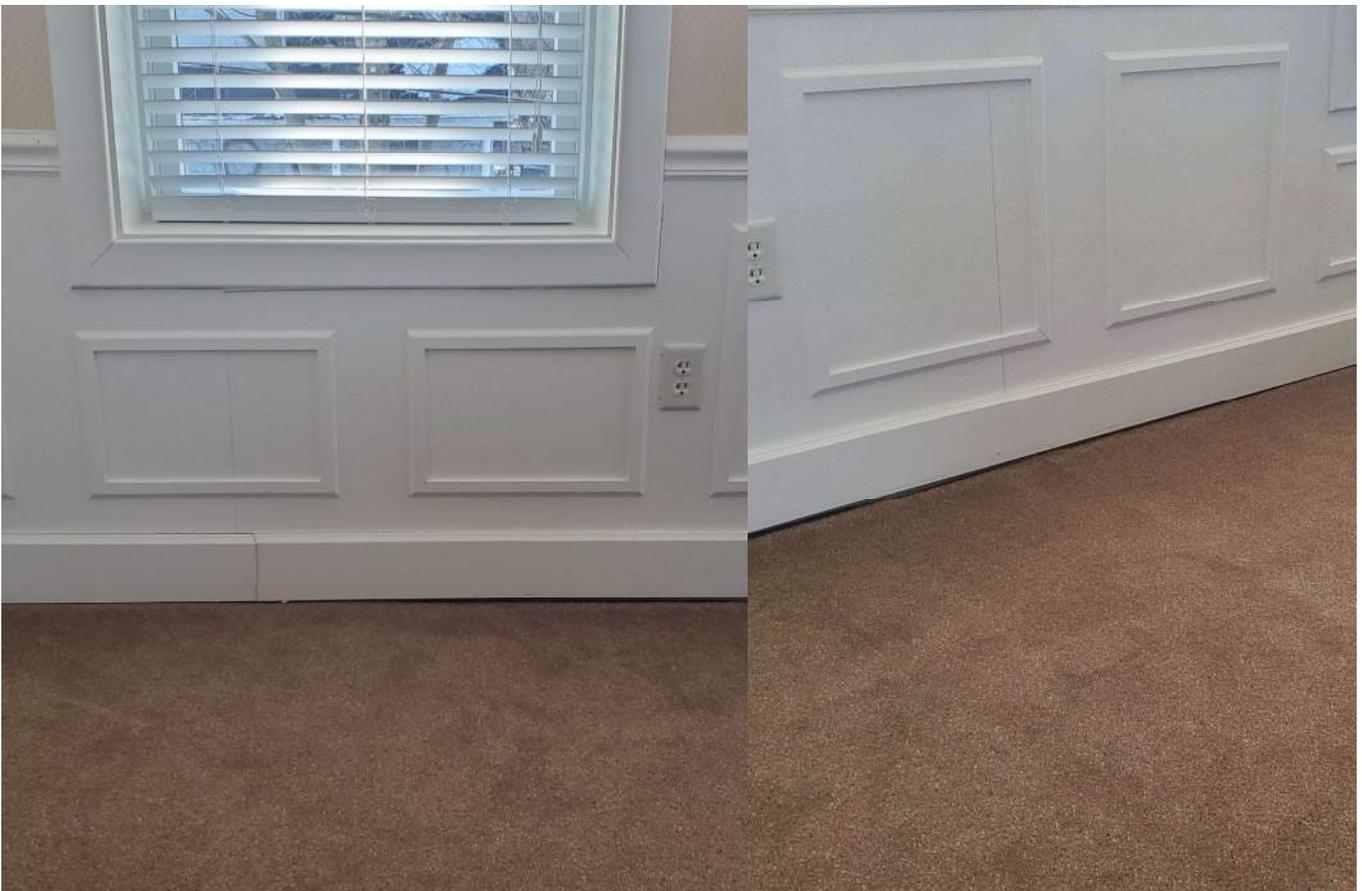
10. Wall cracks on the second-floor. Consider repairing if the aesthetic is of concern.

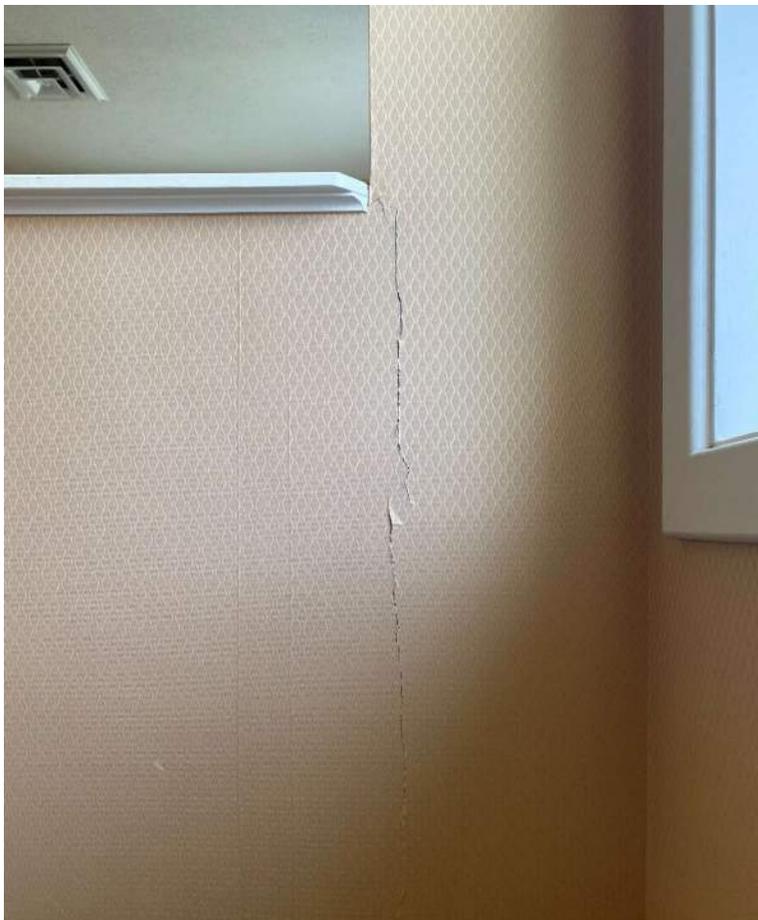
11. Wall crack in the stairwell. The knee wall may be separating from the interior chimney. Consider repairing if the aesthetic is of concern.

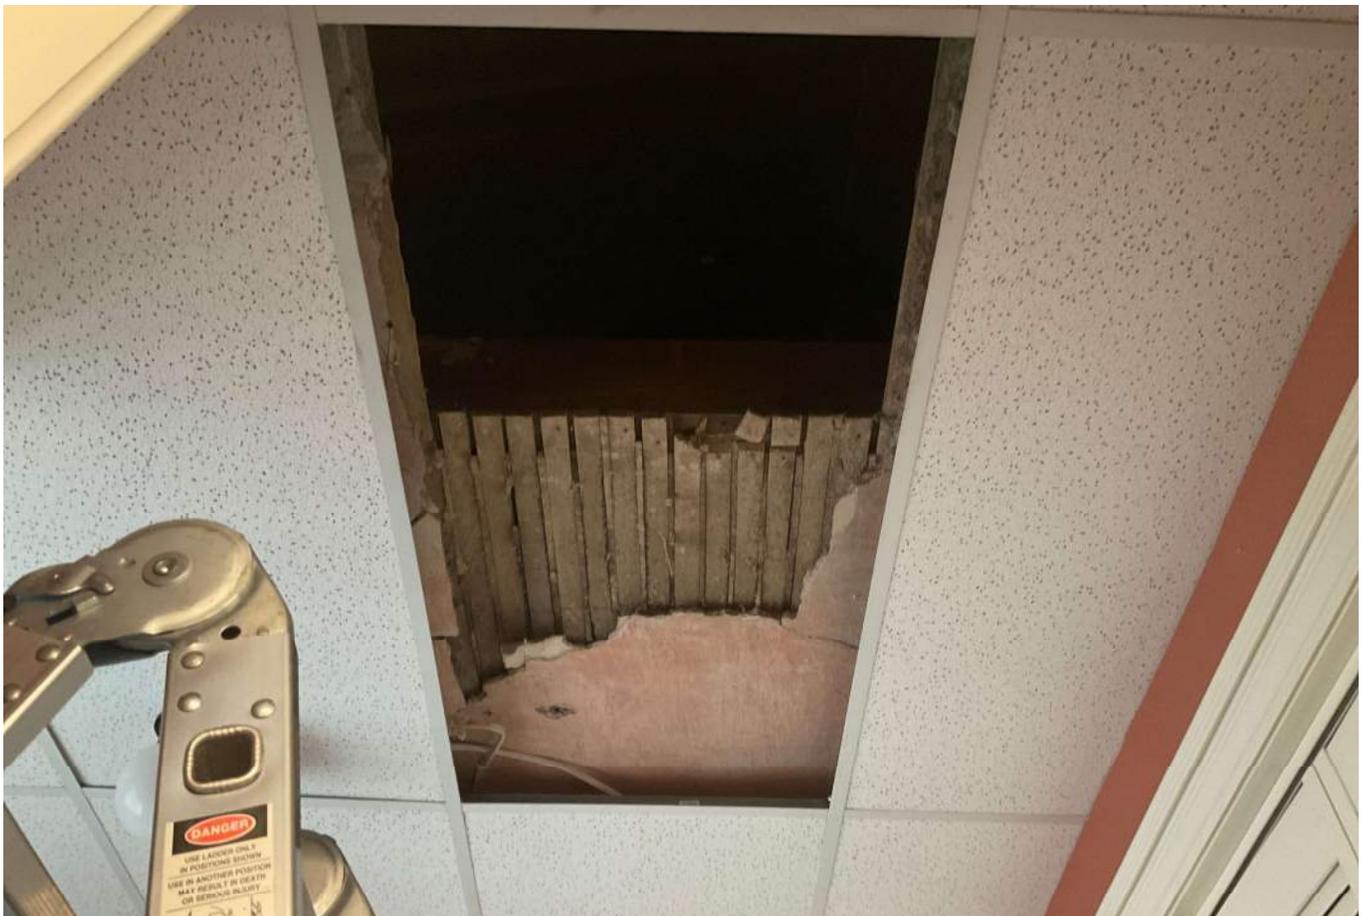
12. Existing second floor attic access does not have a hatch. Recommend an air sealed hatch.
