THOMAS PENDLETON HOUSE

PRESERVATION PLAN

August 2, 2022

RQAW Corporation
8770 North Street, Suite 110
Fishers, IN 46038
Phone: (317) 588-1762
www.rqaw.com

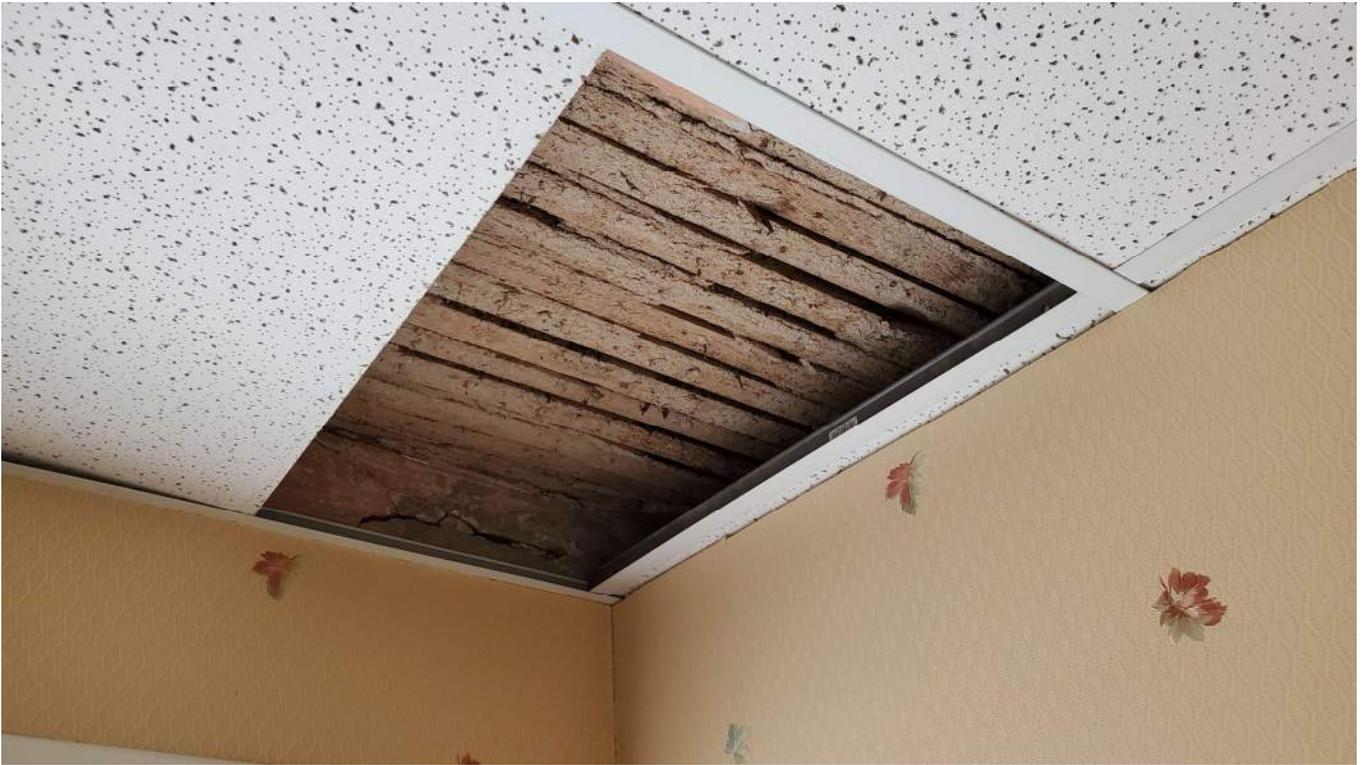
13. Second floor ceiling plaster missing. Recommend drywall ceiling to reduce air leaks into the attic.

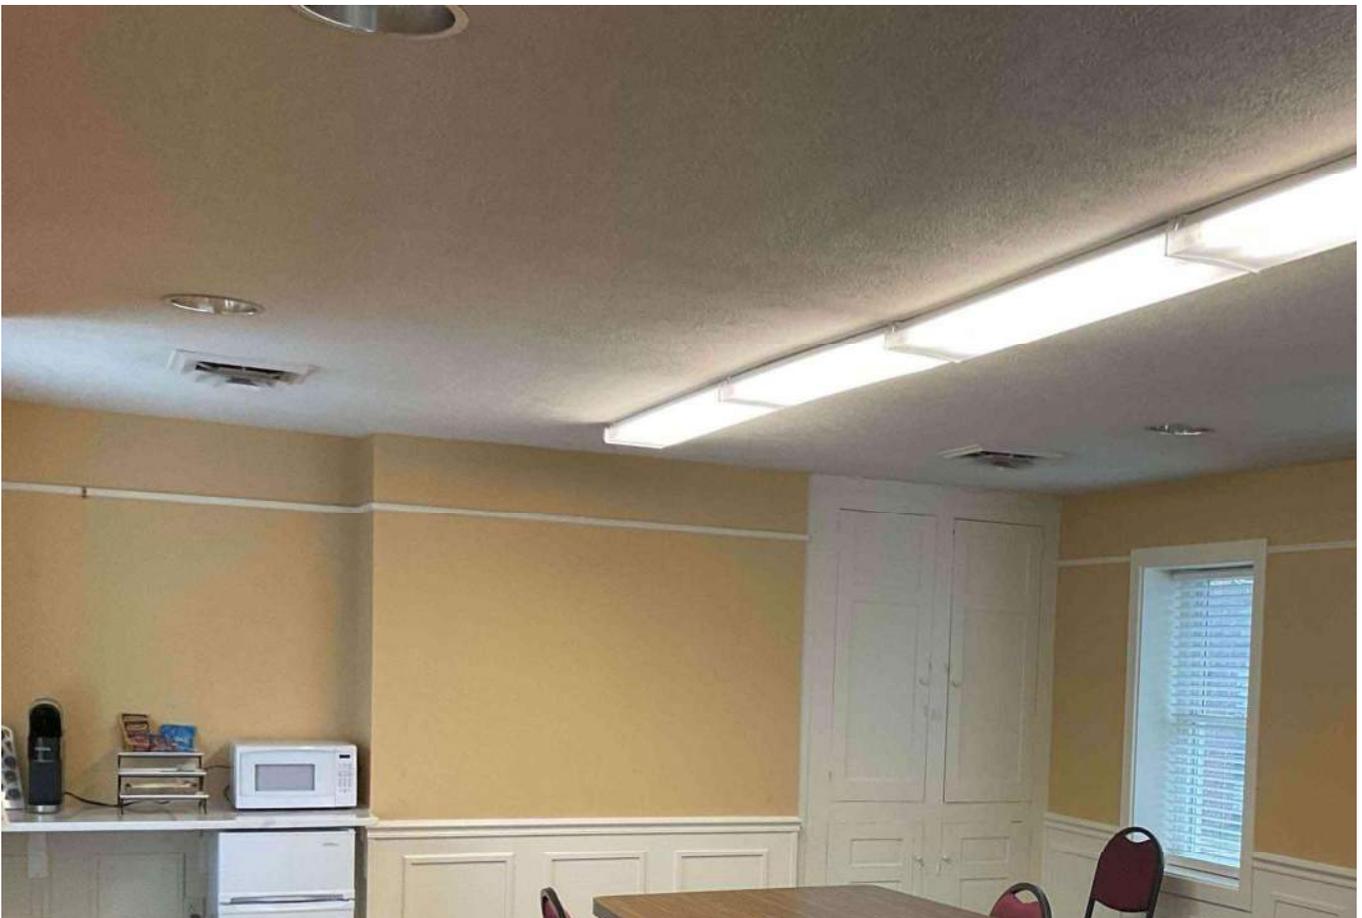
14. Light and HVAC diffuser penetrations in ceiling. Recommend air sealing.

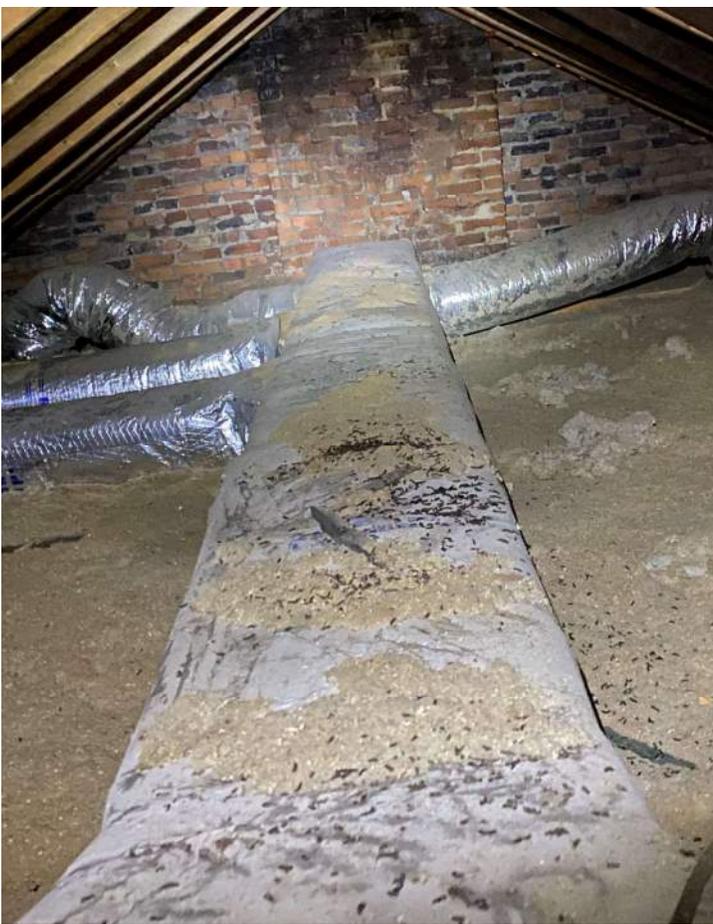
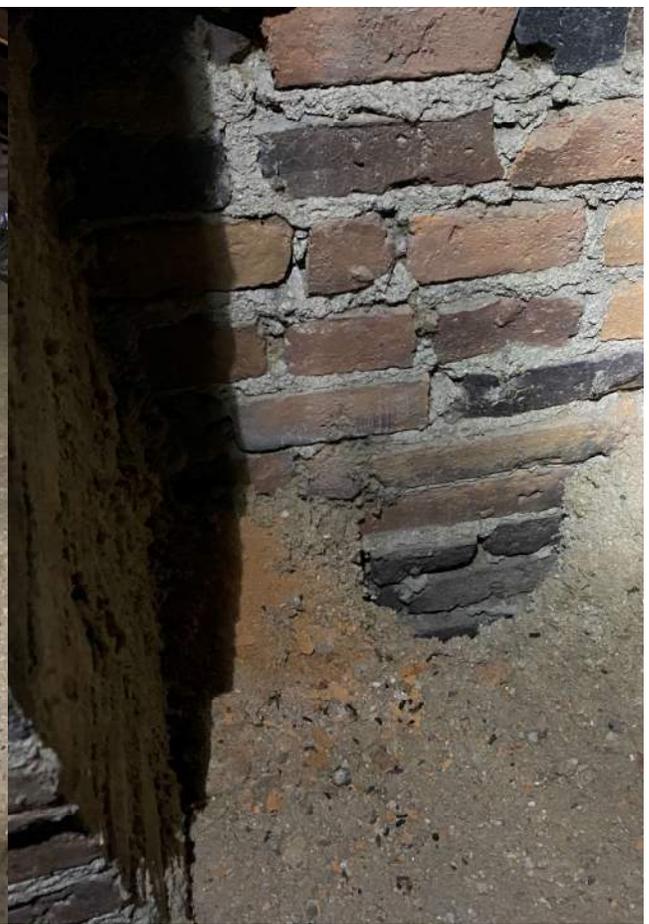
15. Rodent feces on HVAC ducts and insulation. Possible rodent access next to the south chimney. Recommend sealing rodent access to the attic.

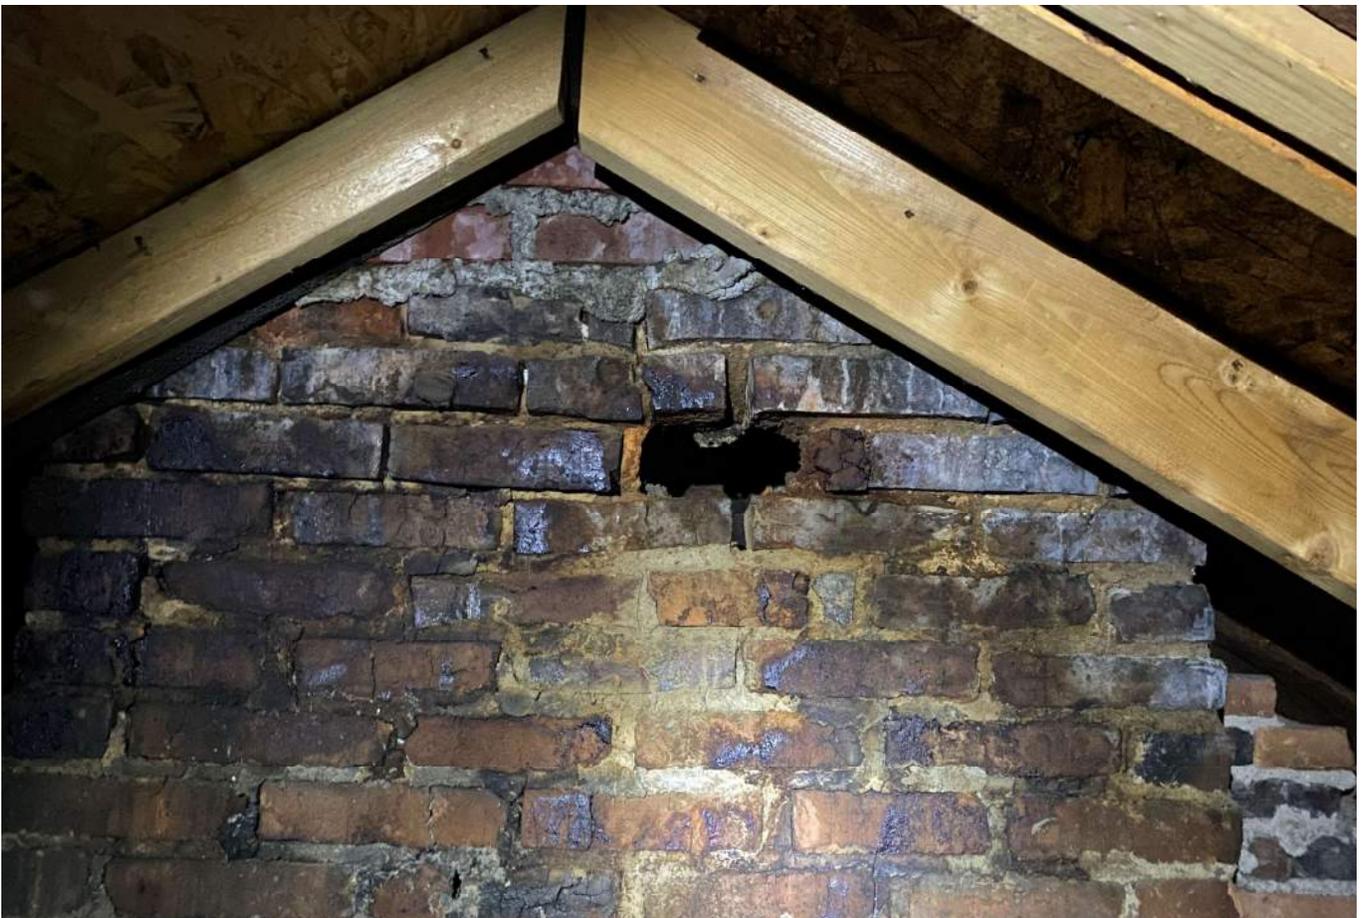
16. Hole in the south chimney interior masonry.

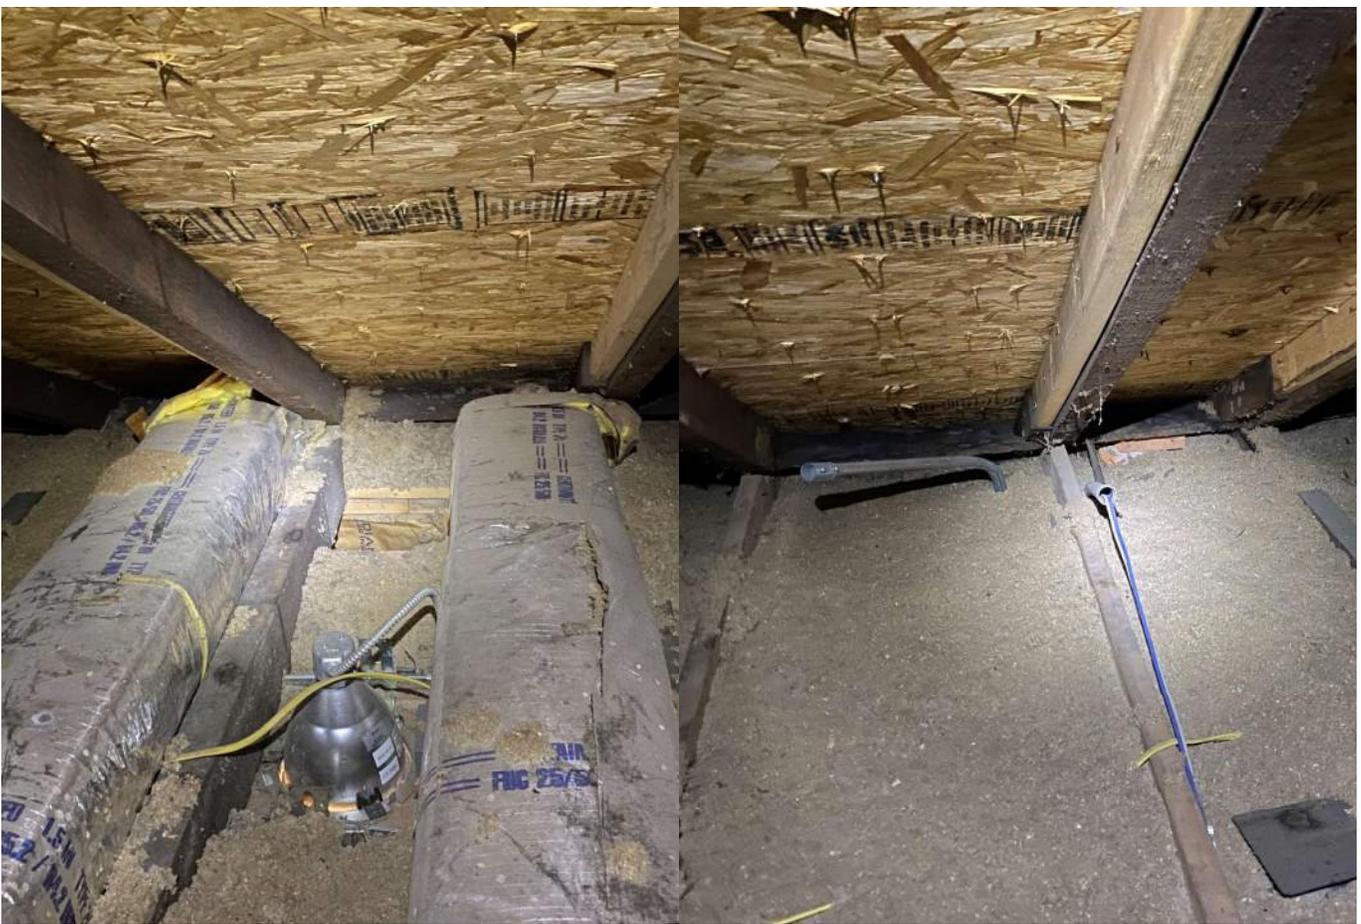
17. Second floor ceiling penetrations to the attic. Recommend air sealing.
