THOMAS PENDLETON HOUSE

PRESERVATION PLAN

August 2, 2022

RQAW Corporation
8770 North Street, Suite 110
Fishers, IN 46038
Phone: (317) 588-1762
www.rqaw.com

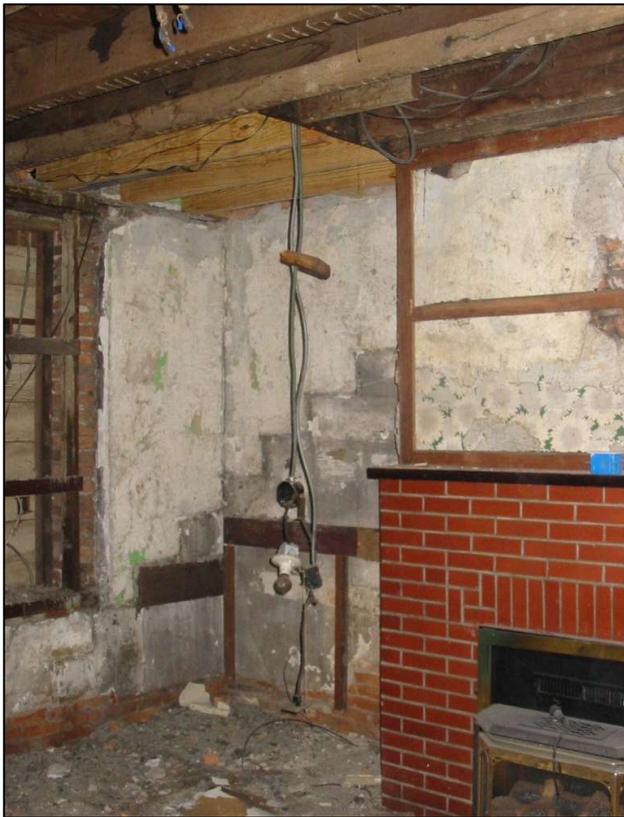
FIGURE 39: LOOKING AT THE SOUTHEAST CORNER WHERE THE STAIRS WERE REMOVED, A CONTEMPORARY HEARTH INSTALLED, AND WINDOW OPENING ENCLOSED – 1990S

Alterations have occurred to the original first floor interior, particularly to the hearths and stair configurations. The south hearth has been updated with a contemporary fireplace while the north and south hearths have been covered. It appears that the original stairs may have been circular steps in both the northeast corner and southeast corners of Rooms #1 and #2. The southeast stairs have been removed and the northeast stairs replaced with a contemporary straight staircase. Furthermore, the window opening near the southern end of the east wall was enclosed. The following photos depict some of these alterations prior to the most recent renovations. The window opening is apparent in Figure 39, but shown as a door in the 1914 Sanborn Map (Figure 22).

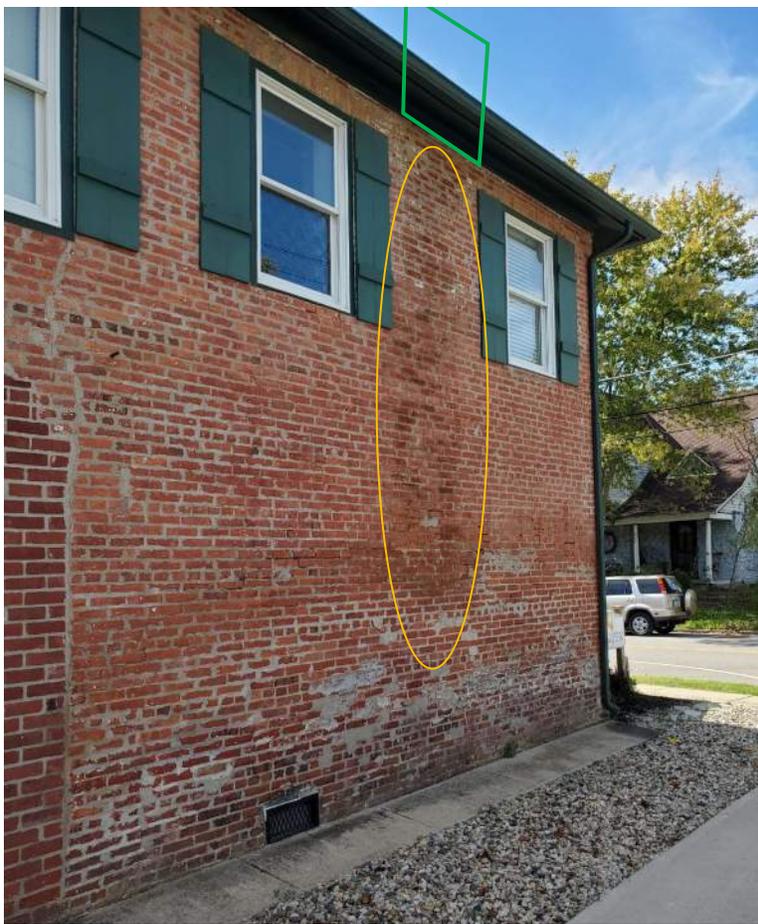
5. Former chimney removed above the roofline (green). Evidence of interior chimney is visible by the darker brick (yellow).

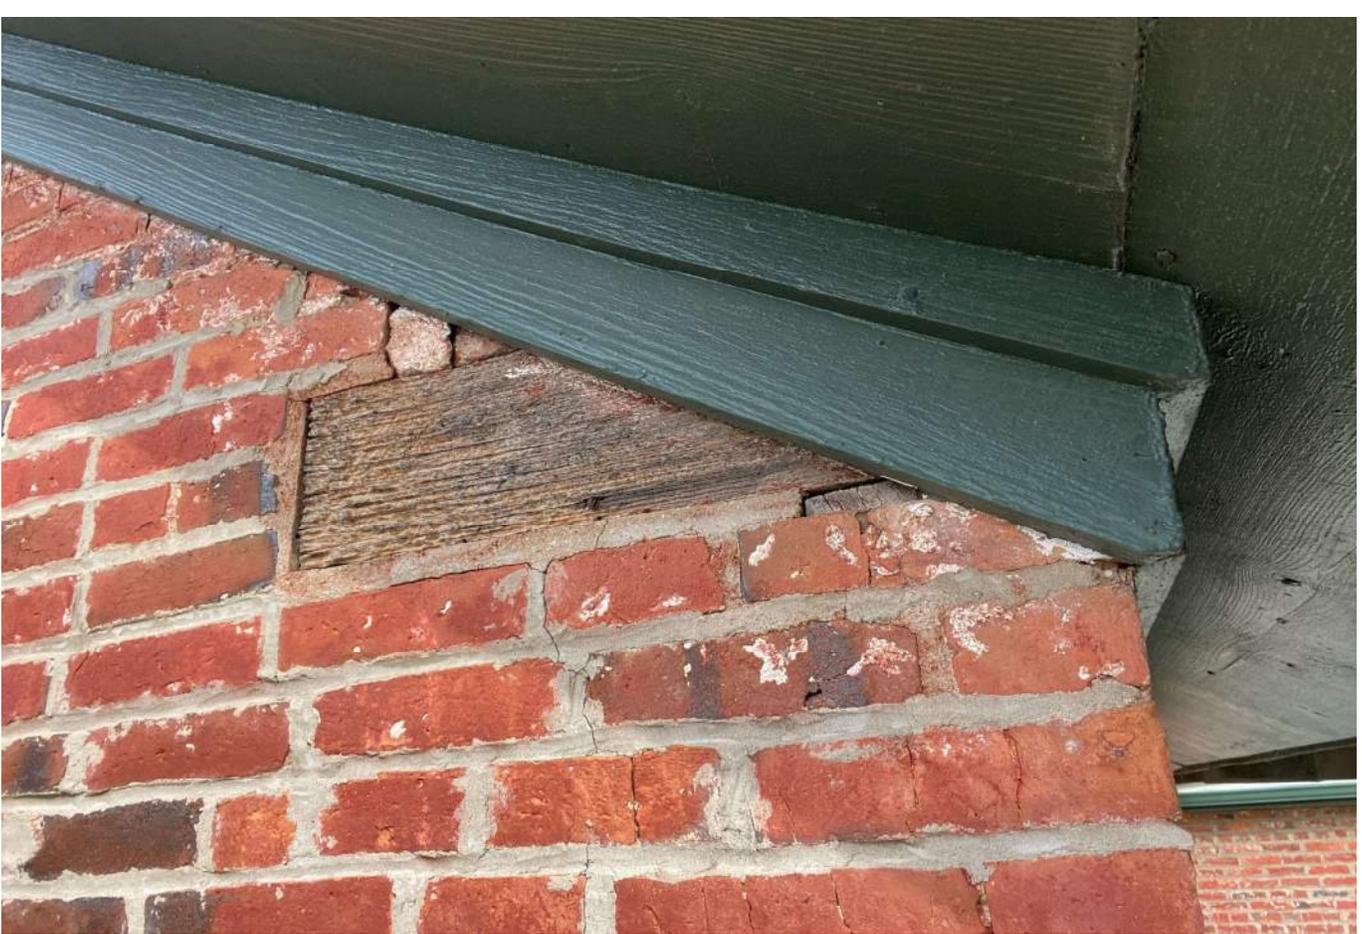
9. Detail of the discontinuous wood frieze band/return at the roof/wall junction.

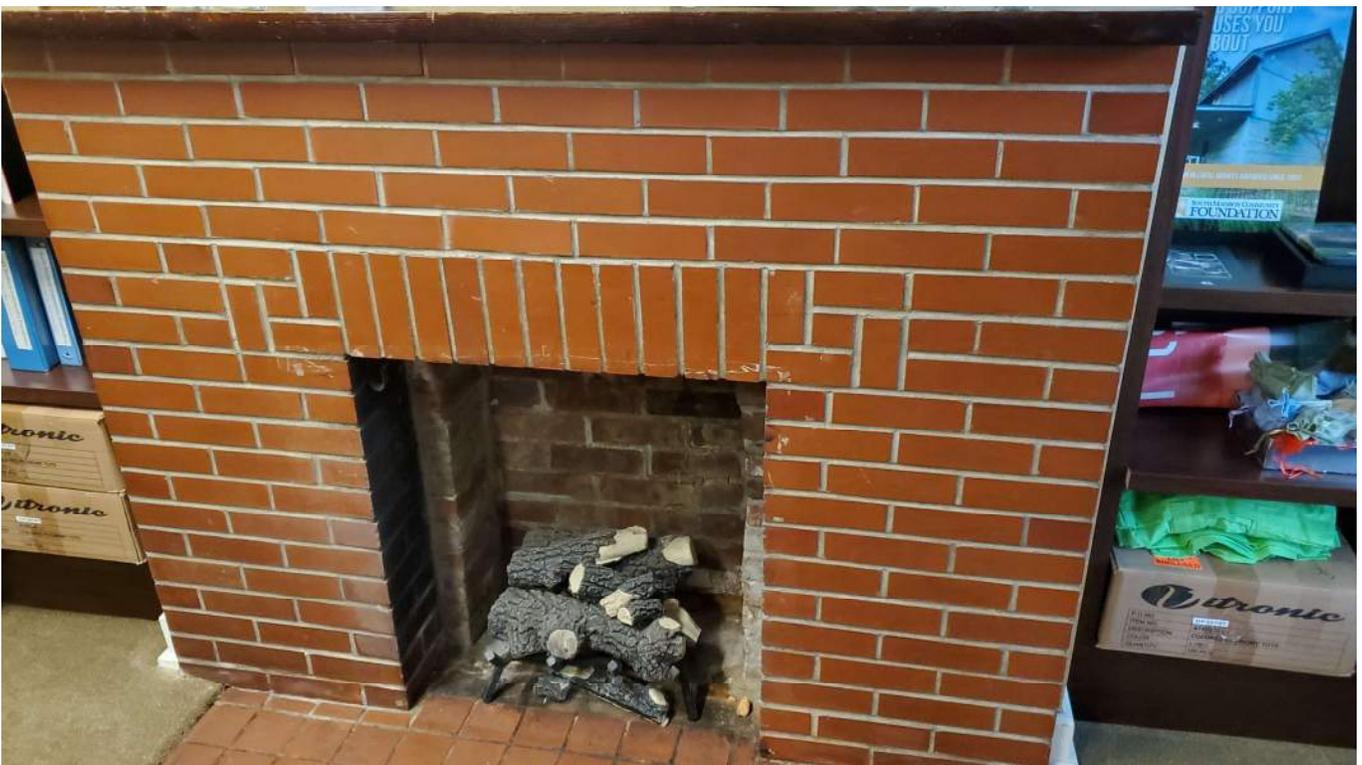
10. Contemporary fireplace in front office replaced the original.

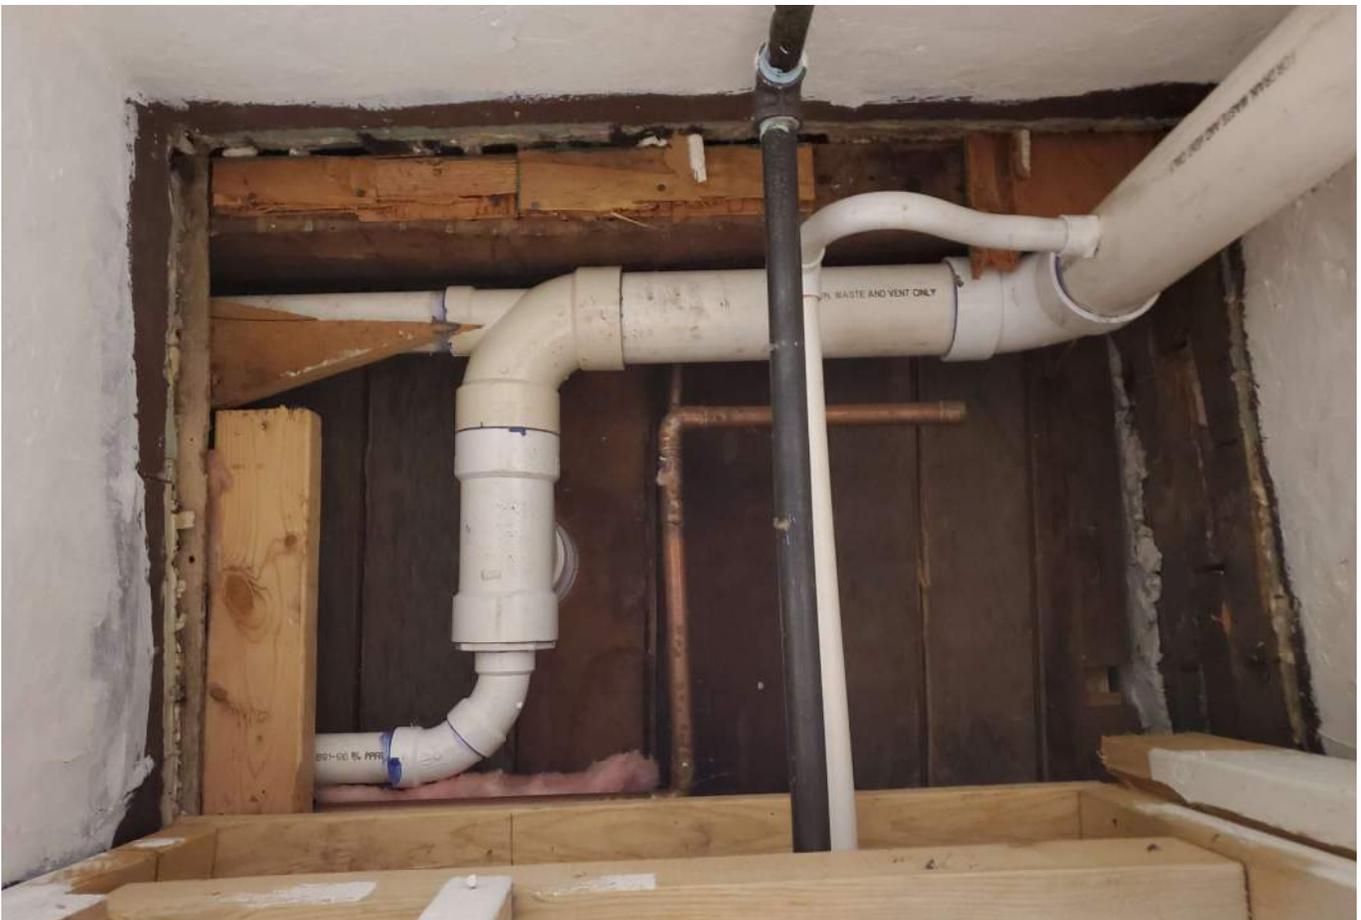
11. Looking up from the northeast closet. Evidence of plaster and lath ceiling, and sawn floor joists, and tongue and groove flooring.

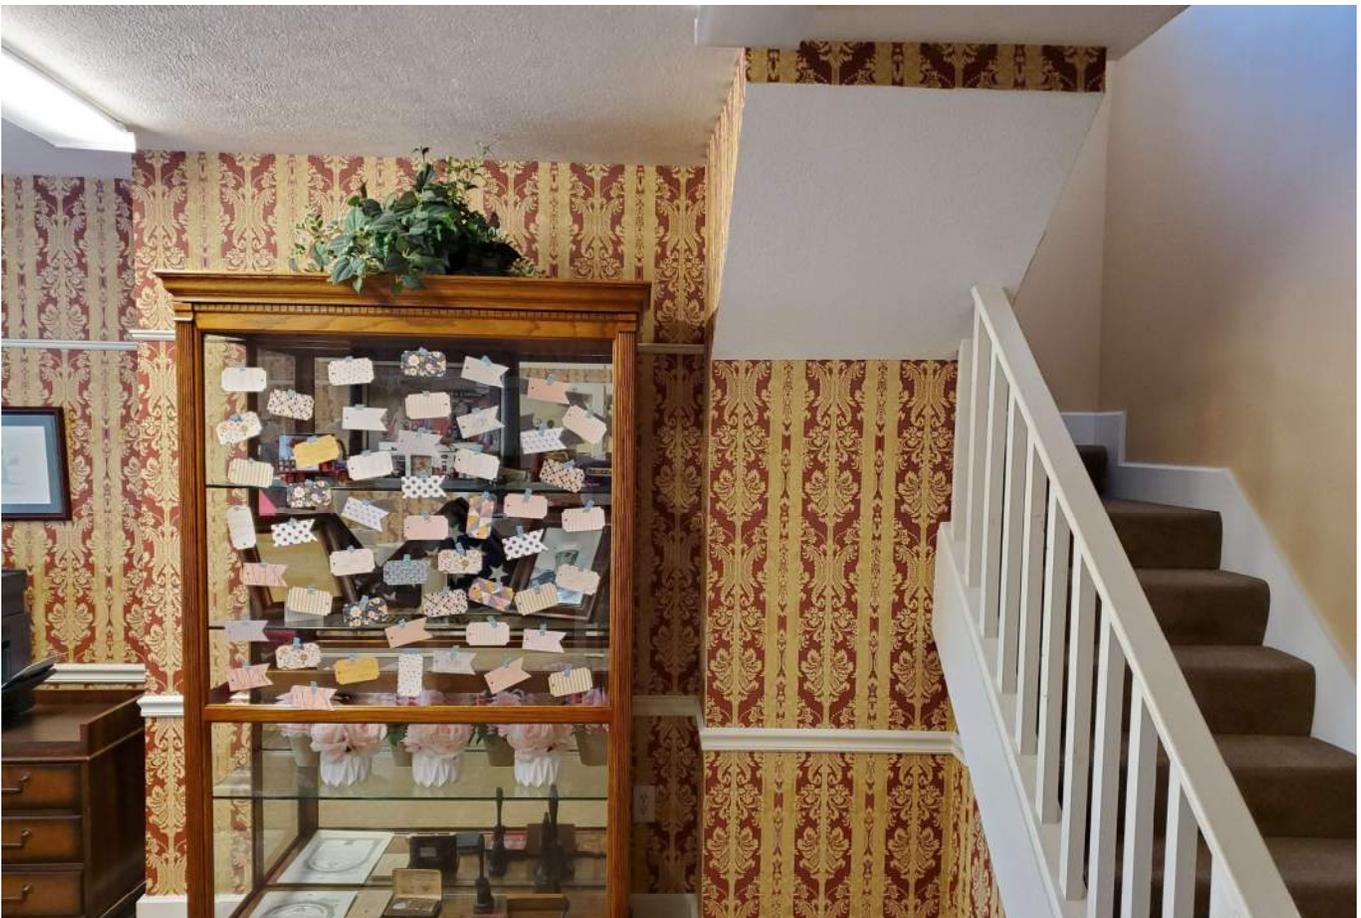
12. Open stairwell along interior wall and interior chimney (former fireplace) behind display case.

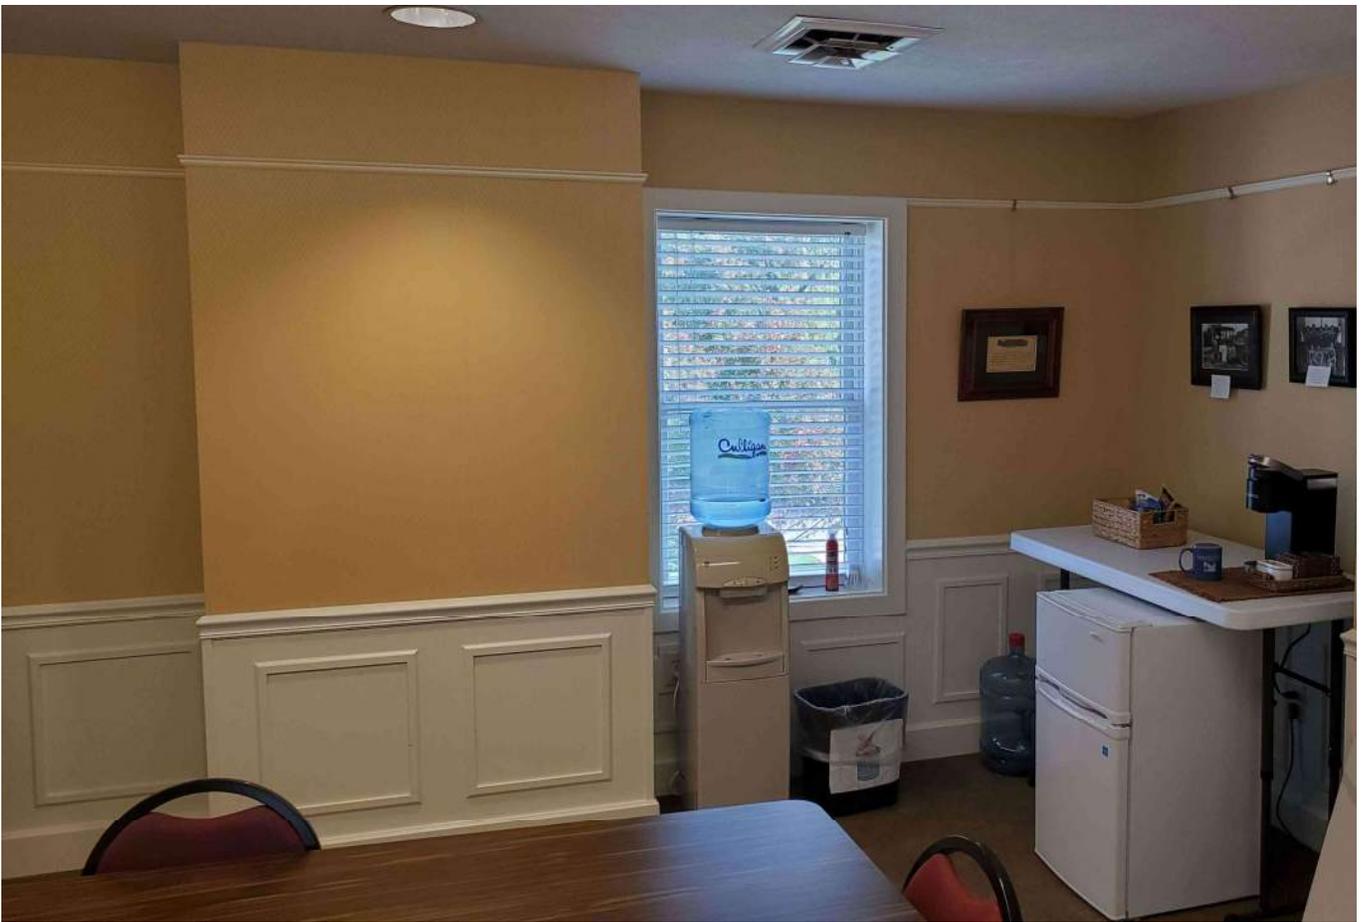
17. Added chase for HVAC ducts and electrical wire. Stairwell in corner removed.

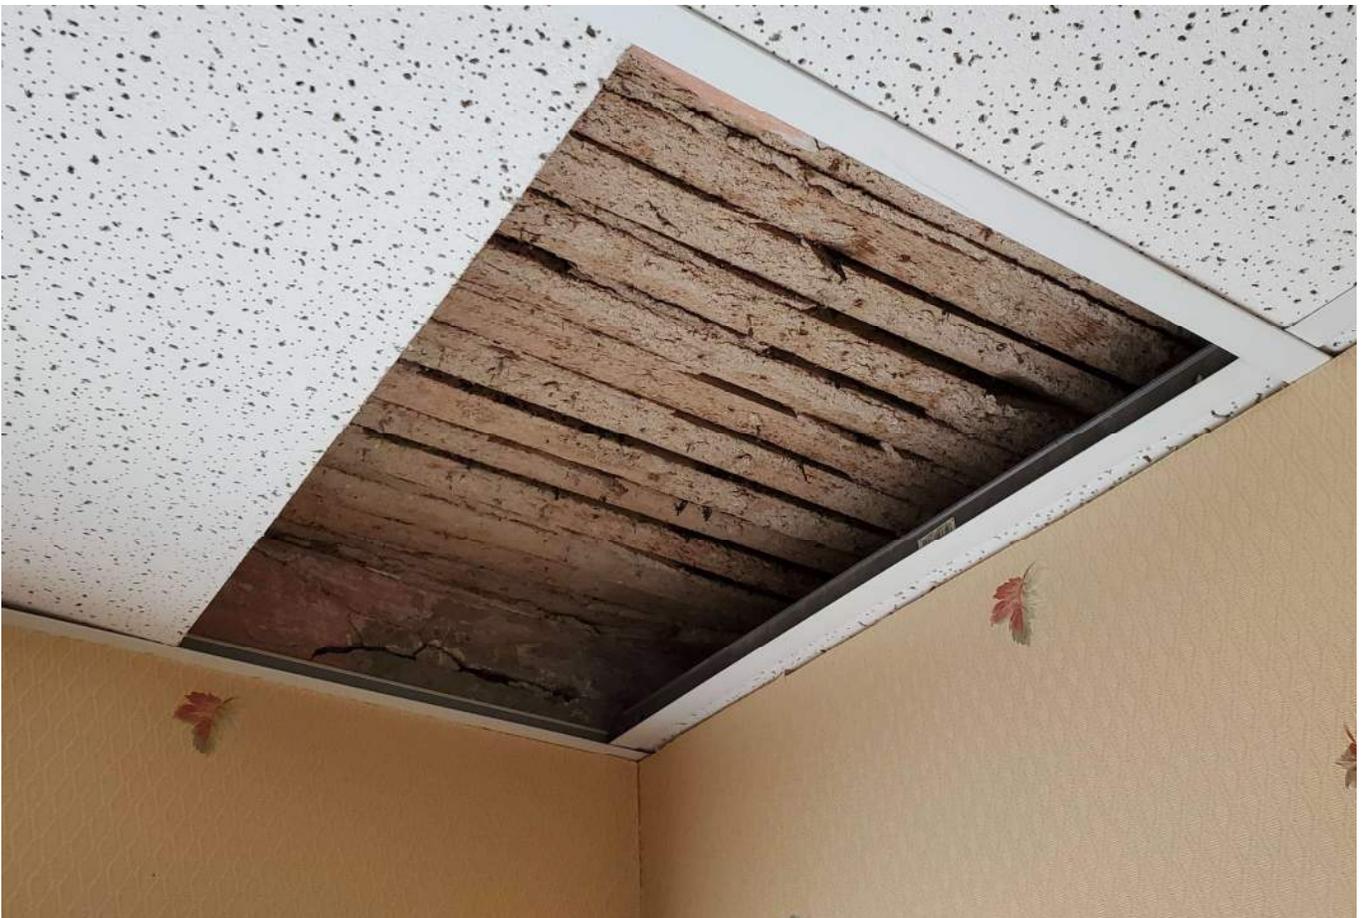
18. Lath and plaster ceiling above 2nd floor drop ceiling.

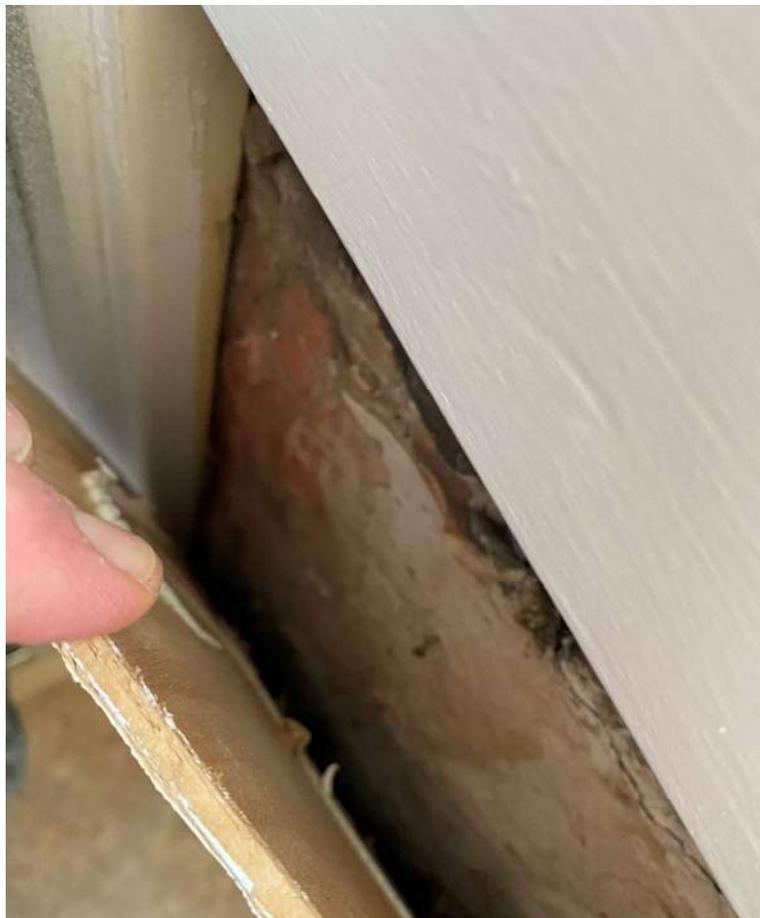
20. Plaster on brick walls behind bathroom wall covering. Plaster could be restored.

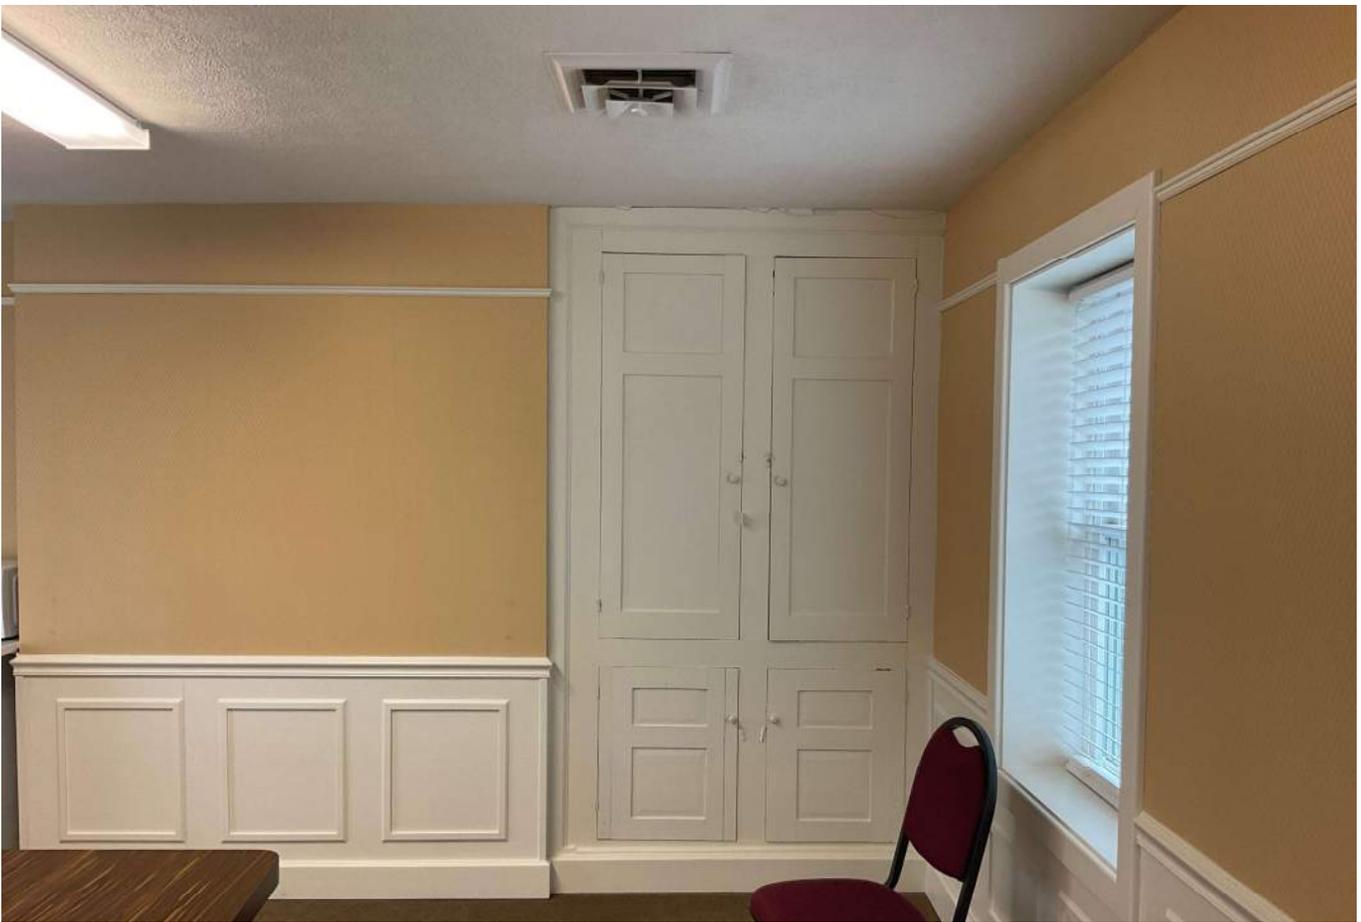
21. Interior chimney with likely second floor fireplace, and historic built-in cabinets.

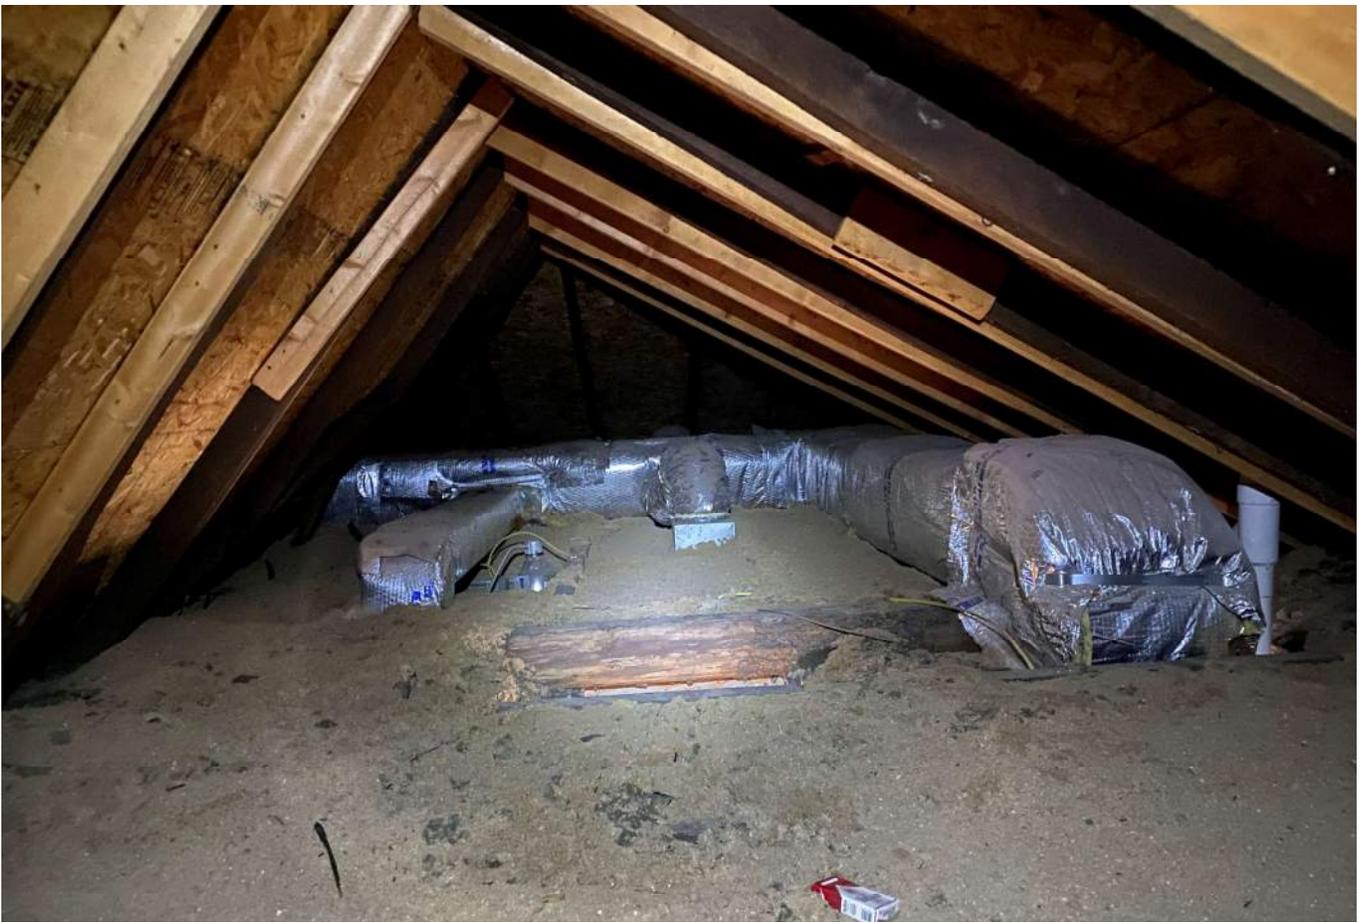
23. Looking west toward the roof hip. Contemporary rafters sistered to historic sawn rafters. Note the south and north roof pitches and lack of a ridge beam.

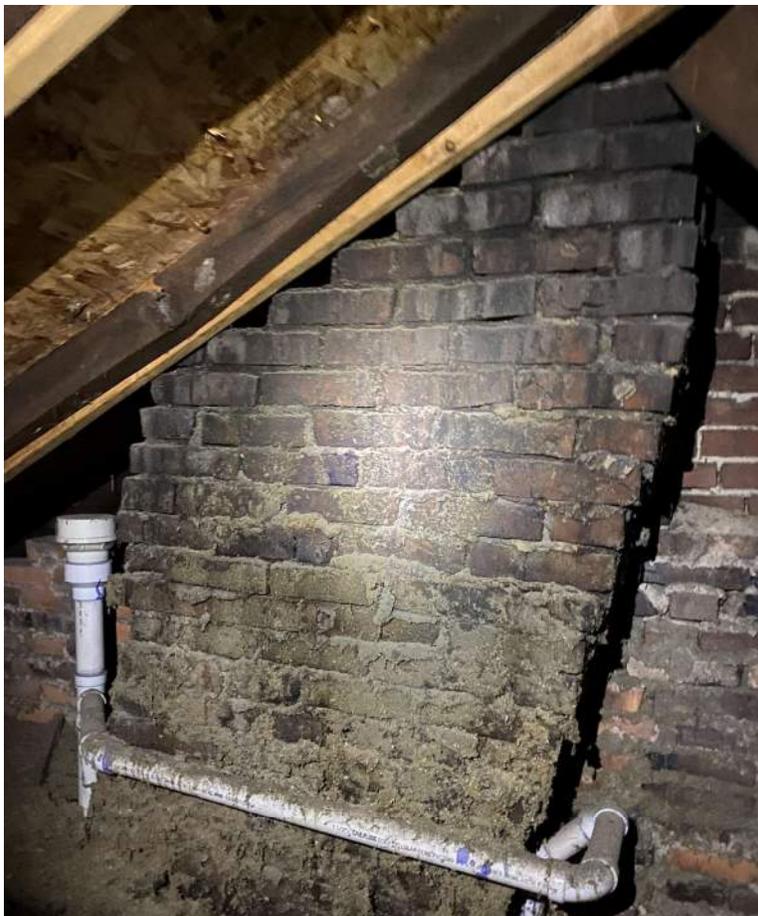
24. Looking at the east chimney that angles to the south and is removed at the roof line.

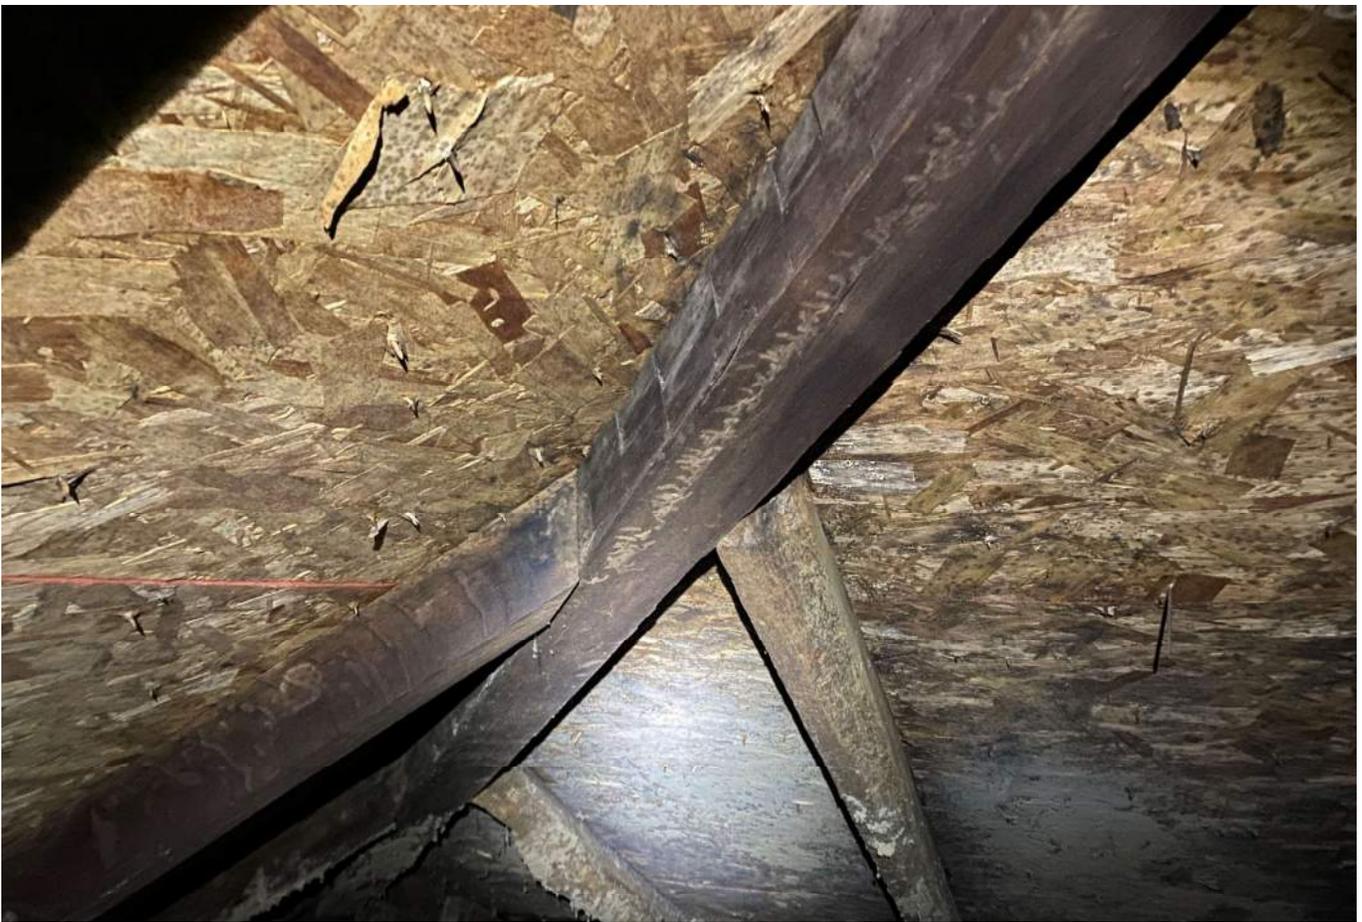
25. Hand-hewn rip rafter. All other rafters are sawn and likely not original.

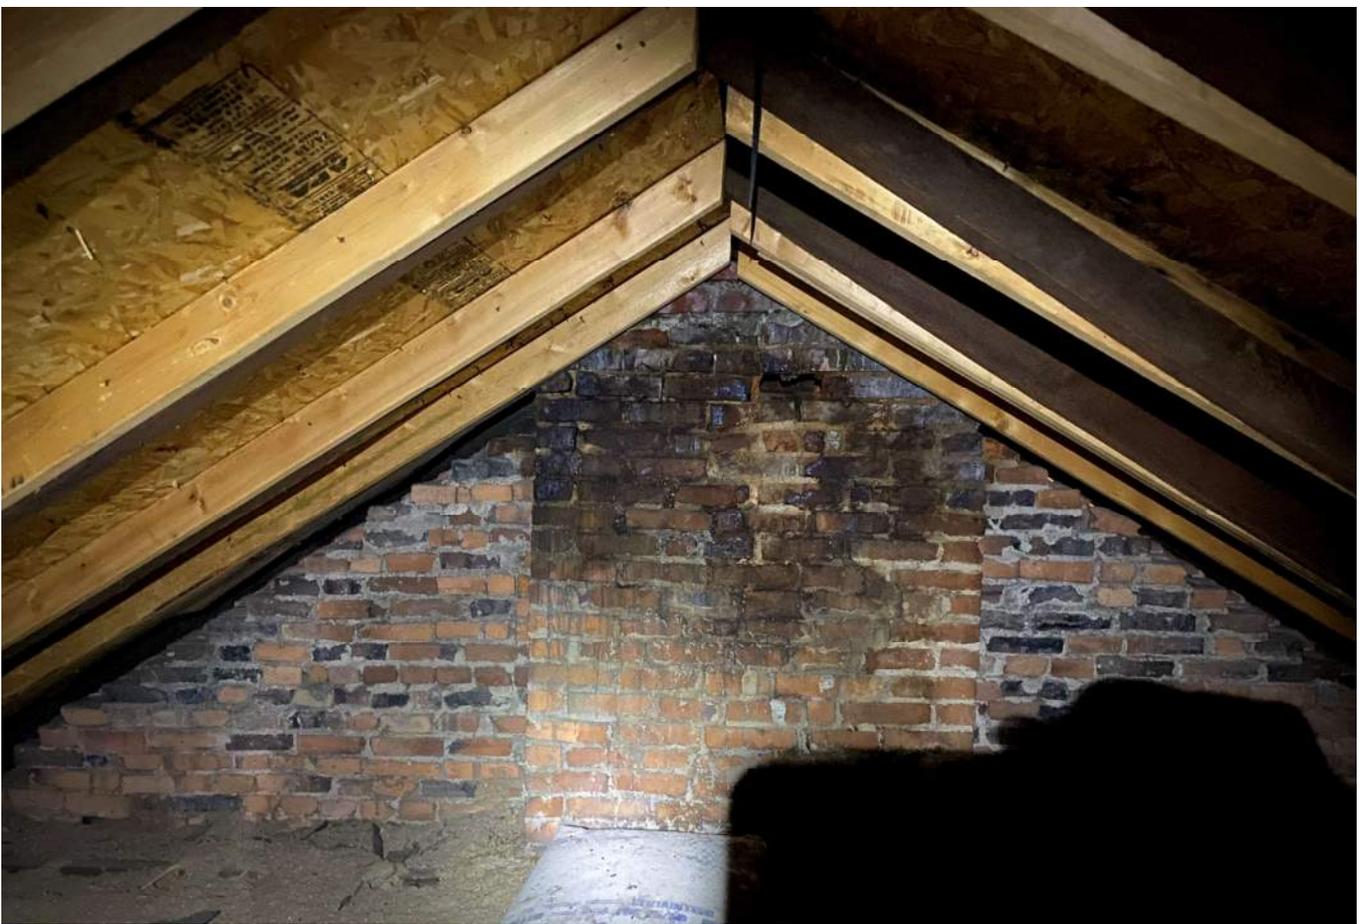
27. Looking at the south chimney that extends above the roof line.

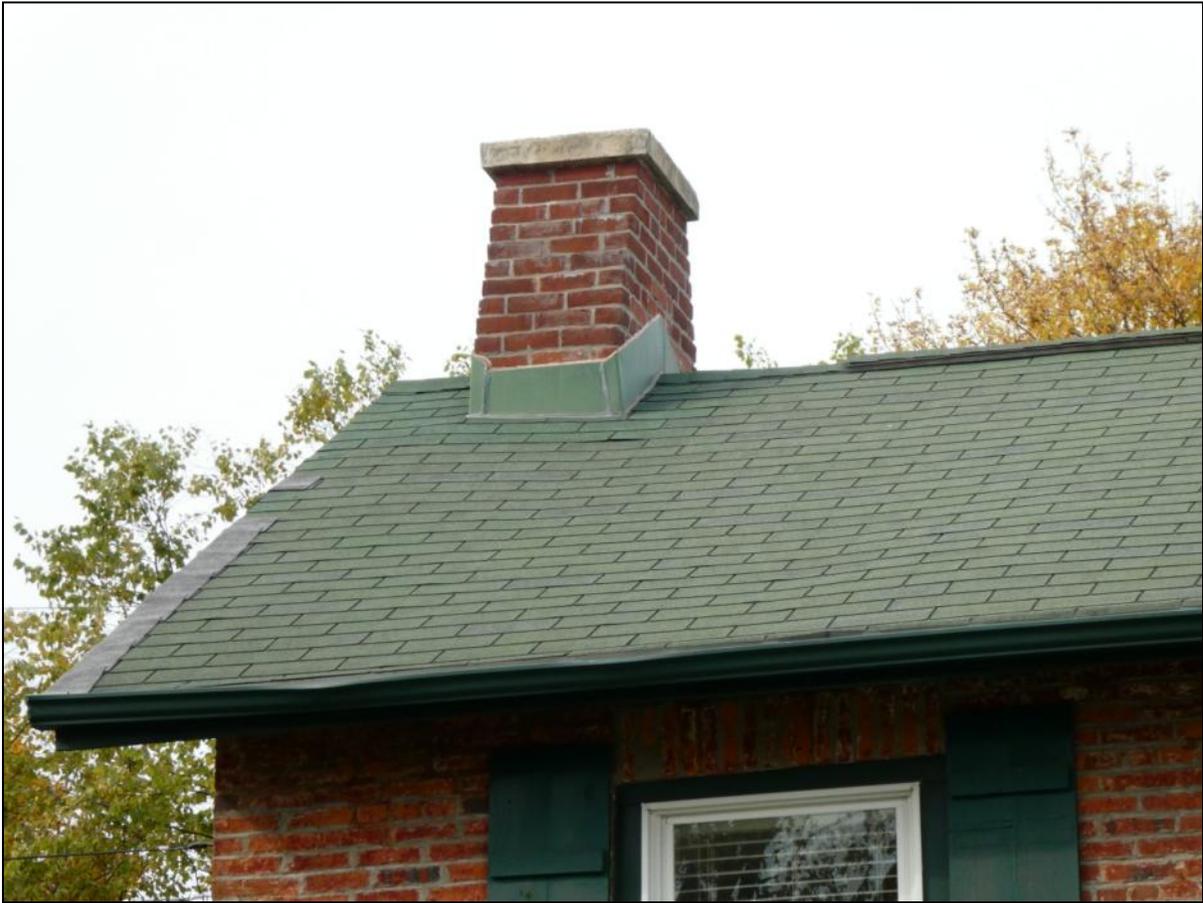
Photo 05 The southern end of the gabled roof.

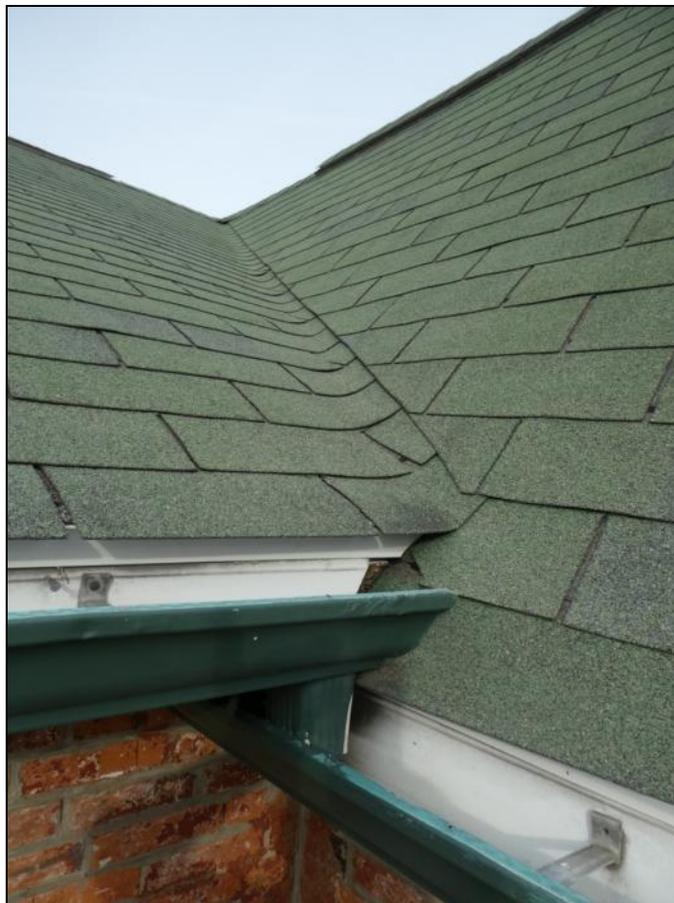
Photo 08 The valleys were simply covered with shingles.

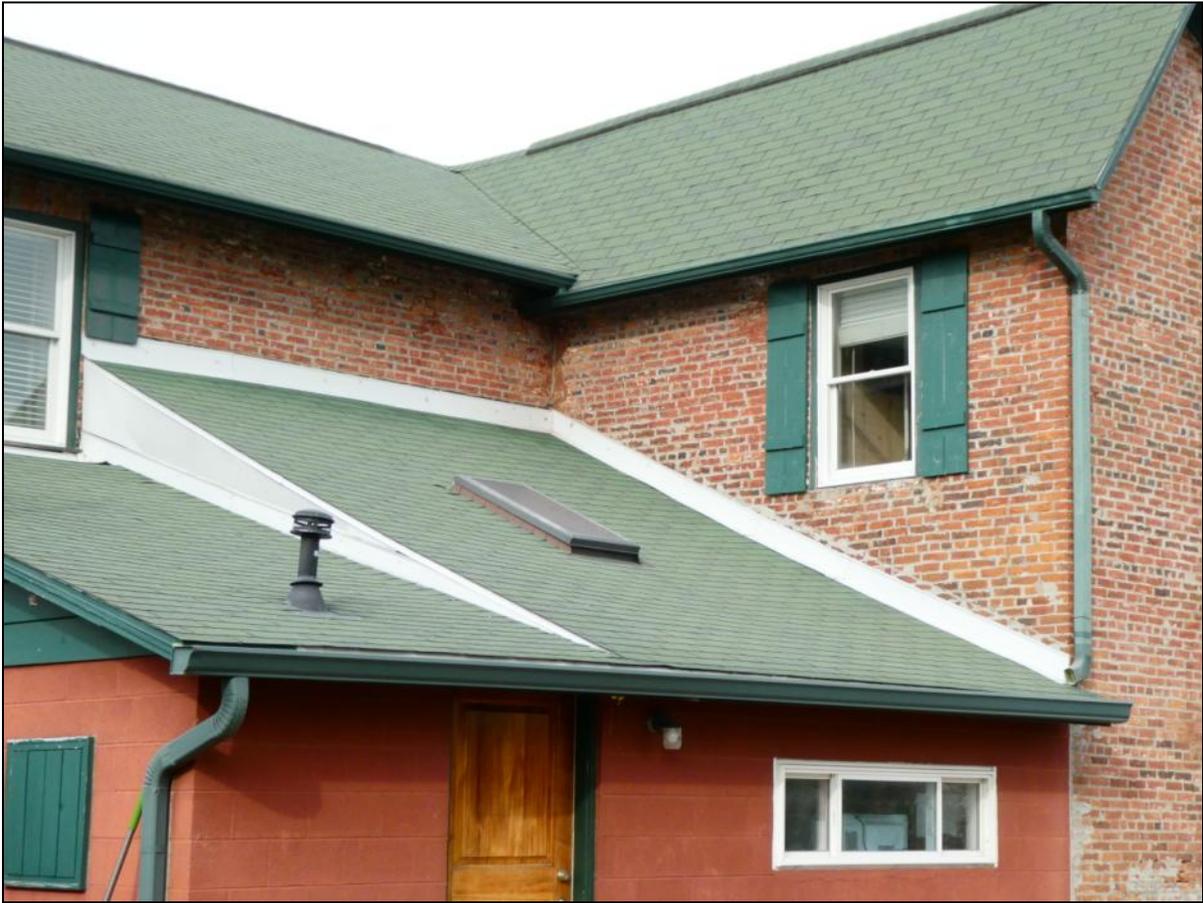
- The addition on the east elevation is covered with a simple shed roof as shown in Photo 9. A number of gaps were found between the flashing and the brick as shown in Photos 10 and 11. The sealant joint that closes off the flashing was typically found to have failed as shown in Photo 12.

Photo 09 The shed roof over the east addition.

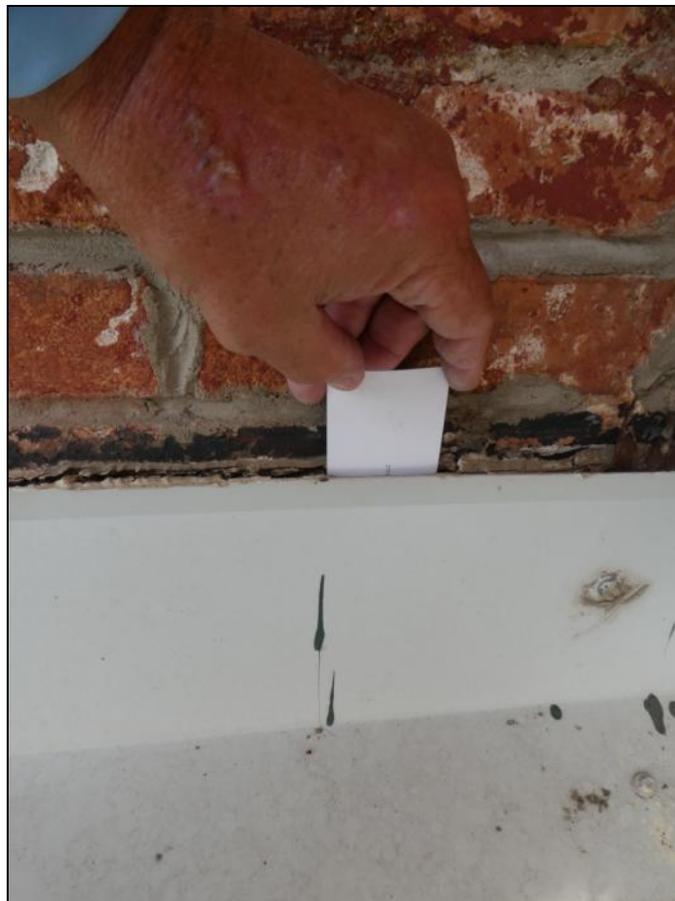
Photo 10 Gaps were present between the flashing and masonry wall.

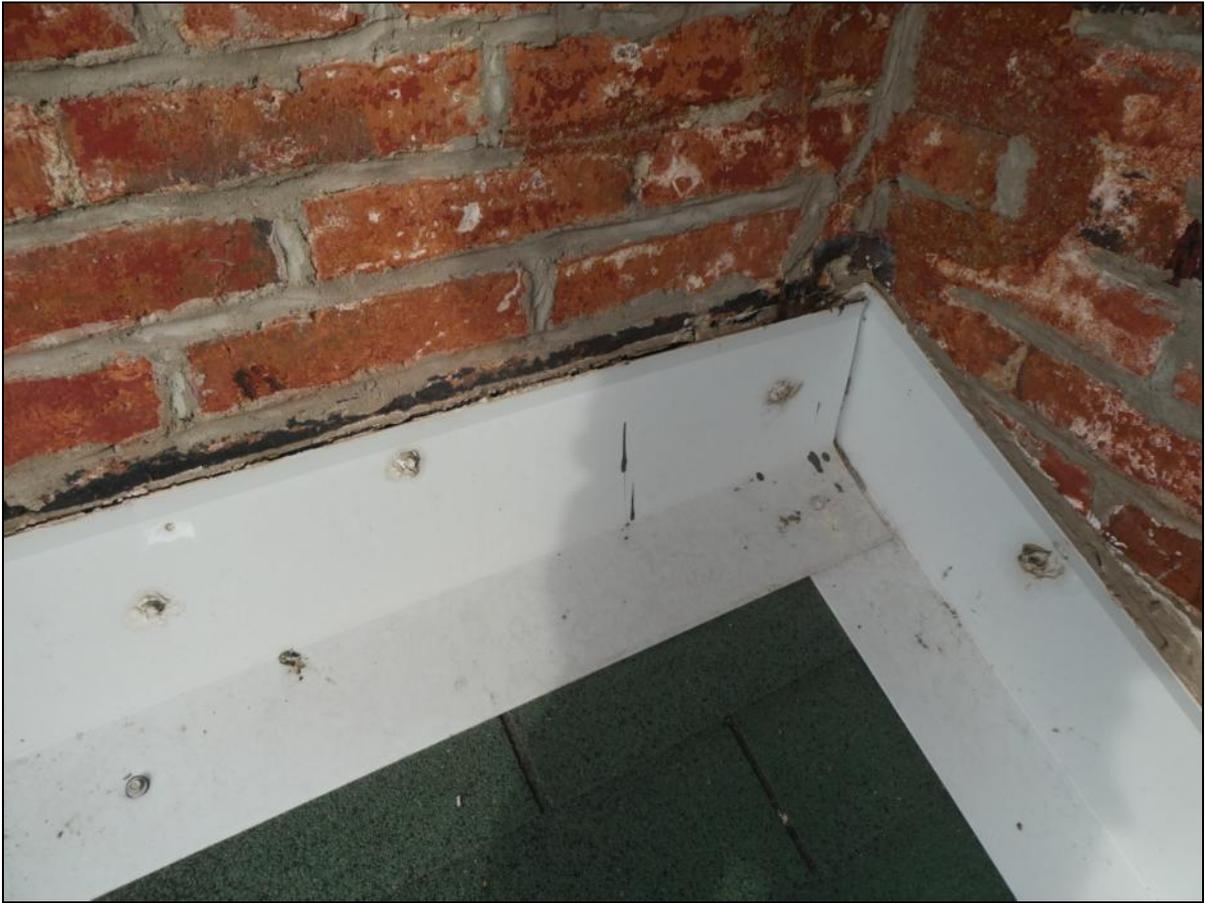
Photo 11 Another large gap near the northwest corner of the addition.

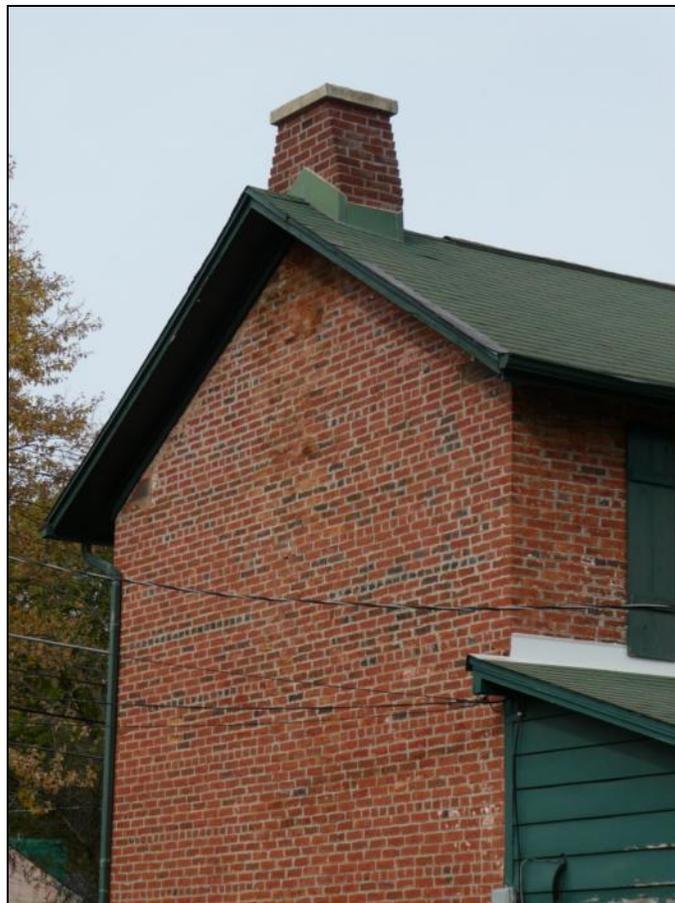
- Downspouts on the upper roof empty directly onto the shed roof as shown in Photo 13.
- An area of eroded masonry was observed on the south elevation beneath the chimney as shown in Photo 14 and 15. The brick chimney is stepped, making flashing details more difficult as shown in Photo 16. It is more generally more effective for flashings to be turned into a reglet within the masonry rather than being simply surface sealed with sealant.

Photo 14 Eroded masonry on the south elevation beneath the chimney.

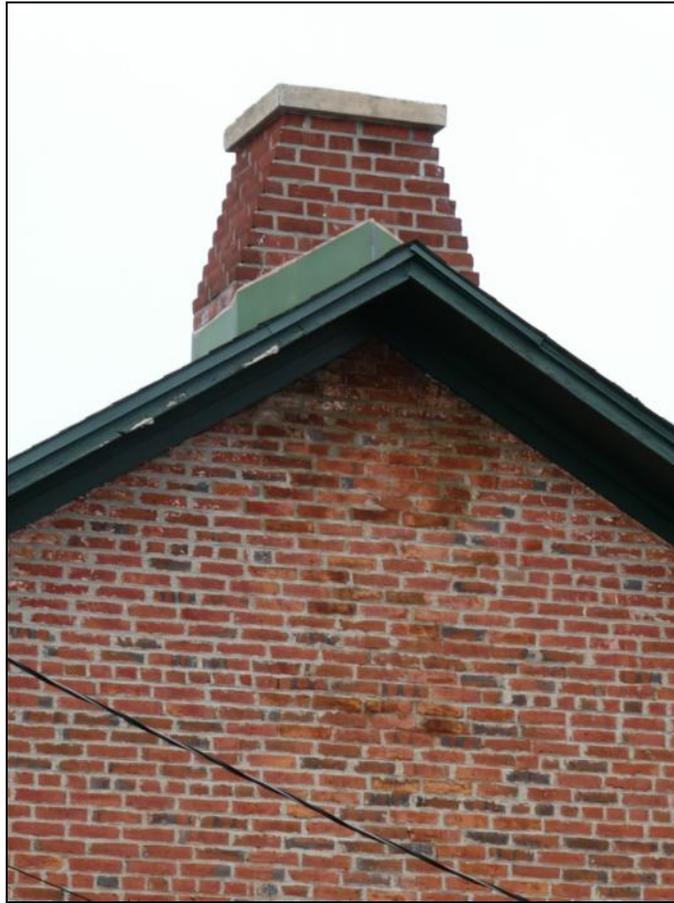
Photo 15 Another look at the erosion in this same area.

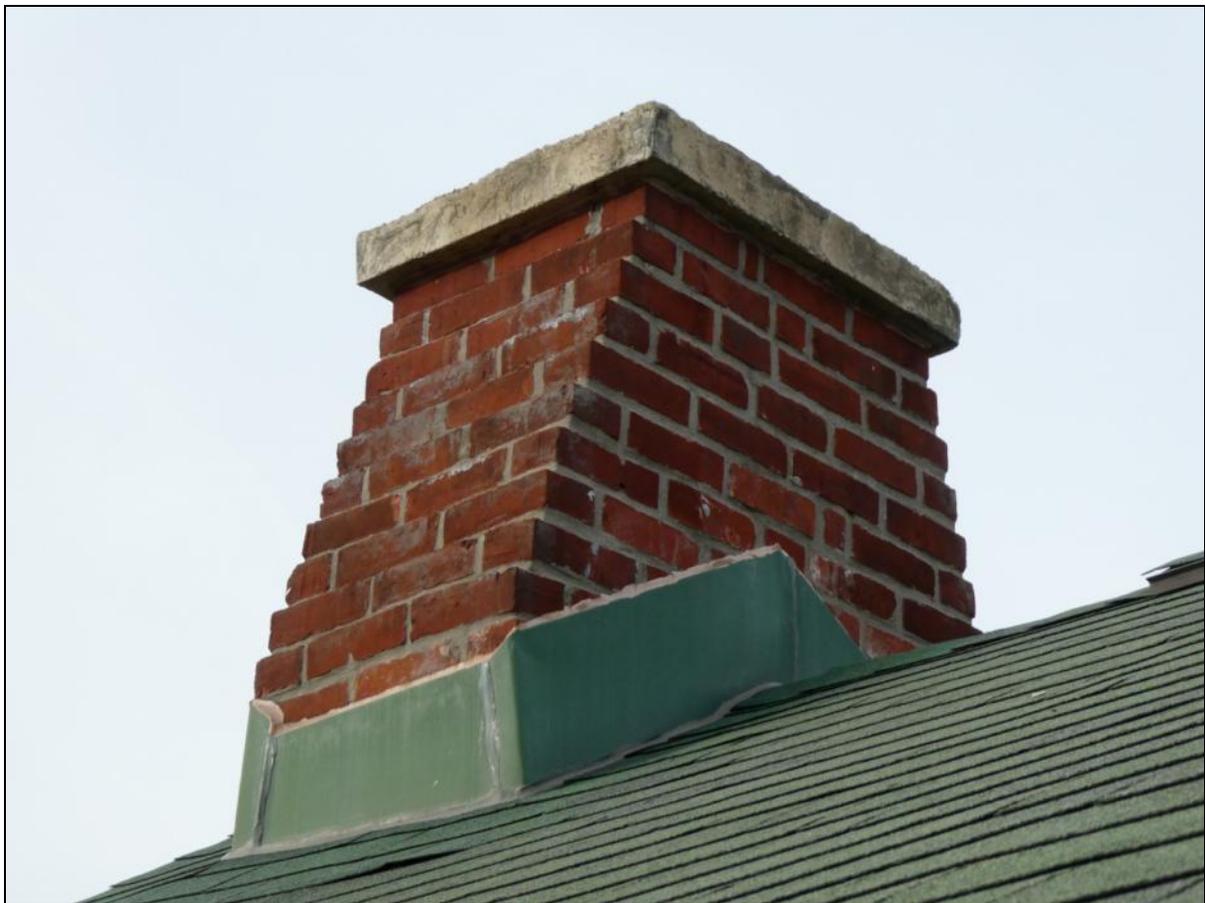
Photo 16 The stepped brick of the abandoned chimney.
