THOMAS PENDLETON HOUSE

PRESERVATION PLAN

August 2, 2022

RQAW Corporation
8770 North Street, Suite 110
Fishers, IN 46038
Phone: (317) 588-1762
www.rqaw.com

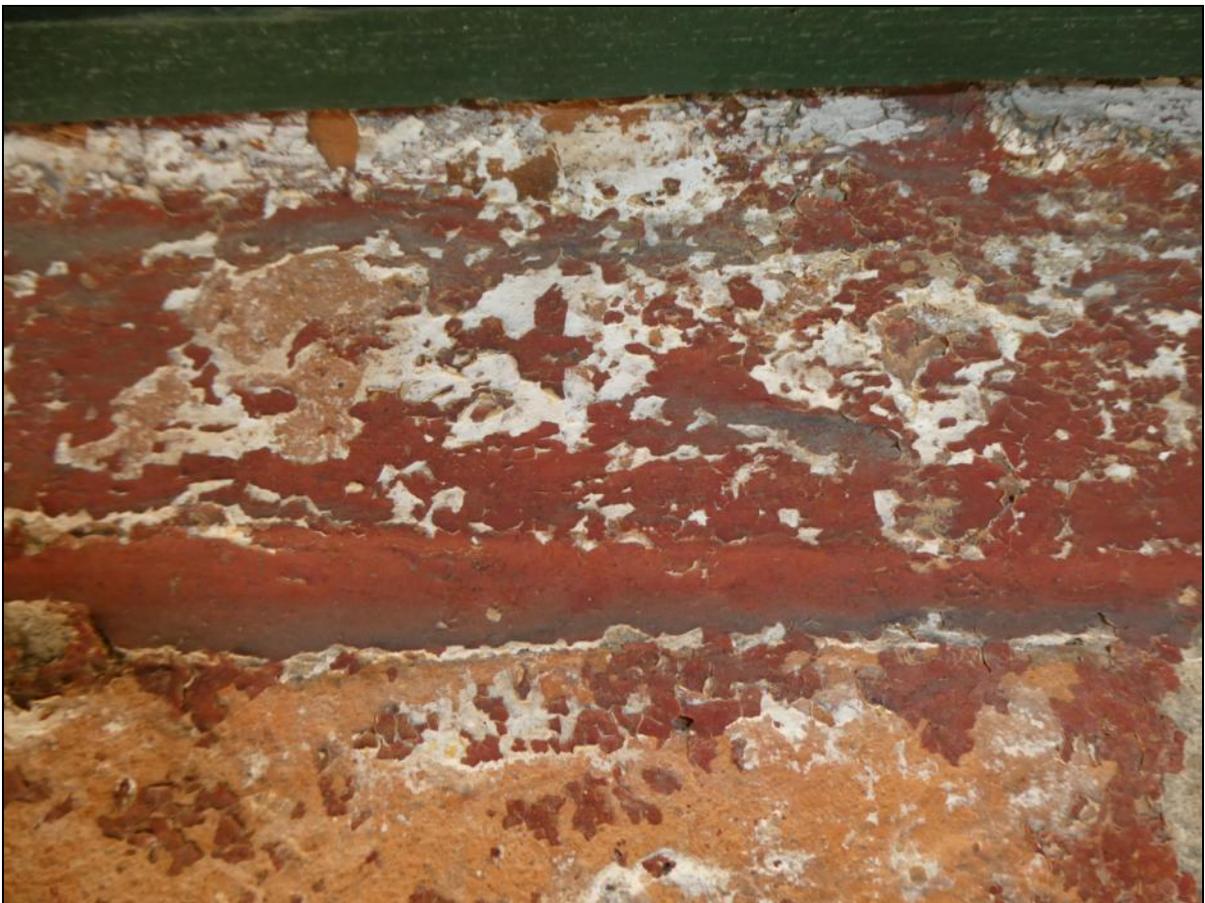
- Some of the brick beneath the eaves of the roof show signs that the masonry had been painted at one time as shown in Photos 27 and 28. Depending on the type of coating used and the amount of time that it covered the exterior, this may be a contributing factor to the advanced erosion within some areas of the masonry.

Photo 28 Remnants of an earlier coating in another area.

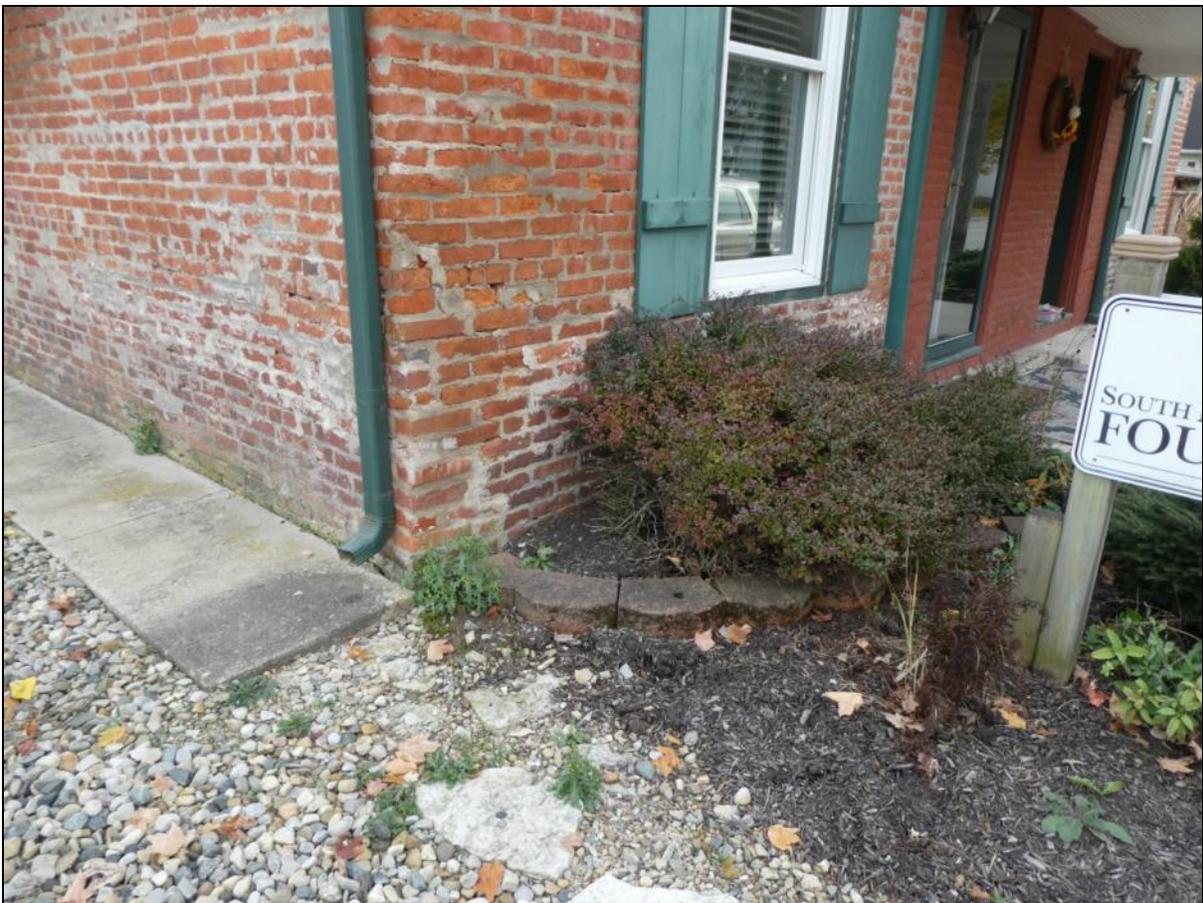
- Landscaping on the Main Street elevation is close enough to the wall to trap moisture within the masonry as shown in Photos 32 and 33. A heavy layer of mulch can be a pathway for moisture and insects to enter the building as shown in Photo 34. A downspout on the southern end of the building empties directly into the planting bed, directing a large amount of water into this area. See Photo 35.

Photo 32 Landscaping near the front entrance encroaches on the masonry.

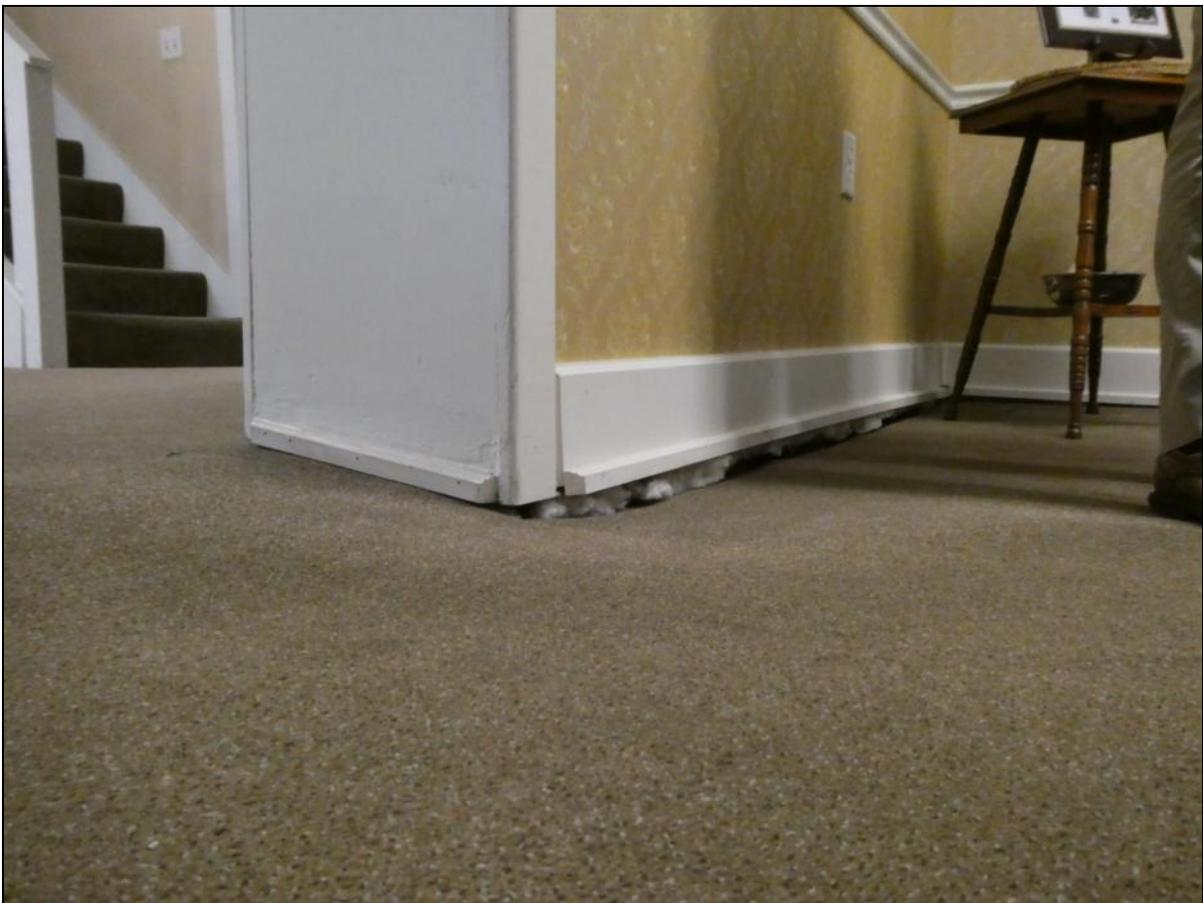
A significant slope was evident in the southernmost office on the first floor. Further investigation led us to the conclusion that insect damage was the root cause of the deformation. Repair efforts will require the removal and reconstruction of the floor joists in this area.

- A notable slope was observed within the southernmost office on the first floor. The displacement measured almost five inches over four feet near the office door. We were able to utilize our remote-controlled camera to observe the condition of the framing in this room from the crawlspace below. Many of the framing members observed contained what we believe to be insect damage. Repairs to this area will require removal of the finish floor in order to access and replace damaged joists. See Photos 36 through 40.

Photo 36 Obvious displacement near the doorway to the southernmost office.

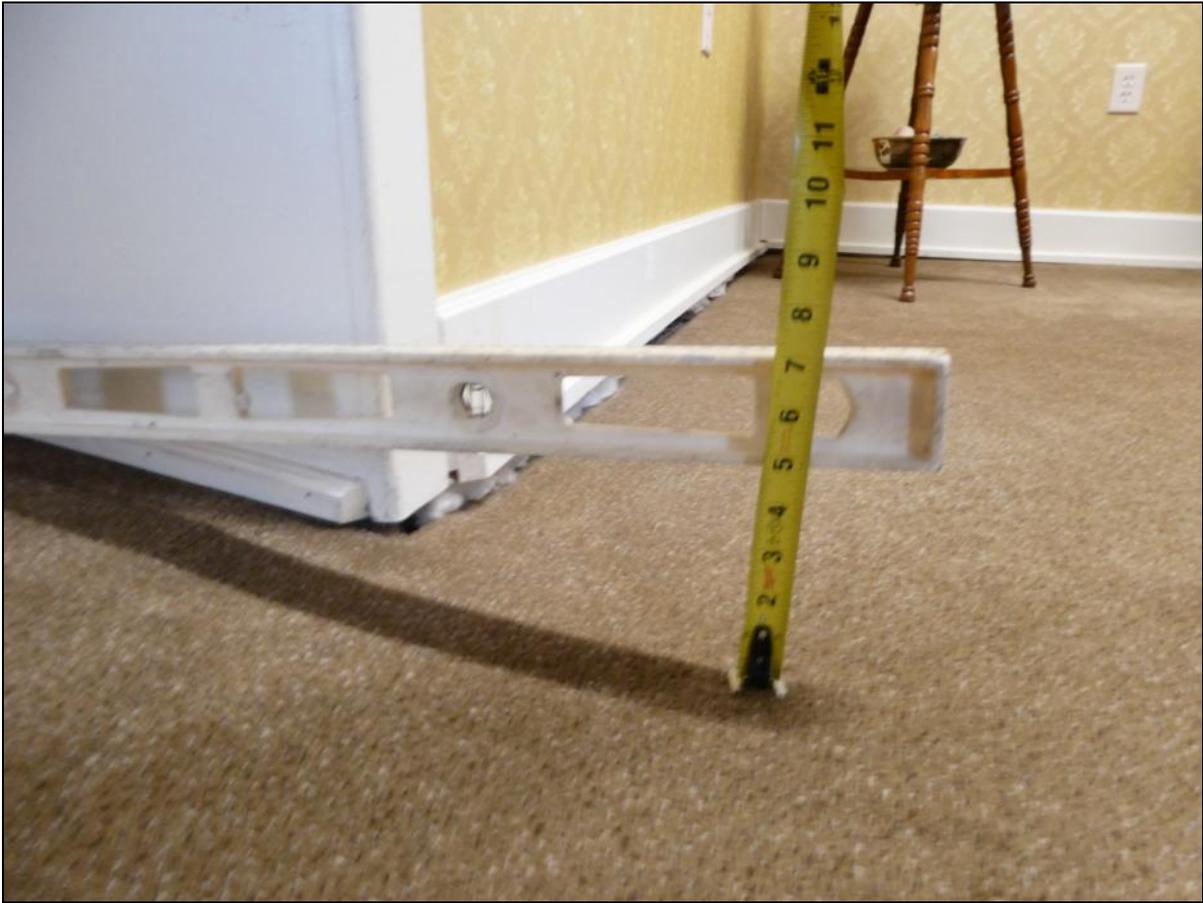
Photo 37 Displacement measures almost five inches over four feet.

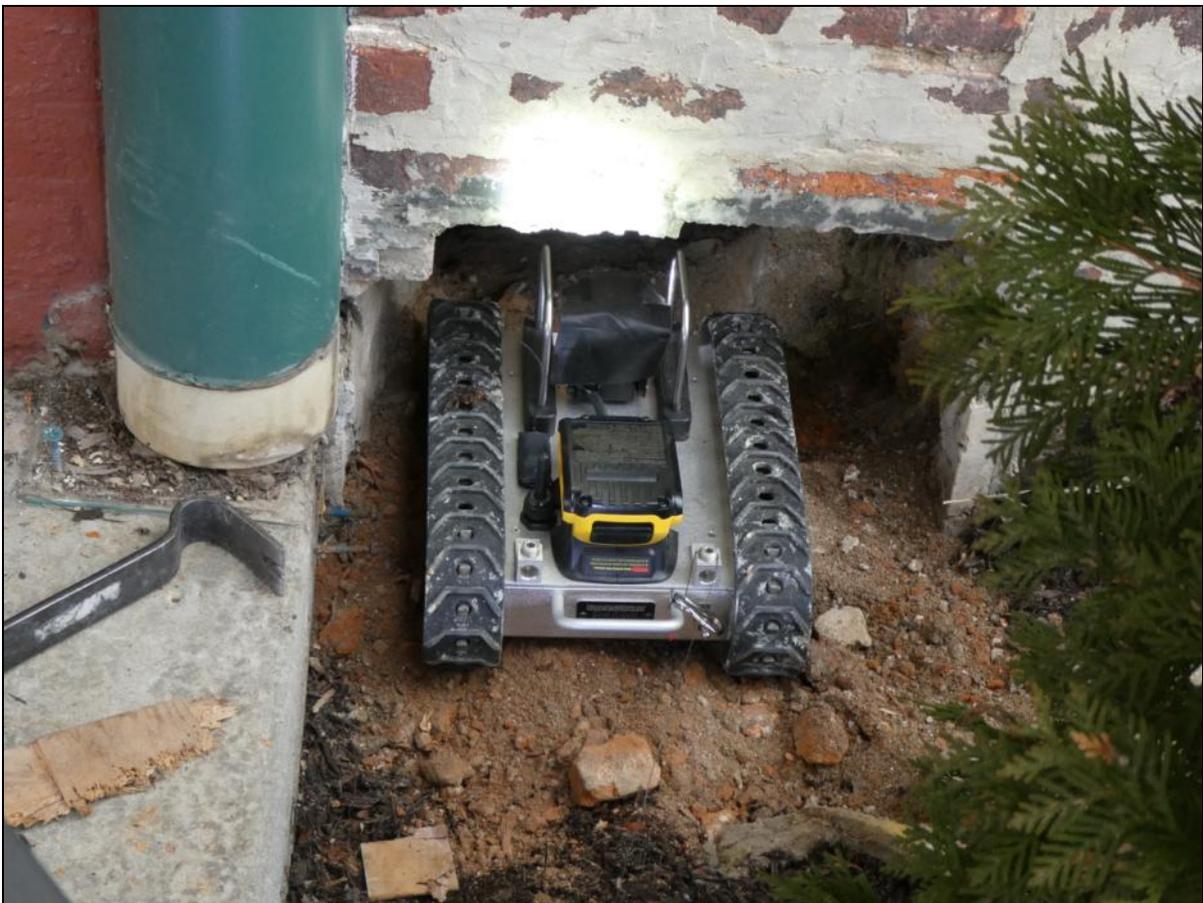
Photo 38 A remote controlled camera was used to provide views of the framing beneath this area.

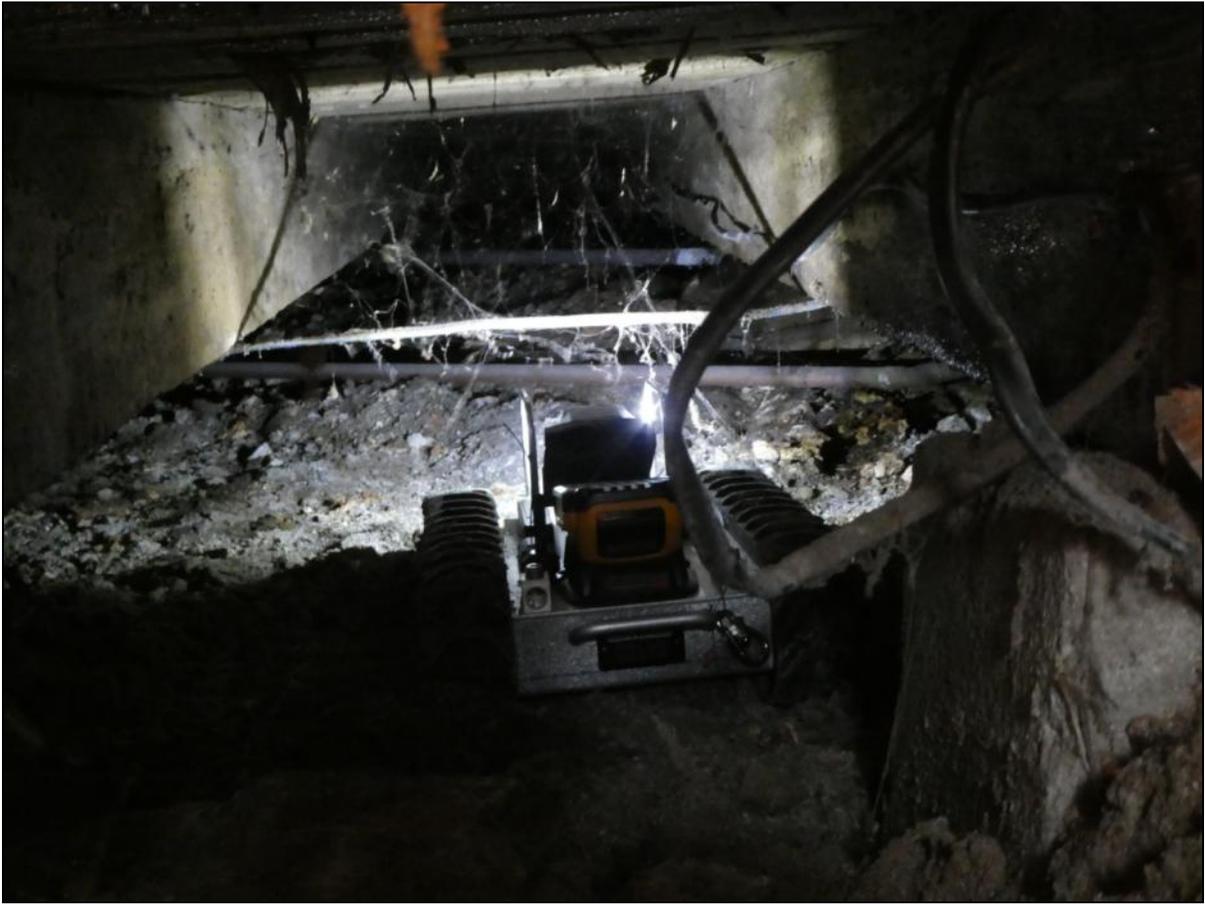
Photo 39 The floor rests over a shallow crawl space.

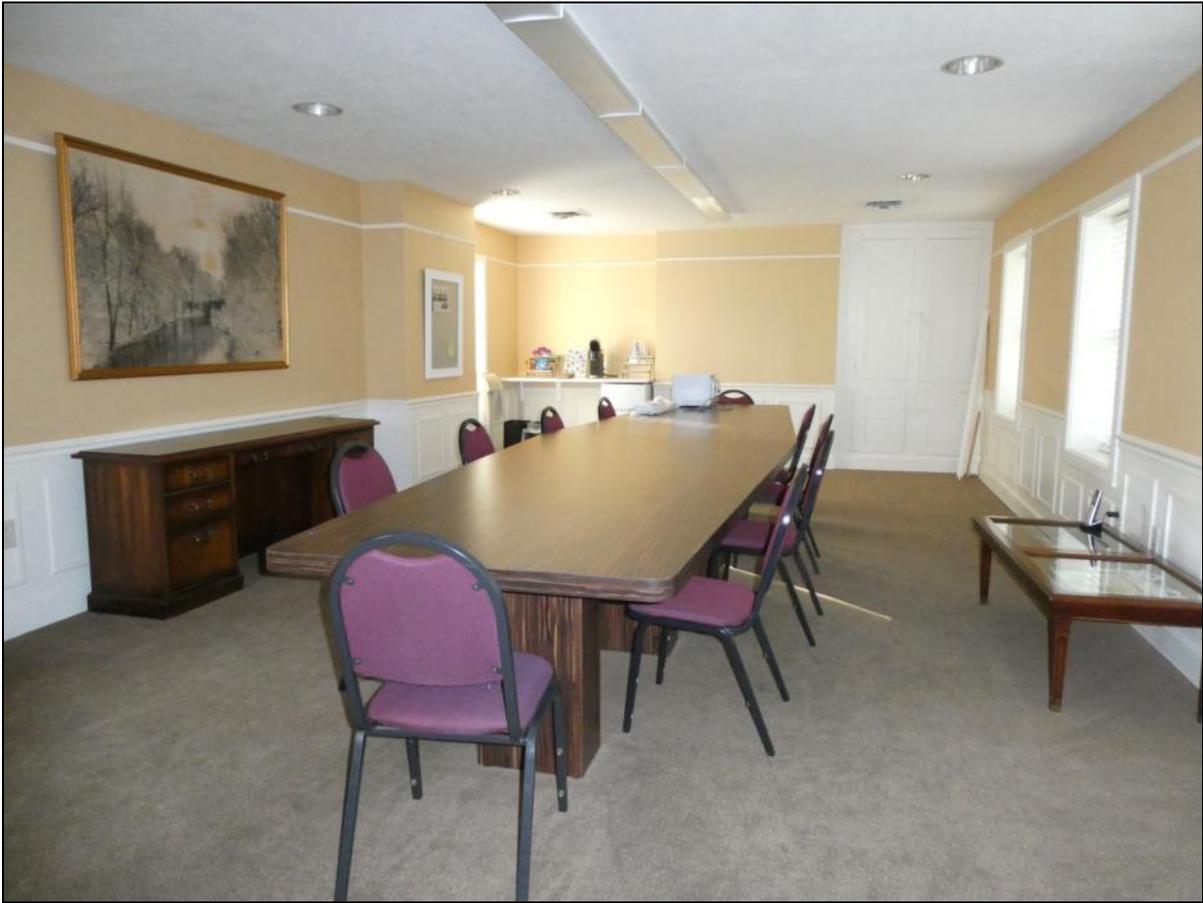
- Failed paint and some slight displacement were observed above a built-in cabinet on the south elevation of the second-floor conference room as shown in Photos 41 through 44. Damage is believed to be due to moisture infiltration from the flashing around the masonry chimney on the south end of the building.

Photo 41 The conference room on the second floor.

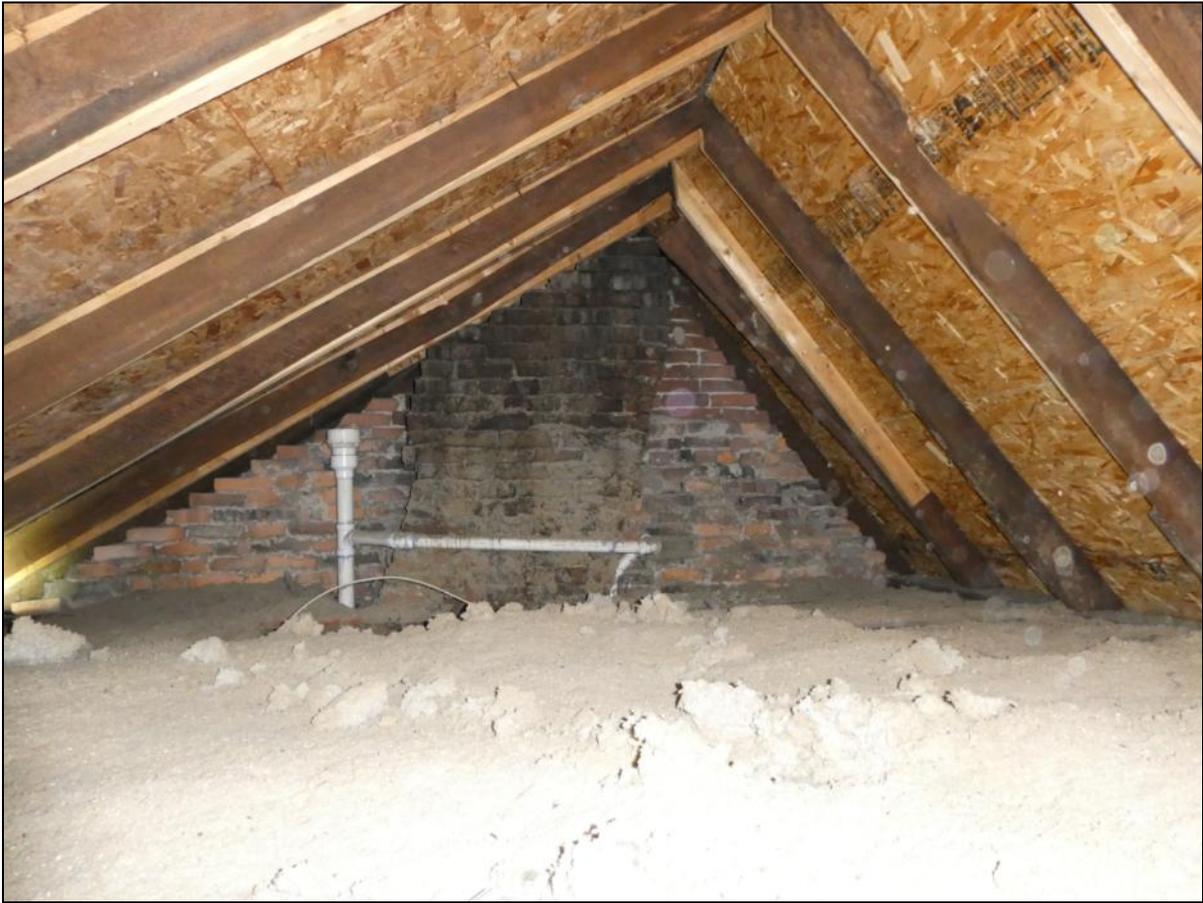
- A section of the attic was observed from an entry point on the second floor as shown in Photo 45. Many of the attic members have been supplemented with new sistered framing members as shown in Photo 46.

Photo 45 A typical view of the attic.

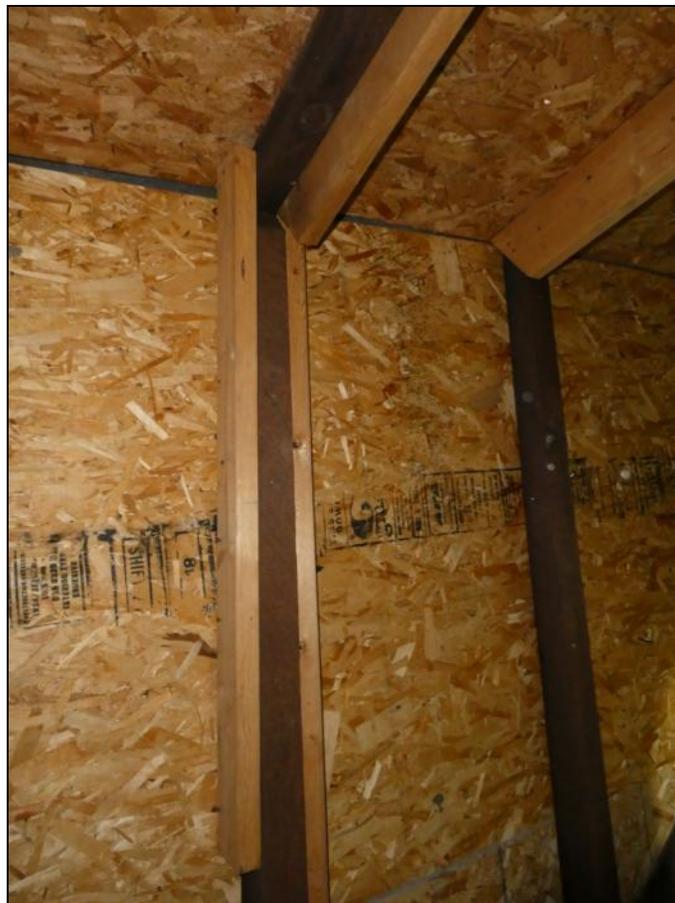
Photo 46 Supplemental framing has been installed in the attic.

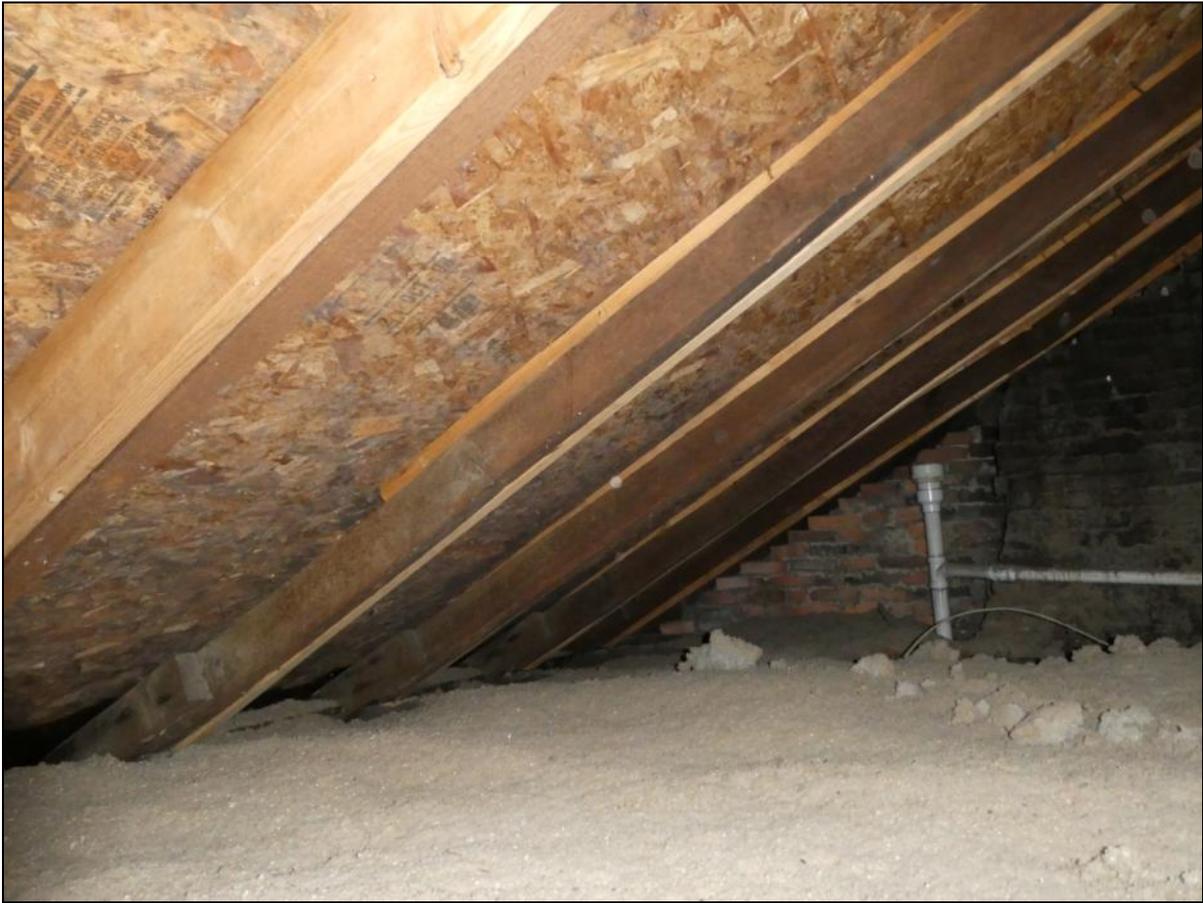
- A series of visibly wet and water-stained areas were found in the roof sheathing along the eaves as shown in Photos 47 and 48. Biological growth was observed on the underside of the sheathing in several areas as shown in Photos 49 and 50. These conditions are believed to be the result of inadequate ventilation of the attic space, resulting in condensation and the subsequent biological growth.

Photo 49 Biological growth on the rafters and OSB decking.

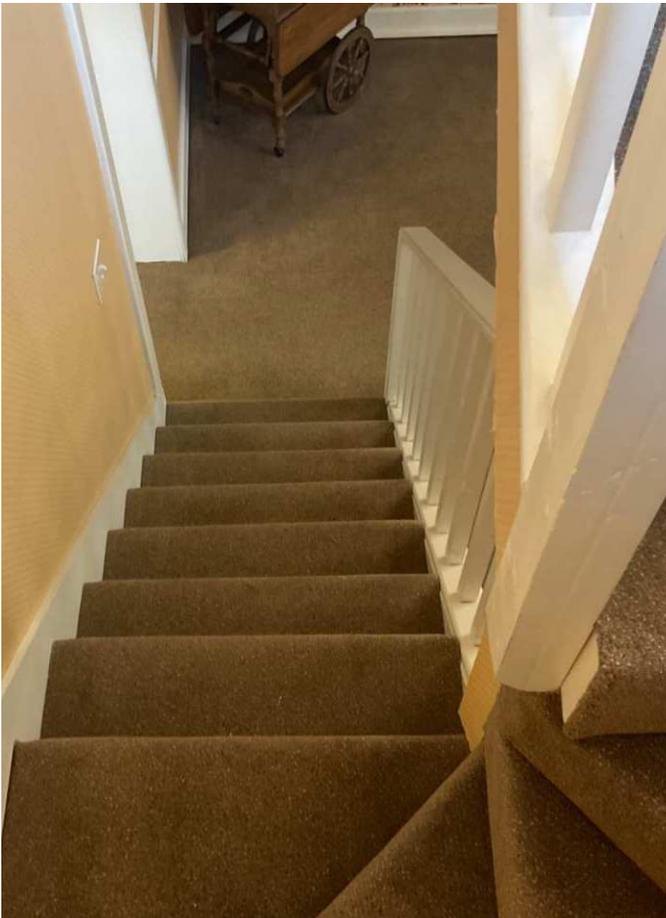
2. Open stairs and second-floor thermostat.

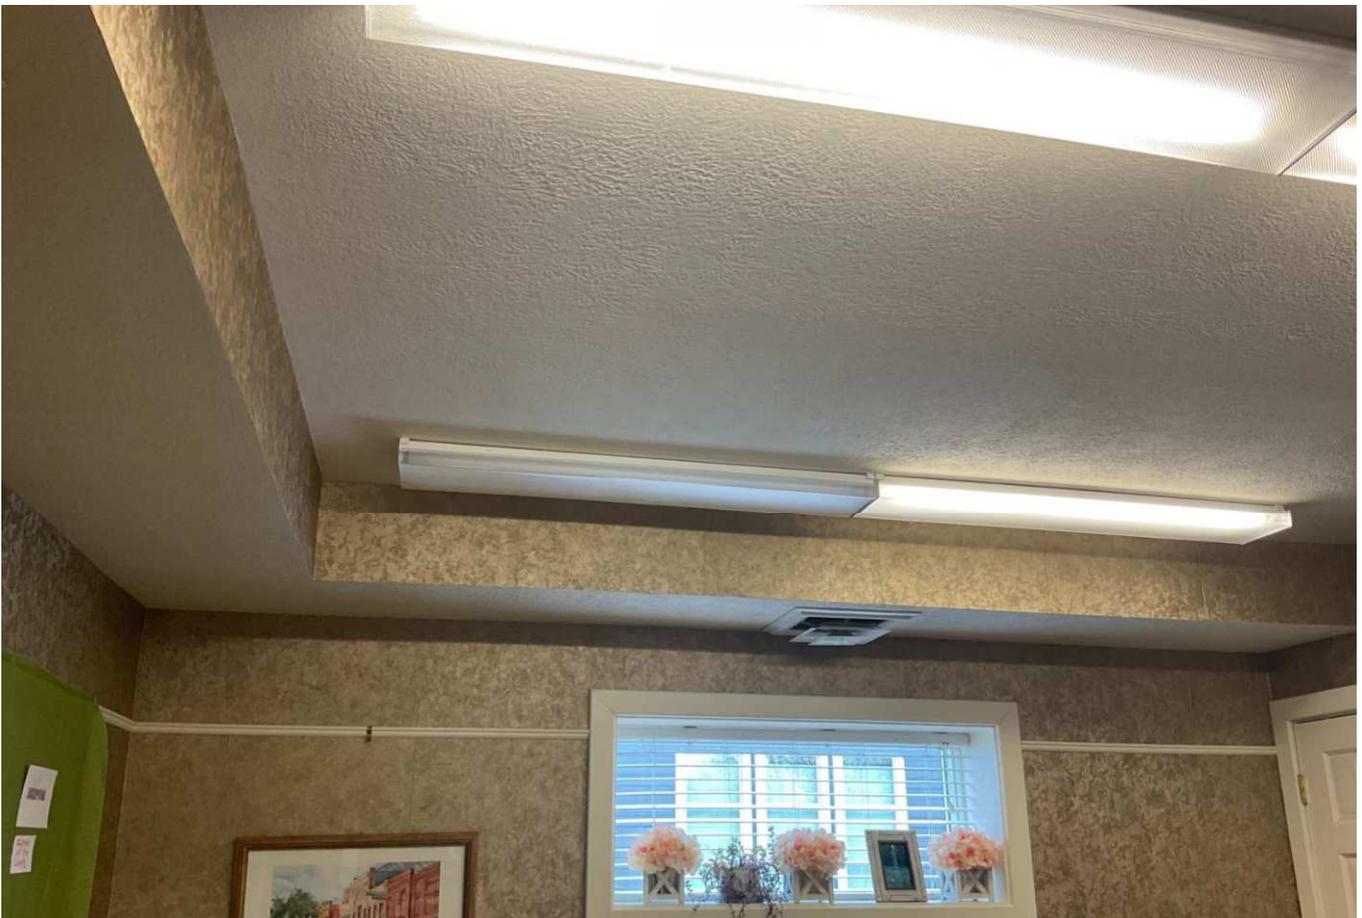
4. Existing bulkhead for ductwork to northeast closet.

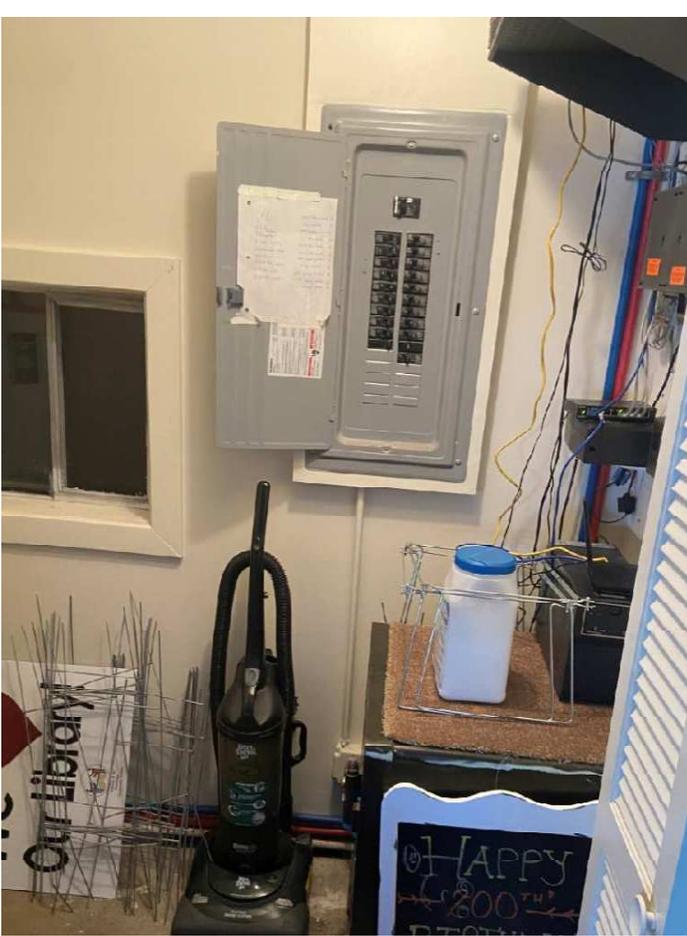
5. Residential load center and HVAC line set and incoming IT wires.

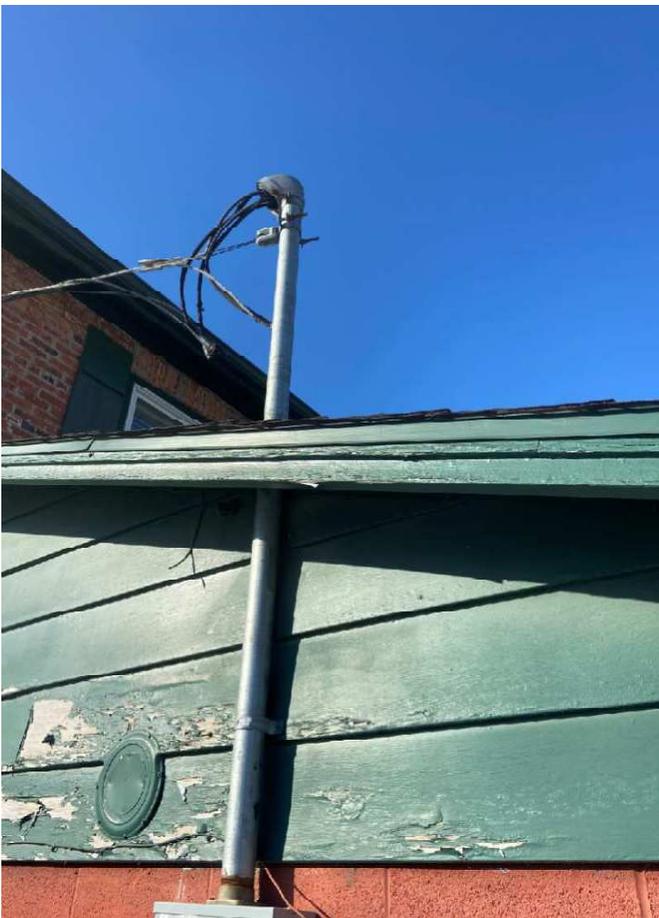
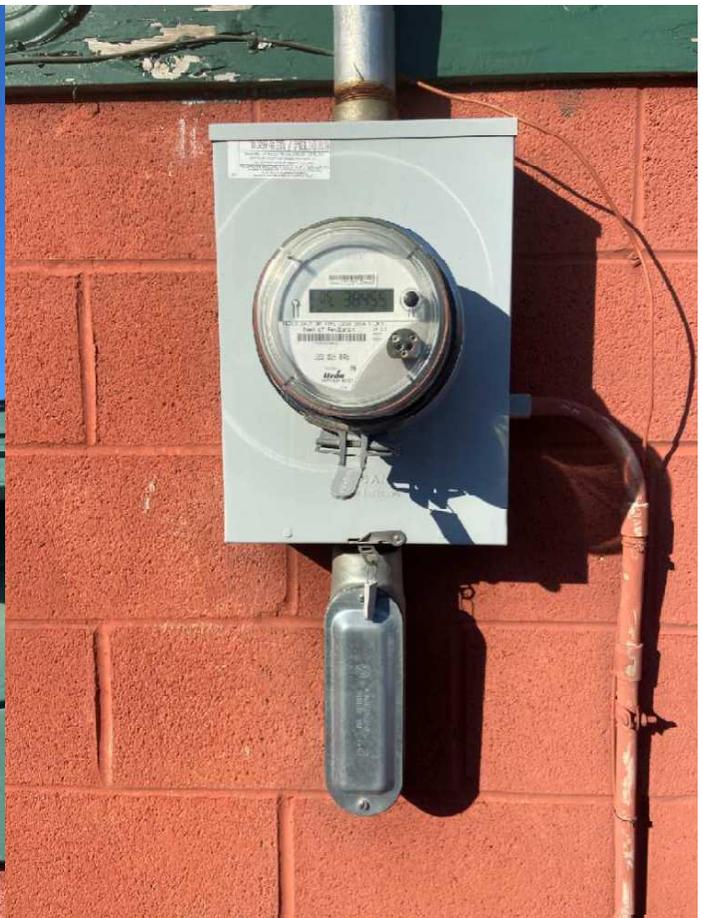
6. Overhead Incoming electrical service.

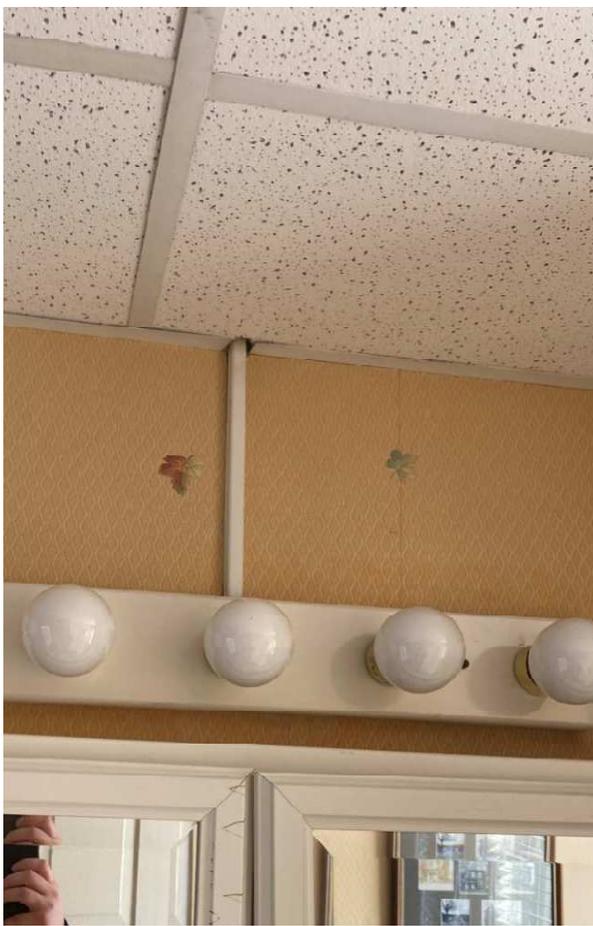
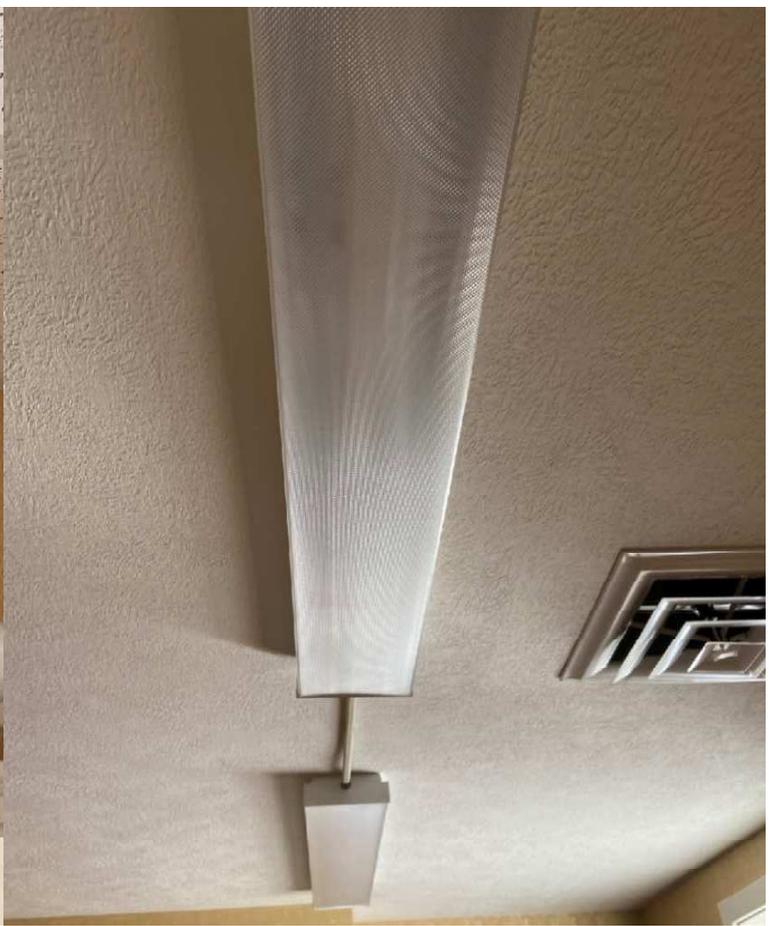
7. Exposed NM-B wiring and surface-mounted fluorescent lighting.

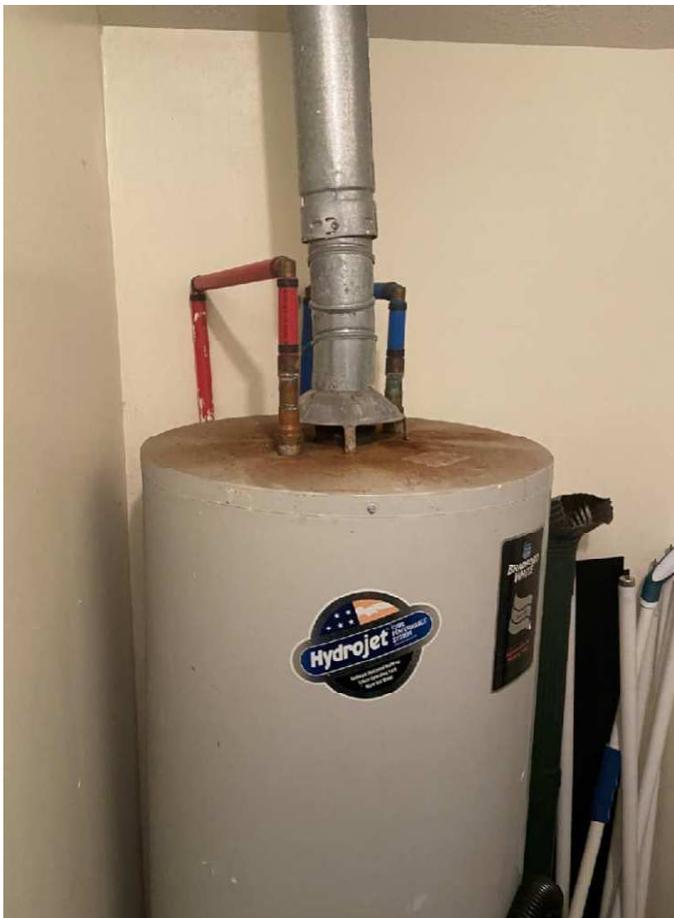
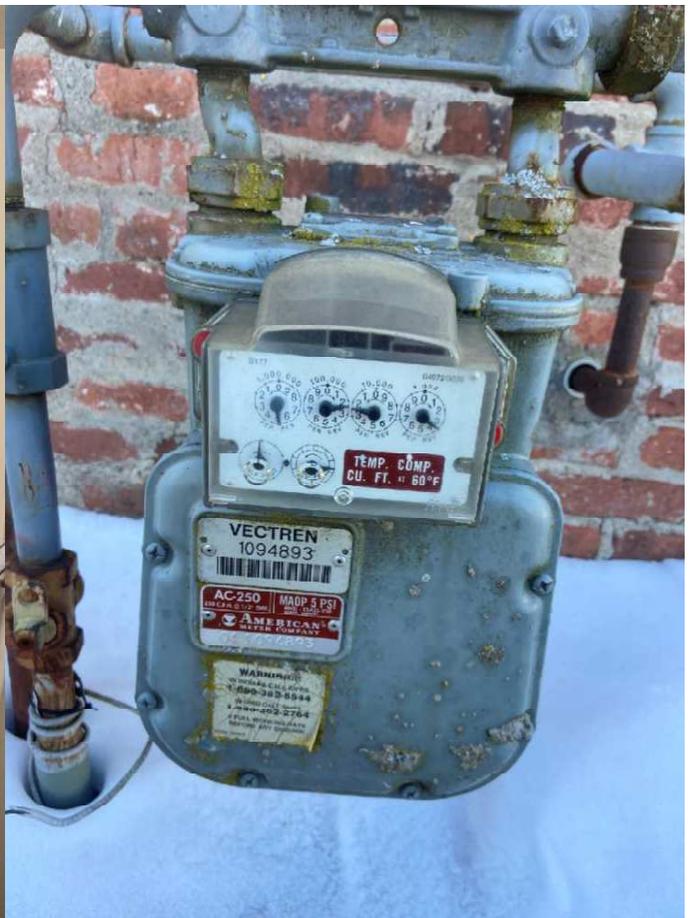
8. Water heater and gas meter.

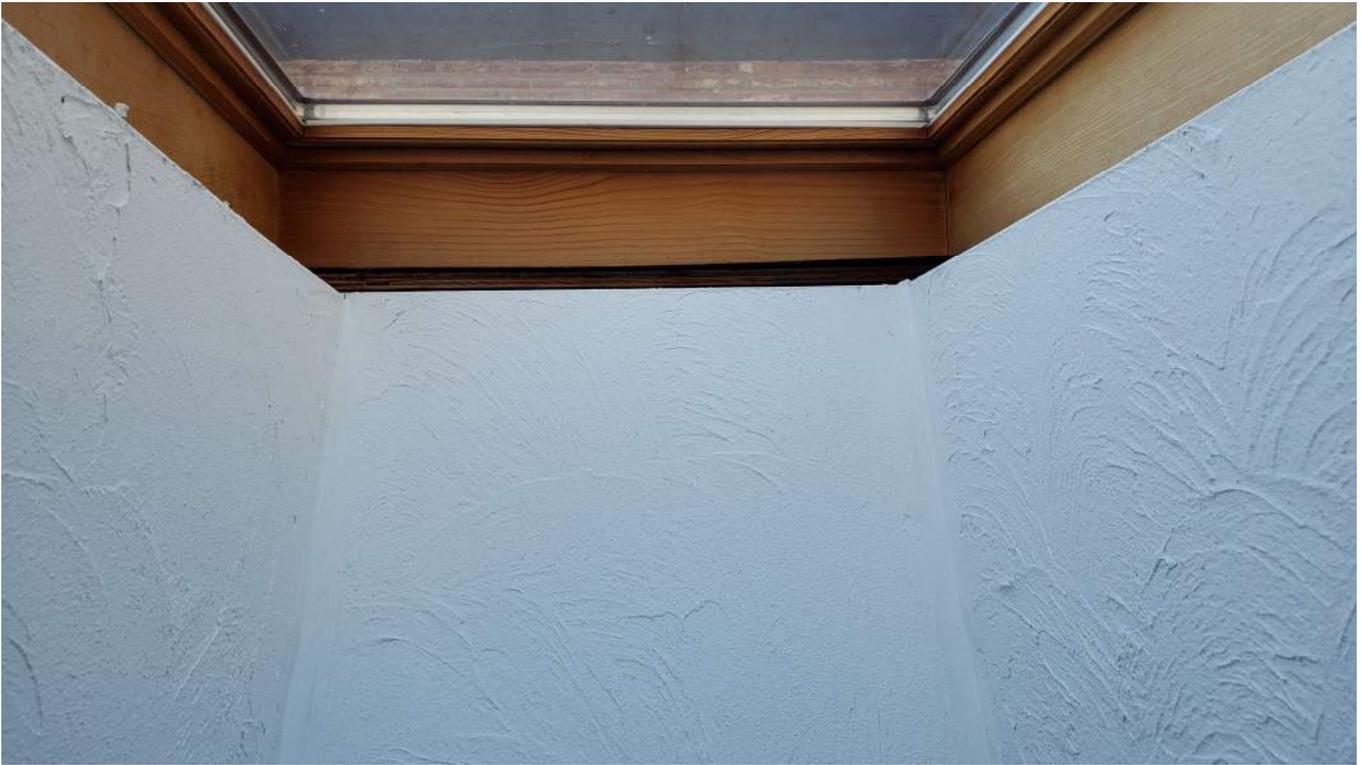
9. Skylight is in good working order.
